**AVIATION INVESTIGATION REPORT
A13A0033**

NOSEWHEEL FAILURE ON LANDING

**AIR LABRADOR LIMITED
DE HAVILLAND DHC-6-300, C-FOPN
ST. ANTHONY, NEWFOUNDLAND AND LABRADOR
27 MARCH 2013**

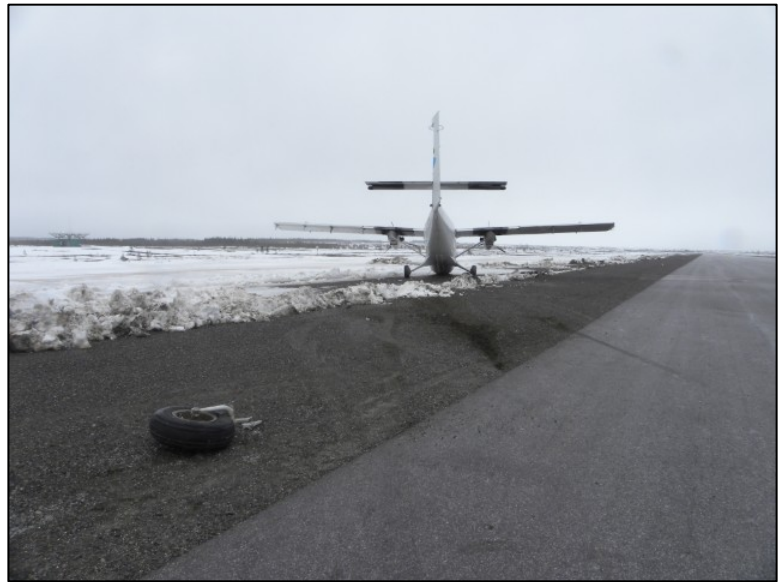
The aircraft yawed left, and the right wing tip momentarily contacted the runway surface. The aircraft slid on its nose for 488 feet, coming to rest off the north side of the runway, approximately 2000 feet from the runway threshold (Photo 1).

Photo 1. Occurrence aircraft, after coming to rest off the side of the runway (Source: Royal Canadian Mounted Police)

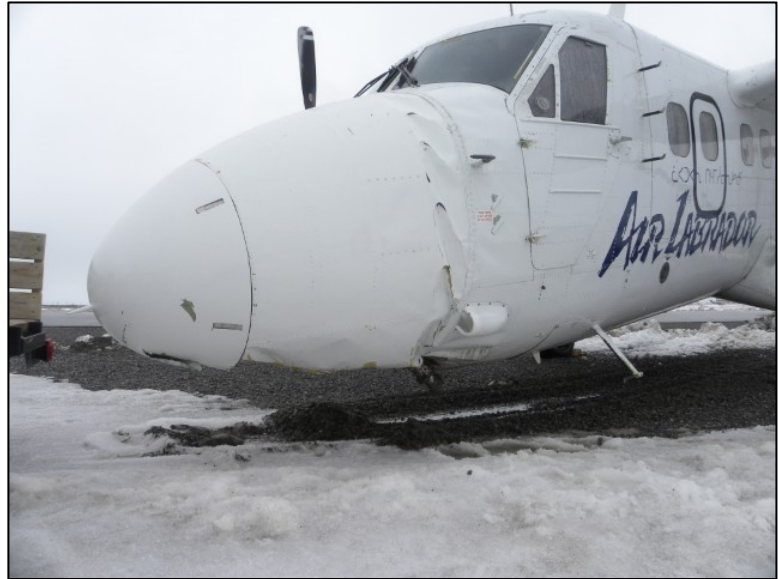
The nosewheel and a portion of the nose fork detached from the nose landing gear (NLG) strut, and the aircraft collapsed onto the NLG strut (Photo 2).

The lower end of the NLG strut was displaced aft, and the structural bulkhead where it is installed was deformed along with various airframe skins and structural components of the fuselage nose section and cockpit floor.

Photo 2. Damaged occurrence aircraft during recovery
(Source: Royal Canadian Mounted Police)

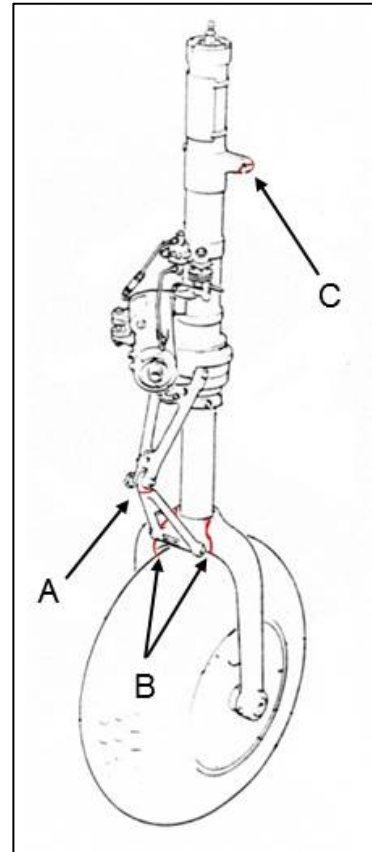
The NLG assembly, along with the attached steering actuator, (Figure 1) were sent to the TSB Laboratory.

The initial NLG failure occurred when the lower torque link arm fractured below the attachment point to the upper torque link arm (Figure 1, A). Additional failures were noted at points B and C in Figure 1.

All fractures were due to overstress, and there were no pre-existing conditions that would have contributed to the failure of the NLG.

Figure 1. Locations of the nose landing gear fractures
