**AVIATION INVESTIGATION REPORT
A13C0105**

LOSS OF CONTROL – COLLISION WITH WATER

**TRANSWEST AIR LIMITED PARTNERSHIP
DE HAVILLAND DHC-3 OTTER, C-FSGD
IVANHOE LAKE, NORTHWEST TERRITORIES, 7 NM S
22 AUGUST 2013**

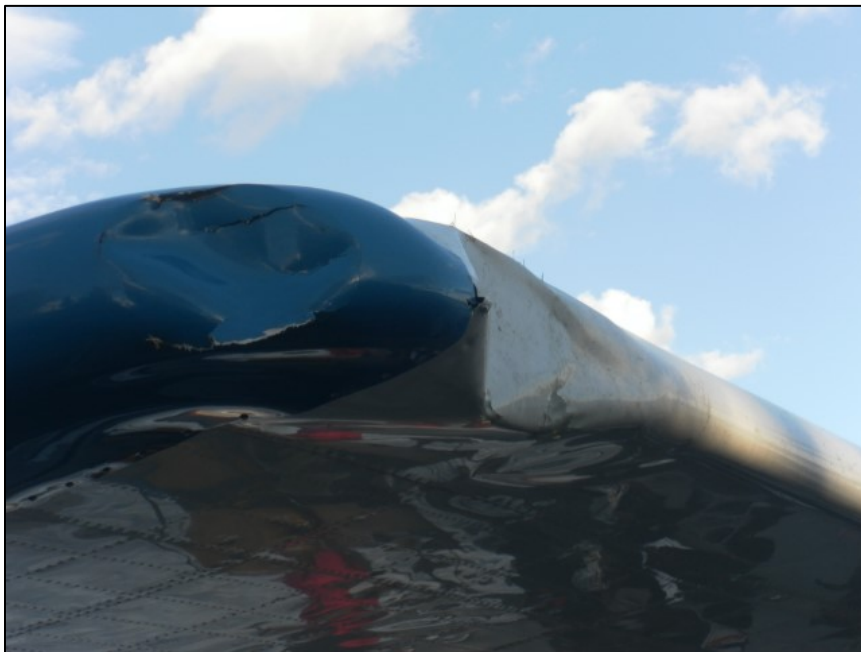
Photo 1. Right wing damage following tree strike (Source: passenger)

The pilot was aware that the wing had struck the stand of trees and with only a cursory glance at the wing, may have decided that the damage was minor in nature. A detailed inspection by a qualified person, as required by company policy, would have been required to determine the full extent of the damage to the wing, wing tip and wing attachment points. The impact with the water obliterated the damage caused by the tree strike, and this complicated the differentiation of damage caused by the 2 events.

1. During approach to landing on the previous flight, the right-wing leading-edge and wing tip were damaged by impact with several trees.
2. The damage to the aircraft was not evaluated or inspected by qualified personnel prior to take-off.
3. Cumulative unmanaged stressors disrupted the pilot's processing of safety-critical information, and likely contributed to an unsafe decision to depart with a damaged, uninspected aircraft.
4. The aircraft was operated in a damaged condition and departed controlled flight likely due to interference between parts of the failing wing tip, acting under air loads, and the right aileron.

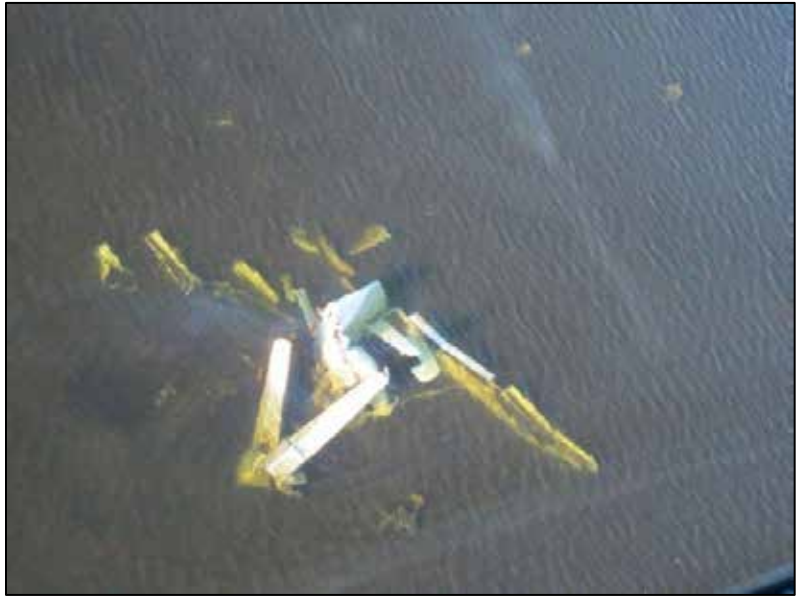
At the crash site, the aircraft wreckage was located in a shallow lake, submerged in approximately 6 feet of water (Photo 2). The lake bottom consisted of deep mud and silt. Depressions in the mud indicated that the aircraft had impacted almost vertically and that the floats and left wing impacted first. All major components were located within an area not much larger than the aircraft itself. The left and right wings were separated from the fuselage, although they remained connected to each other by the rear-spar fuselage carry-through structure (hoop). The fuselage was broken into several major pieces.

Photo 2. Aircraft wreckage (Source: Transwest Air)

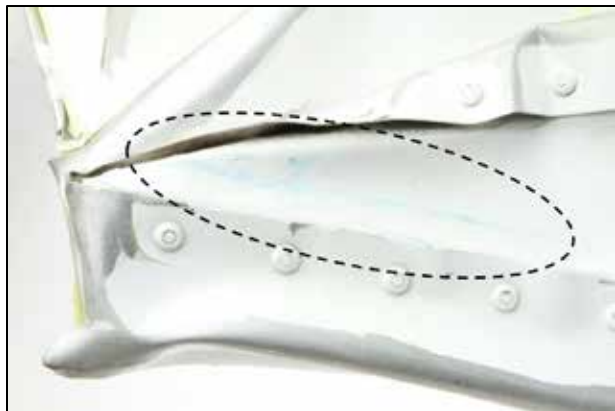
Photo 3. Paint transfer on aileron rib

The wing tip was damaged during the tree strike at Scott Lake. On the subsequent flight, the aircraft flew for approximately 17 minutes and indicates that the factors that led to the apparent loss of control took a period of time to develop. The broken edges of the fibreglass wing tip would have been exposed to the airstream. The wing tip was also subjected to a rise in internal pressure due to ram air entering through the breaks in the fibreglass. The wing tip was likely breaking apart under the combination of these forces. The chord-wise dent and scratch marks on the outboard aileron rib as well as the transfer of blue paint from the wing tip to adjacent aileron components indicates that parts of the wing tip were being pressed against the aileron in flight. Air loads may have forced the remaining aft portions of the wing tip under, or over, the aileron. The blue paint transfer to the top surface of the aileron skin indicates that some wing tip parts moved over the aileron.

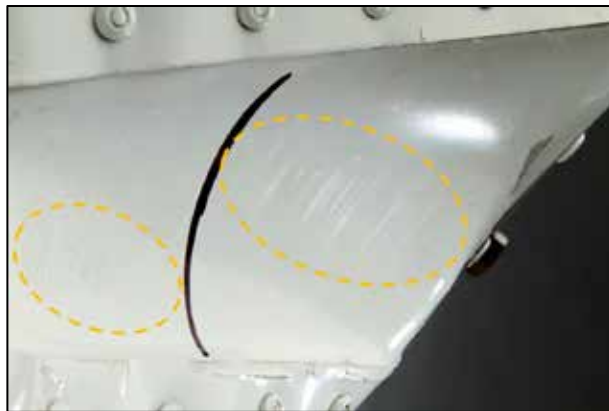
Photo 4. Scratches on aileron rib

It is likely that parts of the failing wing tip, acting under air load, interfered with the right hand aileron. The degree of interference could not be conclusively established but it likely would have been sufficient to affect the pilot's ability to control the aircraft. The uneven, side-loaded wear at the outboard aileron hinge and off-axis scrubbing of the mass balance indicate that the right aileron had likely begun to twist and oscillate over its full travel prior to the impact with the water. It is not known whether the twisting was caused by air-loads that developed after the loss of control or by attempts by the pilot to free the aileron.
