**AVIATION INVESTIGATION REPORT
A13P0278**

AERODYNAMIC STALL - COLLISION WITH TERRAIN

**CBE CONSTRUCTION LTD.
CESSNA C-185E, C-FQGZ
WEST CRACROFT ISLAND, BRITISH COLUMBIA
24 OCTOBER 2013**

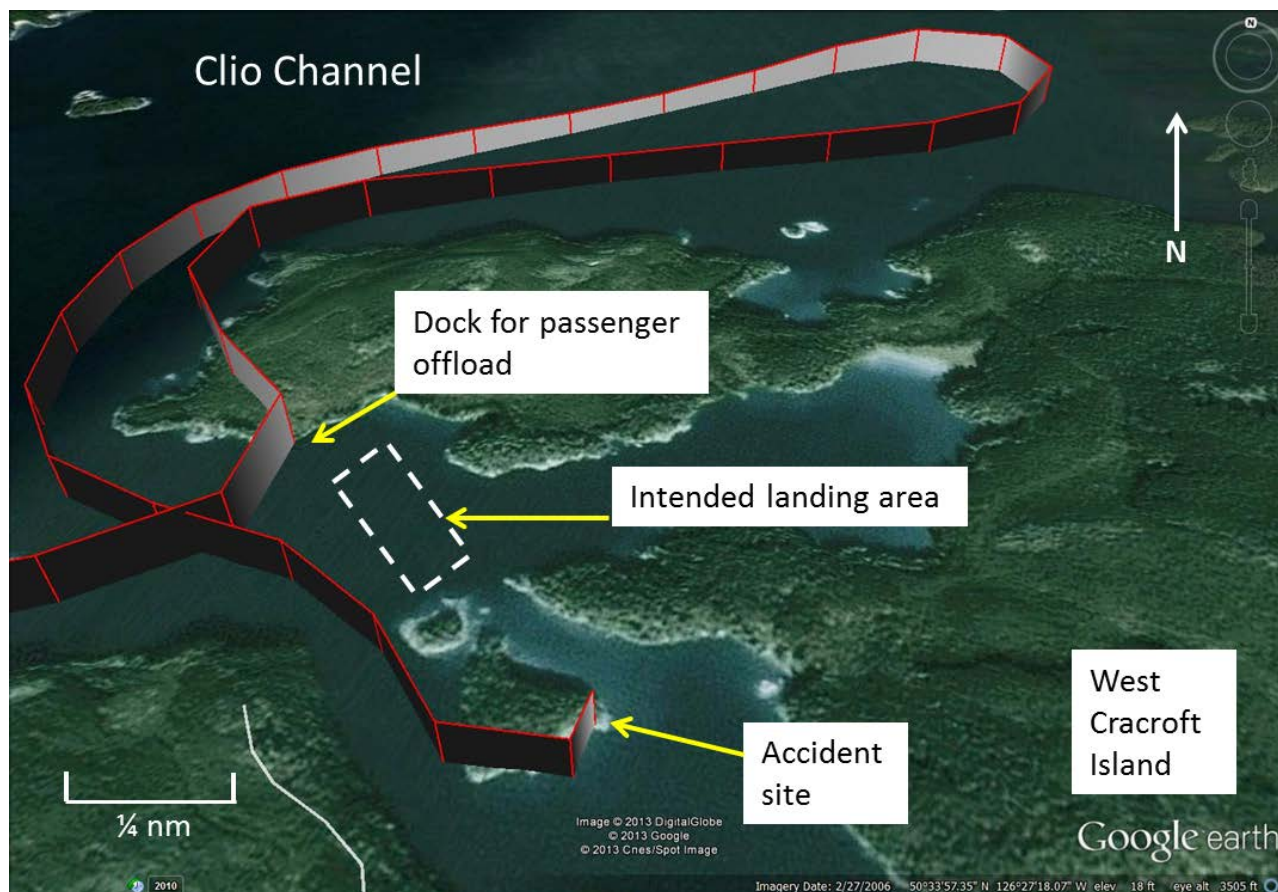
At 1135, near the entrance of Potts Lagoon, the aircraft was observed approaching from the west. It overflew the log sorting area at an altitude of about 300 feet asl before continuing across the island and out of sight to the northeast (Figure 1). After a short period of time it returned into view. The aircraft continued to fly at low level along the shoreline and entered the lagoon.

Shortly after entering the lagoon the aircraft commenced a steep left turn back towards the intended landing area. During the turn, the aircraft rolled very steeply to the left; this was accompanied by an abrupt increase in engine sound. The aircraft crashed into tall trees on a small island in the centre of the lagoon.

Figure 1. Aircraft flight path (Source: Google Earth, with TSB annotations)

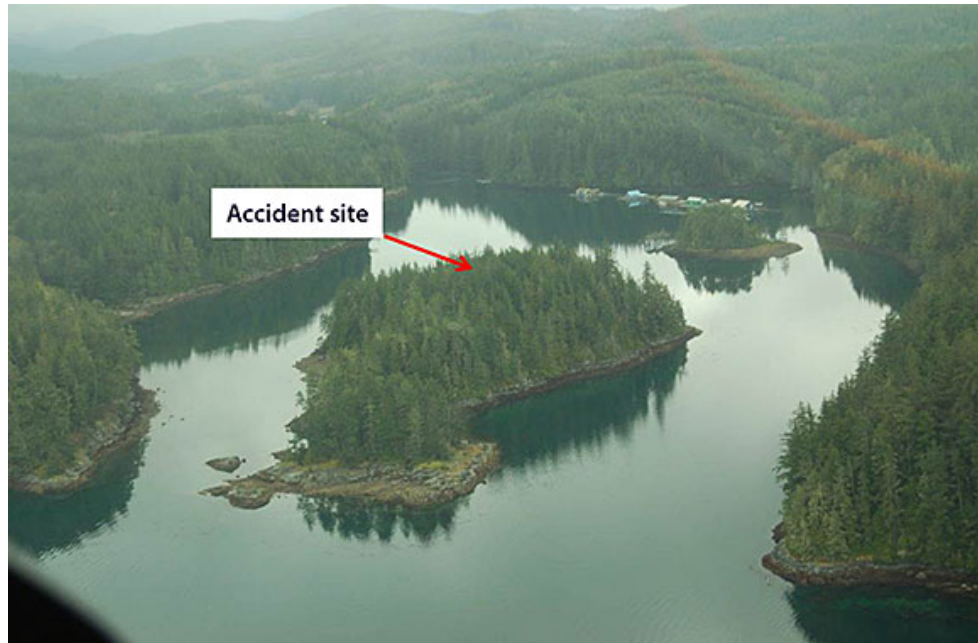
The aircraft came to rest, almost inverted, in heavily wooded terrain at an elevation of 27 feet asl on the larger of the 2 islands located in the entrance to Potts Lagoon (Photo 1). Tree heights in the area surrounding the accident site were approximately 75 to 80 feet above ground level (agl). Impact scarring on these trees showed the final track of the aircraft was about 350° magnetic, and that its descent angle was initially about 70° below horizontal, and steepened to vertical after it struck a stand of large trees (Photo 2).

Photo 1. Accident site looking south (Source: Sealand Aviation Ltd.)

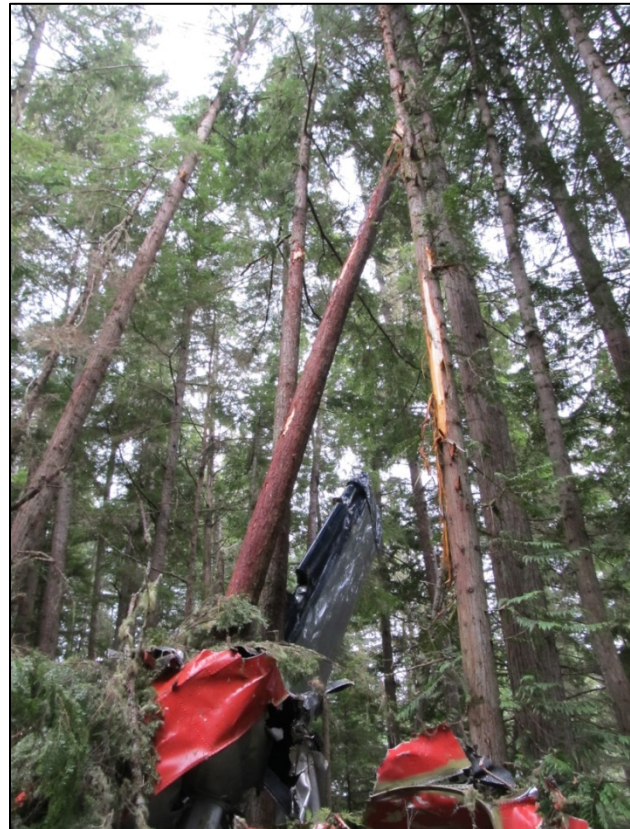
Impact damage on the airframe indicated that the initial tree contact occurred while the aircraft was in a nose-down attitude of about 15° and left bank of about 60°. Upon impact, the left wing, left horizontal stabilizer, and vertical stabilizer separated from the airframe.

Photo 2. Wreckage and tree strike damage

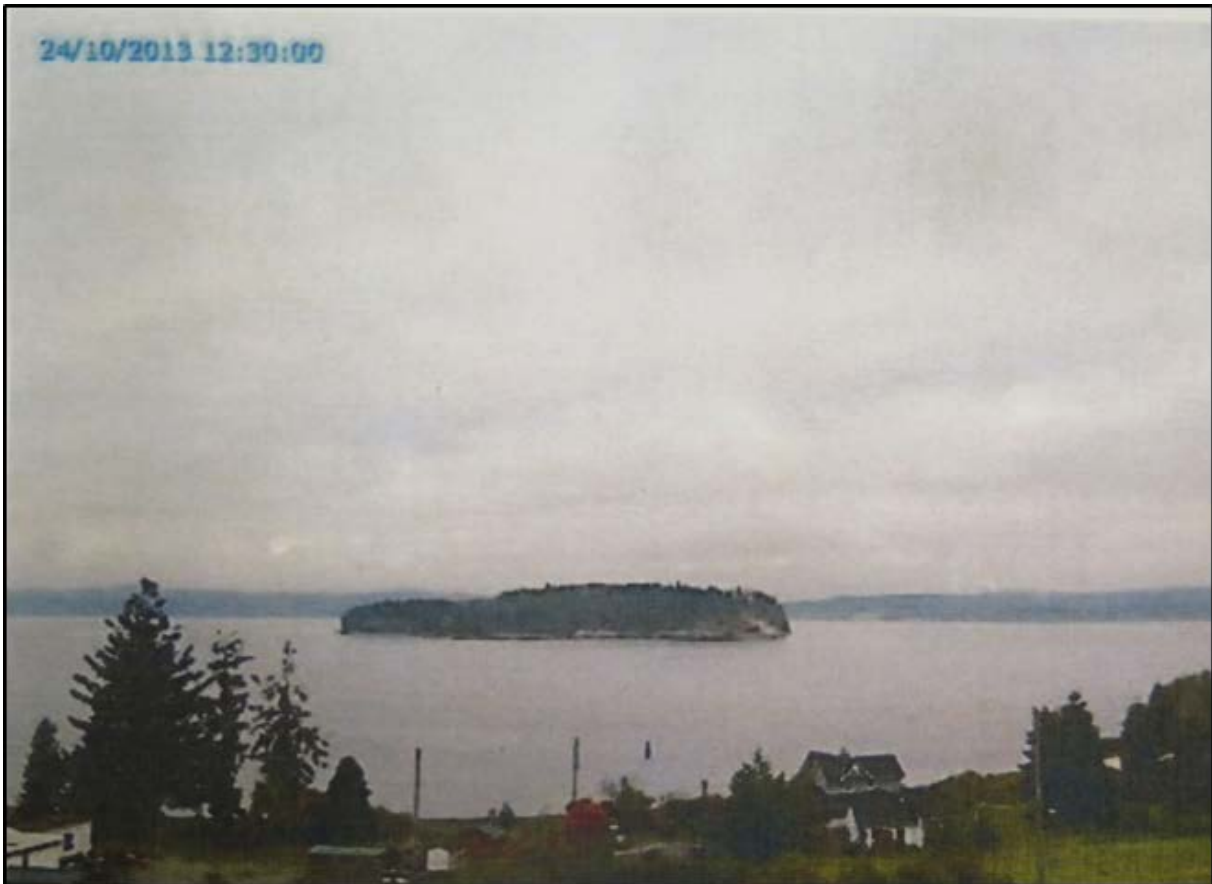
On the day of the accident, localized areas of low ceiling and visibility were present in the vicinity of Port McNeill and West Cracroft Island.

Photo 3. Image of weather in the vicinity of Port McNeill at the time of the accident (Source: Port McNeill Weather and Webcam)
