**AVIATION INVESTIGATION REPORT
A14C0112**

RUNWAY INCURSION

**WESTJET ENCORE LTD.
DE HAVILLAND DHC-8-402, C-FOEN
WINNIPEG RICHARDSON INTERNATIONAL AIRPORT
WINNIPEG, MANITOBA
04 AUGUST 2014**

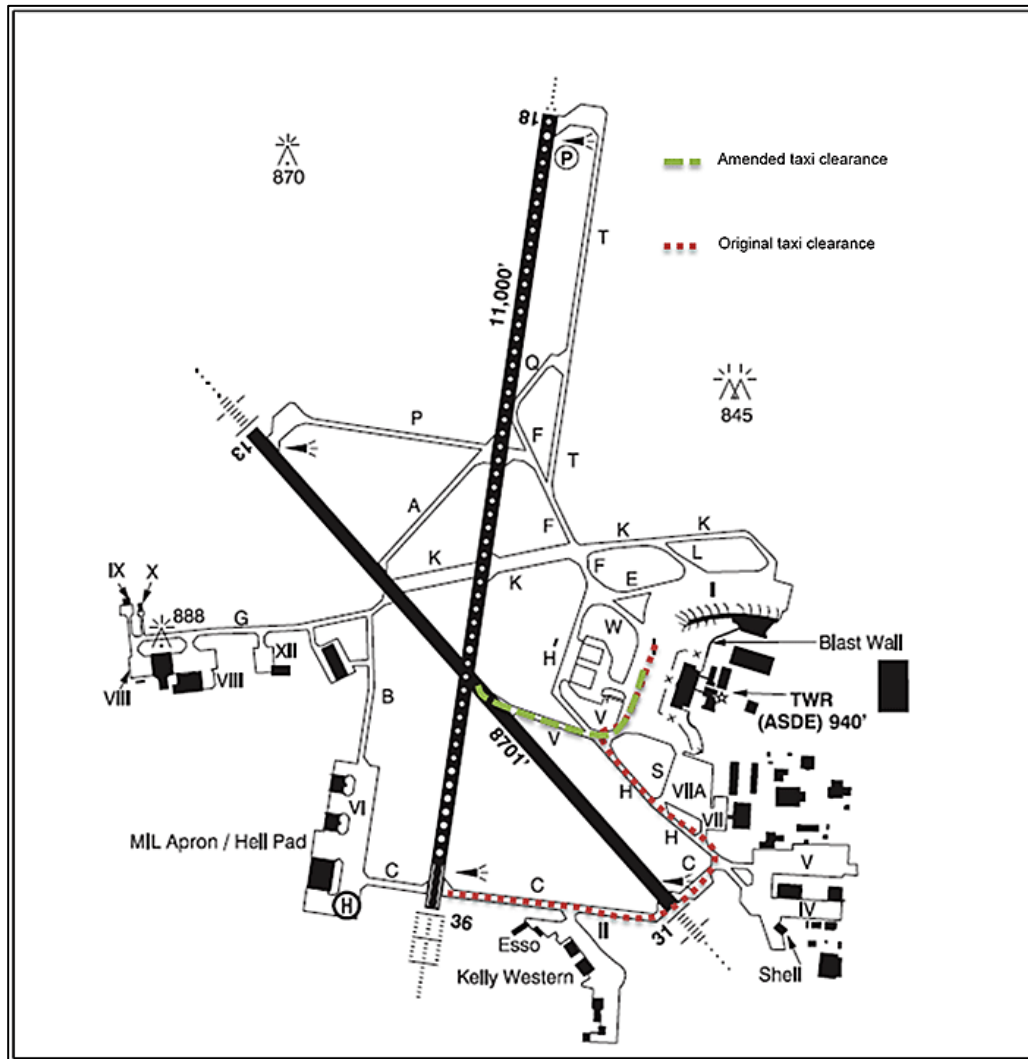
On 04 August 2014, WestJet Encore Ltd. flight WEN3112 was ready to taxi from Apron 1 at Winnipeg Richardson International Airport (CYWG), Winnipeg, Manitoba. The flight crew consisted of a captain and a first officer. The first officer requested a taxi clearance from the CYWG ground controller at 0856¹ for departure to Thunder Bay, Ontario. The ground controller issued a clearance to taxi for Runway 36 via taxiways Victor, Hotel, and Charlie, then across Runway 31 to hold short of Runway 36. The first officer acknowledged the clearance, and the captain began taxiing the aircraft as cleared (Figure 1).

Figure 1. WestJet Encore Ltd. flight WEN3112 taxi clearances (Source: NAV CANADA, *Canada Flight Supplement*, with TSB annotations)

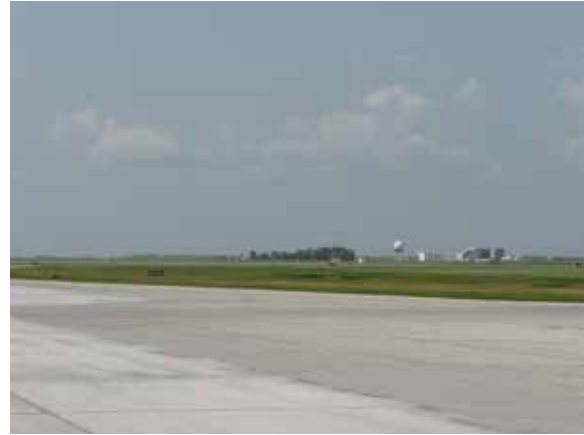
Runway holding position signs are also located at runway-to-runway and taxiway-to-runway intersections. These signs identify the runway that a taxiing aircraft or ground vehicle is approaching. “Holding position signs are also installed at runway-to-runway intersections when one runway is regularly used as a taxi route or when simultaneous intersecting runway operations⁵ are authorized.”⁶ At runway-to-runway intersections, the holding position signs are installed on each side of the runway. Holding position signs were installed at the intersection of Runway 31 and Runway 36, and conformed to existing standards (Photo 1, Photo 2, and Photo 3).

Photo 1. Right runway holding position sign and runway guard lights viewed from centre of Runway 31

In addition to the runway position signs, there were runway guard lights (RGL) installed to indicate the hold-short position. Since the left RGL was aimed 15 degrees away from Runway 31, this RGL was not visible to the pilots along the taxi route. Furthermore, the orientation of the right RGL relative to the aircraft's position and the reduced RGL intensity setting likely contributed to the pilots not identifying the hold-short position.

On 05 August 2014, the Winnipeg Airport Authority Inc. (WAA) repainted the degraded hold-short line on Runway 31 and realigned the runway guard light located on the left side of Runway 31 southeast of Runway 36. The WAA has also incorporated new procedures for return-to-service inspections and computer-based inspection tracking software that contains checklists and intervals for specific airfield elements inspections.

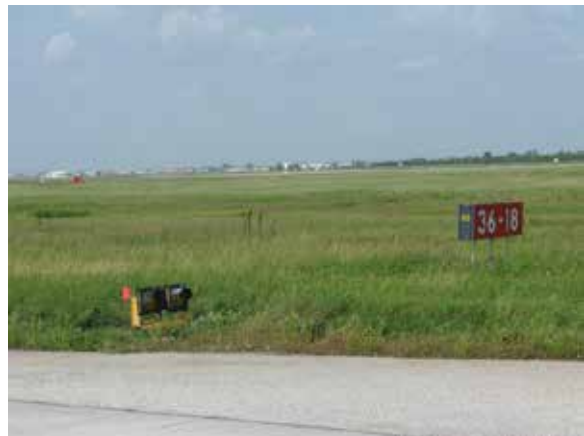
Photo 2. Right runway holding position sign and runway guard lights viewed from Taxiway Victor

Runway holding position signs were installed to indicate the hold-short position. However, the orientation of the runway holding position signs was optimized for traffic on Runway 31, which likely contributed to the pilots not identifying the hold-short position. As the aircraft approached Runway 31 from Taxiway Victor, the viewing angles of the holding position signs were more acute (Photo 1, Photo 2, and Photo 3), and the distance to the left sign was greater thus reducing the pilots' ability to notice the signs.

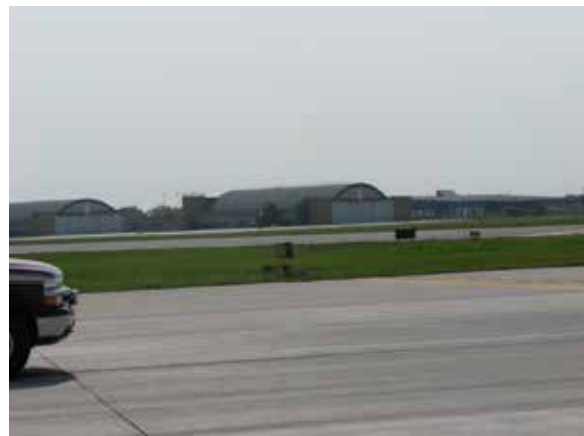
Photo 3. Left runway holding position sign and runway guard lights viewed from Taxiway Victor

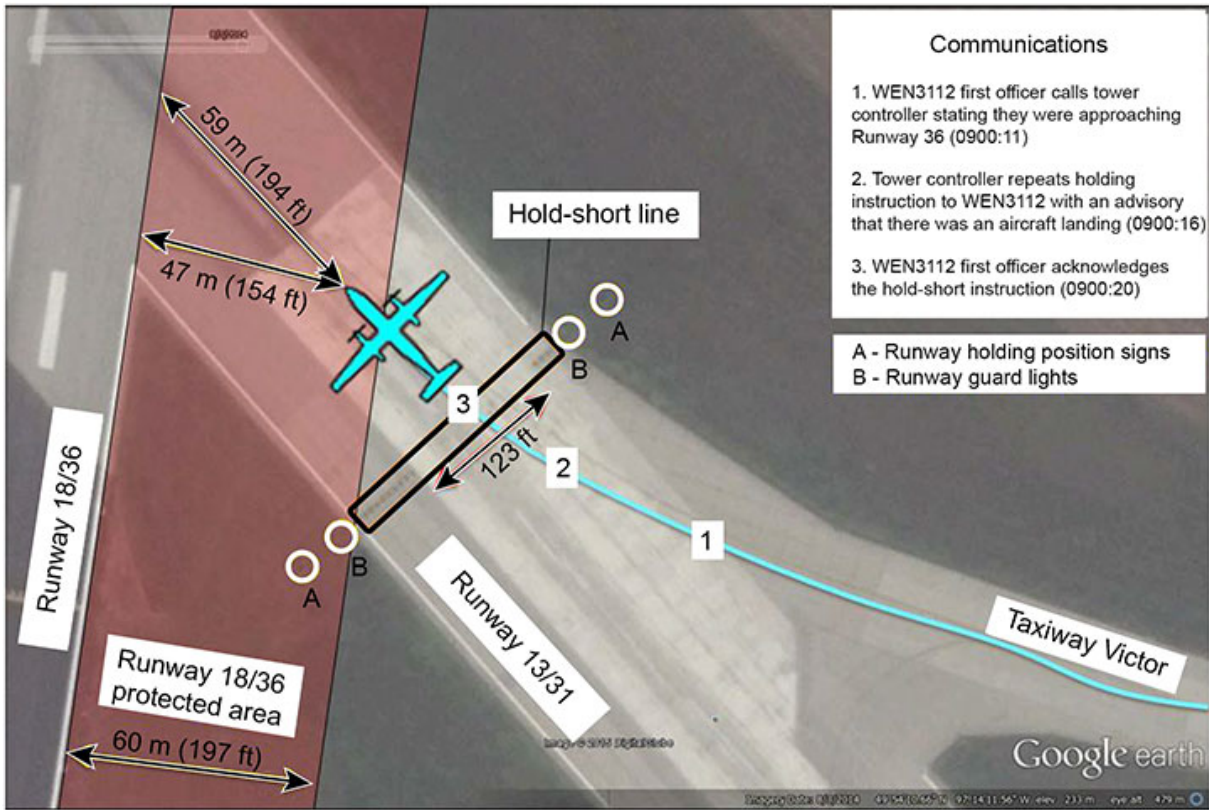
Appendix A – Runway incursion area

At CYWG, the runway protected areas extend 60 m outward from the edge of the active runway (Appendix A). Every taxiway-to-runway and runway-to-runway intersection at CYWG was equipped with all 3 defences listed above to identify hold-short positions outside the 60 m width of runway protected areas. However, the hold-short line southeast of Runway 36 on Runway 31 was significantly degraded. A satellite image, taken the day before the occurrence, shows the hold-short line was missing approximately 123 feet of paint (Appendix A).

TSB analysis of ASDE recordings showed the ground movement of WEN3112 to have been as follows: at 0900:18, as it was slowing, the aircraft breached the hold-short line; and at 0900:26, WEN3112 stopped with the nose of the aircraft approximately 47 m from the edge of Runway 36 (Appendix A).

On 03 August 2014, when the satellite image was taken, the hold-short line painted on Runway 31 southeast of Runway 36 was significantly degraded, with 123 feet of the line missing (Appendix A). The missing portion of the hold-short line was located on the centre section of the runway; the line was still present on the edges of the runway. As a result, the crew of WEN3112 did not see it and stopped in the runway protected area.

The aircraft was taxiing straight ahead on the centreline, and both pilots assessed that they had stopped at an adequate distance from Runway 36. The aircraft stopped 59 m from the active runway (Appendix A). However, due to the angle between Runway 31 and the active Runway 18/36, the aircraft was only 47 m from the edge of Runway 18/36 when it stopped
