AVIATION INVESTIGATION REPORT
A14O0077

LOSS OF CONTROL - COLLISION WITH WATER

CESSNA 185E, C-FYKU
TAYLOR LAKE, ONTARIO
24 MAY 2014

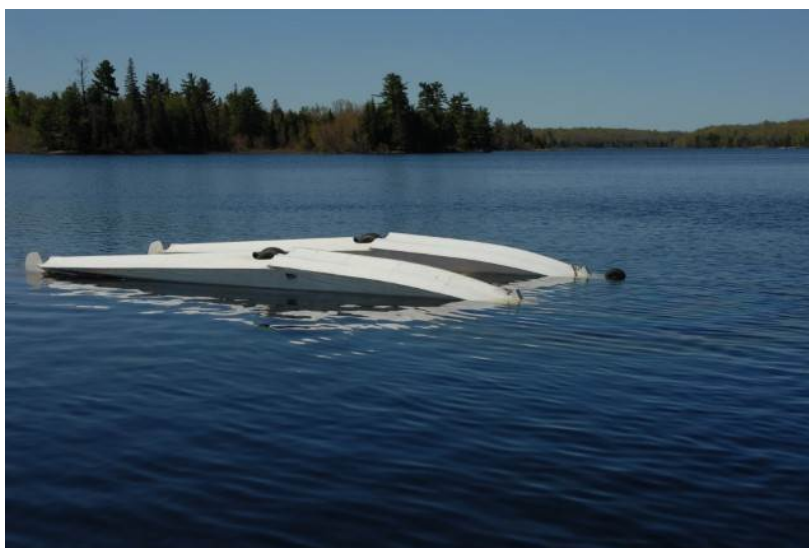
The aircraft touched down approximately level to the surface of the water with the right float slightly lower than the left. The floats then dug in causing the aircraft to cartwheel and flip inverted. The aircraft sank quickly and only the floats remained visible on the surface (Photo 1). Bystanders immediately proceeded to the submerged aircraft and attempted to rescue the pilot, but were unable to open the doors and get the pilot out. Ontario Provincial Police divers recovered the pilot's body several hours later.

Photo 1. Submerged aircraft. (Source: Ontario Provincial Police)

- the bottom of the left door was pushed partially into the cabin so that the door couldn't be opened;
- the left door handle was in the unlocked position;
- the left door window was found to be open; however, the window frame was bent, the window pane was broken and the lock was in the closed position;
- the bottom of the left wing was distorted and blocked the top of the left door so that it couldn't be opened;
- the right door and window handle were in the locked position;
- the windscreen was not broken and the V brace was not damaged;
- the pilot was not wearing the lap or shoulder harness when divers recovered the body;
- the baggage was not secured and was floating loosely within the cabin;
- the pilot was carrying sublingual nitroglycerin spray on his person and in his luggage; and
- a CPAP machine was found in the aircraft.

The impact forces were sufficient to cause airframe and door deformation rendering the pilot's door inoperable. The pilot's door window was damaged, but still functional and found to be open even though the window handle was in the locked position. It is not known when, how, or who opened the window, but egress could have been possible through the open window. The passenger door and window handles were both locked from the inside and had no damage. Egress from one of these 2 points would have been possible if the pilot had unlocked either the passenger door or window. Rescuers were unable to assist the pilot as neither door would open from the outside. If rescuers are unable to open doors or windows from the outside, then there is a risk that the aircraft occupants will drown.
