**AVIATION INVESTIGATION REPORT
A14W0127**

RISK OF COLLISION

**CANADIAN NORTH INC. BOEING 737-36Q, C-GICN
AND
JAZZ AVIATION LP (DBA AIR CANADA EXPRESS)
DE HAVILLAND DHC-8-402, C-GGDU
FORT MCMURRAY, ALBERTA
04 AUGUST 2014**

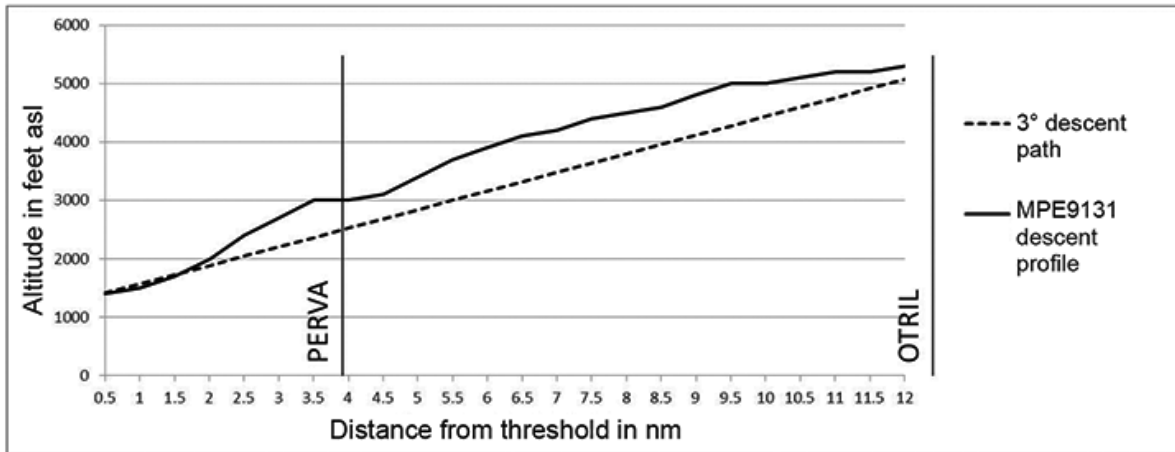
At 1835:46, the CYMM tower controller instructed a Cessna 172, which was orbiting to allow a regional jet to approach and land, to proceed direct to the threshold of Runway 25. At 1835:52, the Edmonton ACC controller cleared MPE9131 for the ILS/DME Runway 25 approach and instructed it to switch over to the CYMM tower frequency; MPE9131 was descending through 4000 feet at the time (Figure 1).

Figure 1. MPE9131 descent profile (Source: RADAR data)

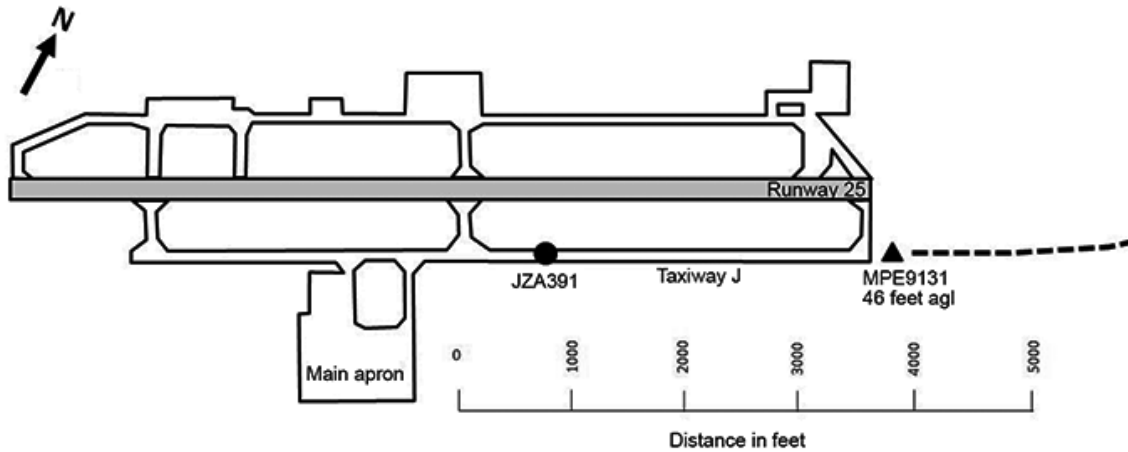
At 1836:54, while MPE9131 still had the autopilot engaged, the crew acquired visual contact with what they believed to be the runway environment. The crew used control wheel steering to manoeuvre the aircraft to the left and increase the rate of descent. The intent was to line up with what was believed to be Runway 25; however, the aircraft was in fact lining up with Taxiway J (Figure 2).

At 1838:21, when it became clear to the crew of MPE9131 that the aircraft was lined up with Taxiway J, the crew initiated a go-around when the aircraft was at 46 feet agl (Figure 2), and, 2 seconds later, the aircraft crossed abeam the threshold of Runway 25, 2800 feet away from JZA391. When MPE9131 overflew JZA391, it was 230 feet above JZA391, and climbing.

Figure 2. Plan view of MPE9131 at 1838:21; go-around initiated

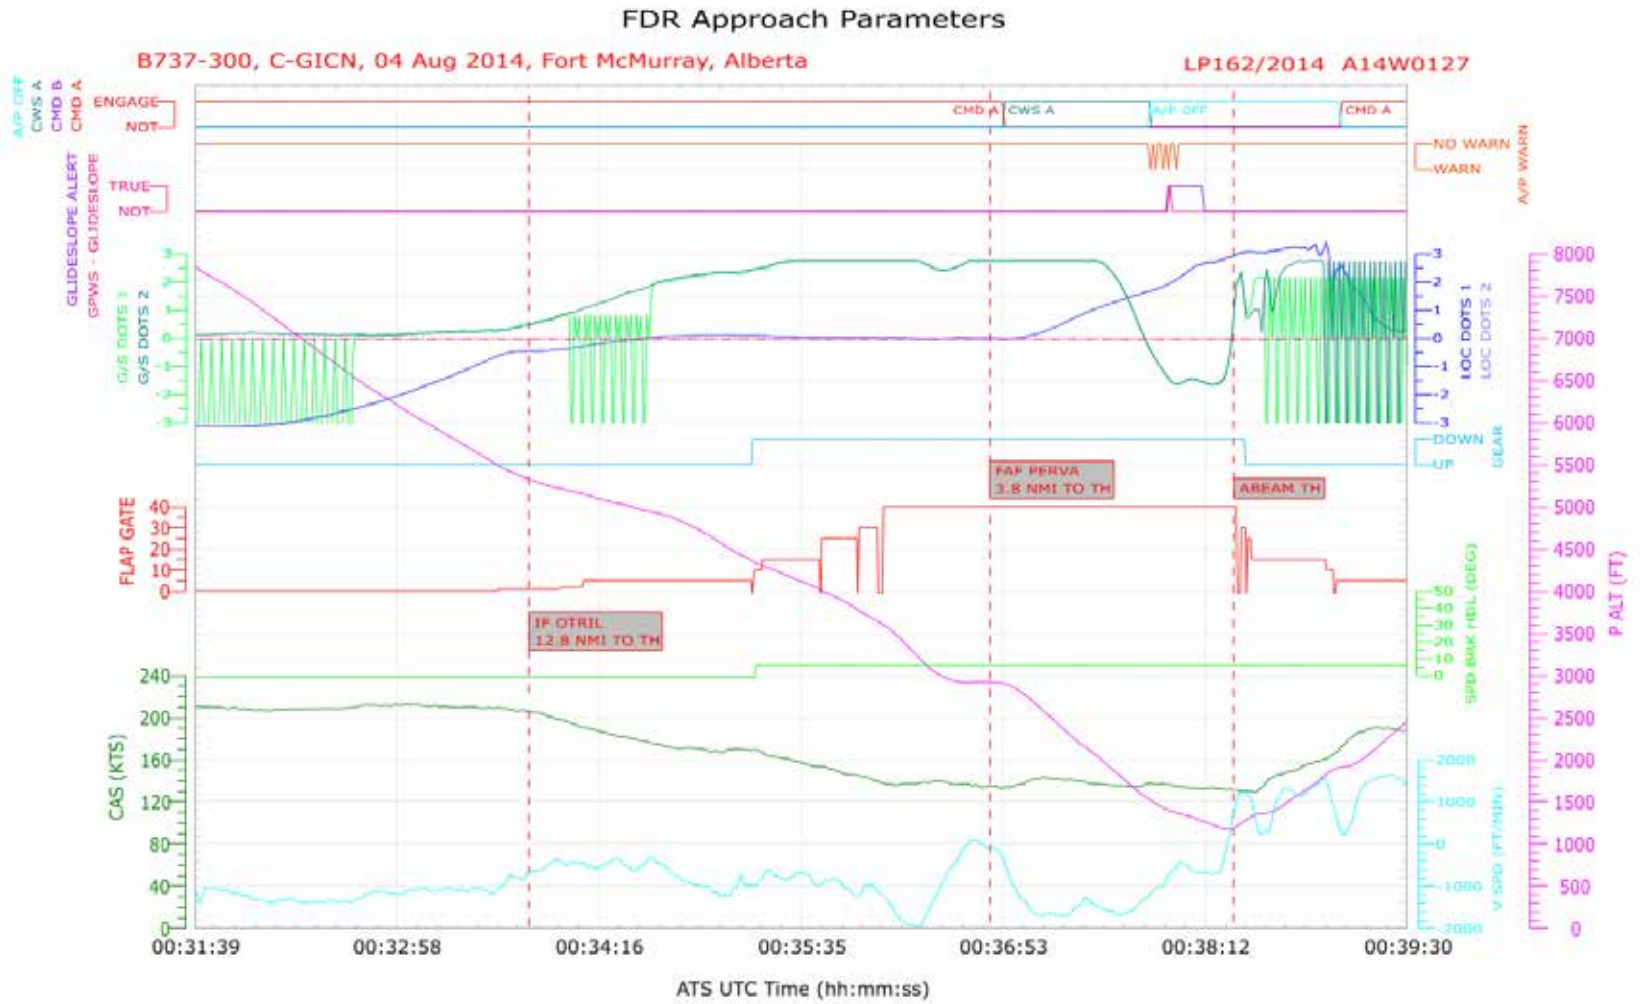
Appendix B – Flight data recorder approach parameters

At 1836, the CYMM tower controller instructed the MPE9131 crew to reduce to their lowest speed and informed them that they were following a Cessna 172 that was at ½ mile on final. The MPE9131 crew advised that they were at their minimum safe speed. Flight data recorder airspeed showed the aircraft at 135 knots calibrated airspeed (CAS) at the time (Appendix B).

PERVA, which was not planned for by the flight crew. The autothrottle increased thrust to maintain the selected speed (Appendix B).

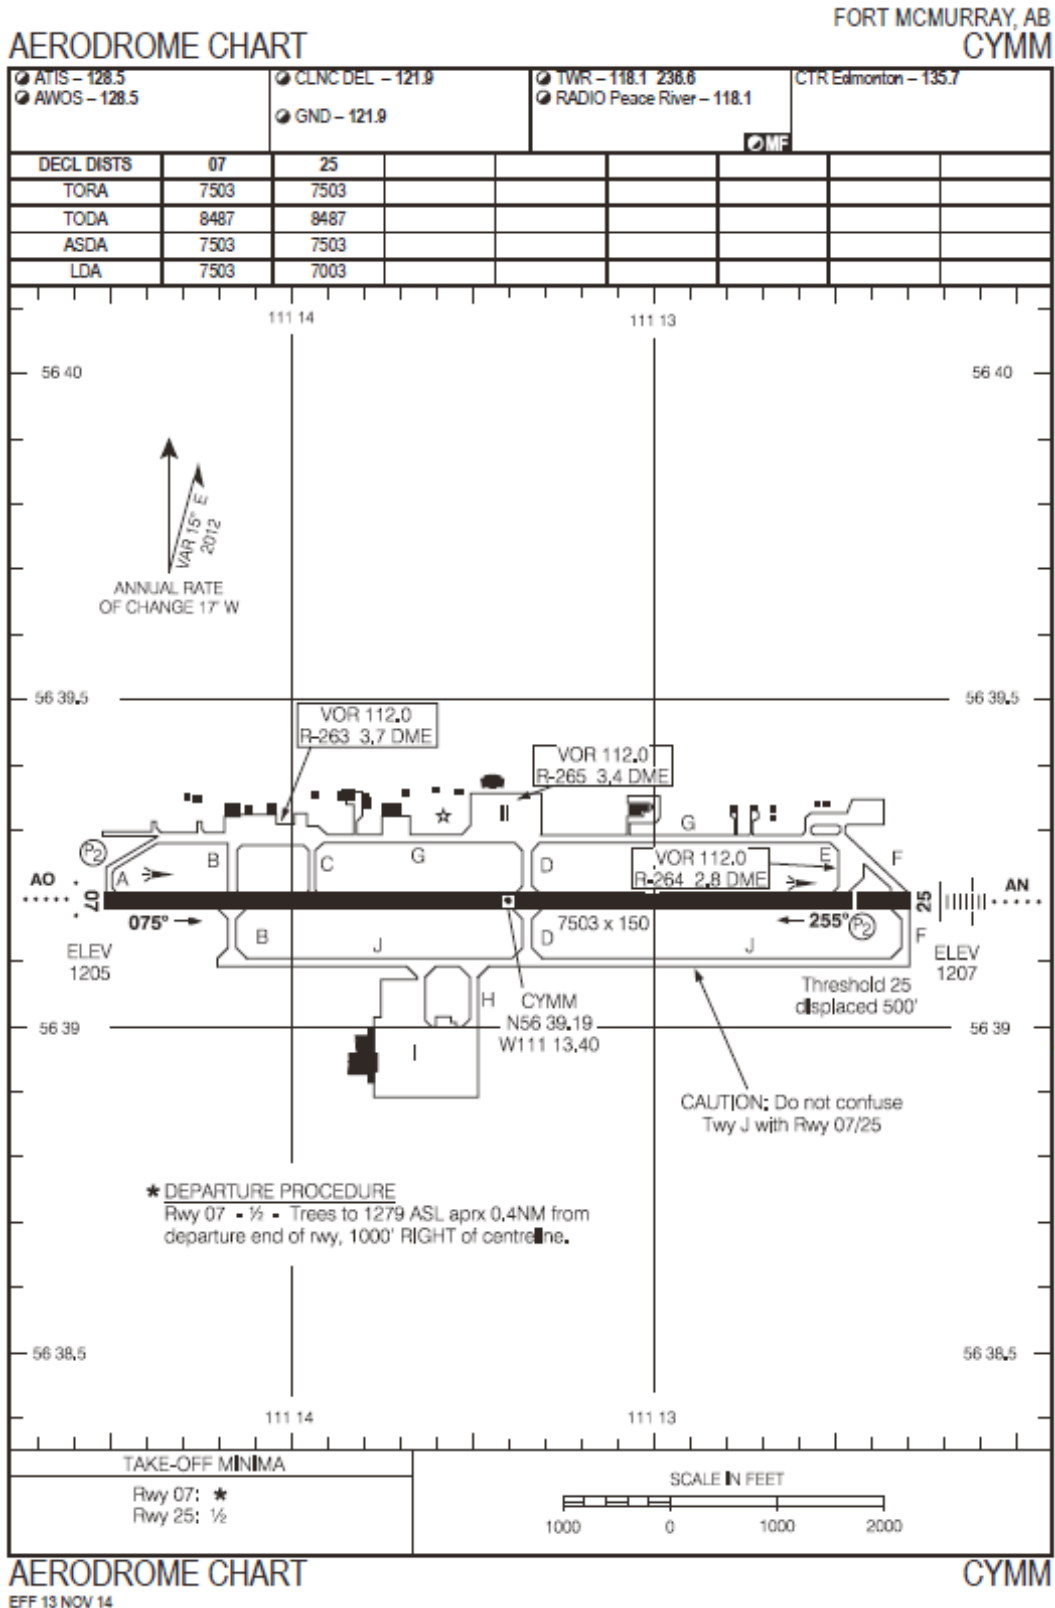
Appendix C – Aerodrome chart

Fort McMurray International Airport has a single runway (07/25), which is 7503 feet long and 150 feet wide (Appendix C). The runway is flanked by 2 parallel taxiways (G and J). Taxiway G is located north of the runway and runs east–west. It is connected to the runway thresholds via taxiways A and F, which are at 45° angles to the runway. Taxiway J lies south of the runway. It is 75 feet wide and joins the runway via Taxiway B (east of the threshold of Runway 07), Taxiway D (located at the midpoint of Runway 25), and Taxiway F (located at the threshold of Runway 25). Both Taxiways B and F are perpendicular to the runway and have square corners.
