# AVIATION INVESTIGATION REPORT

## A15Q0075

### Runway overrun

Boeing 737-6CT, C-GWCT

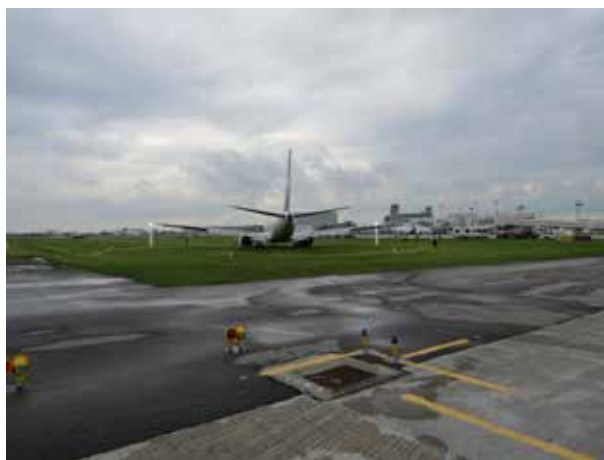
No one was injured (Table 1), and all passengers and crew deplaned by a mobile staircase placed at the front right door.

Figure 1. C-GWCT after coming to a stop

The aircraft was not damaged.

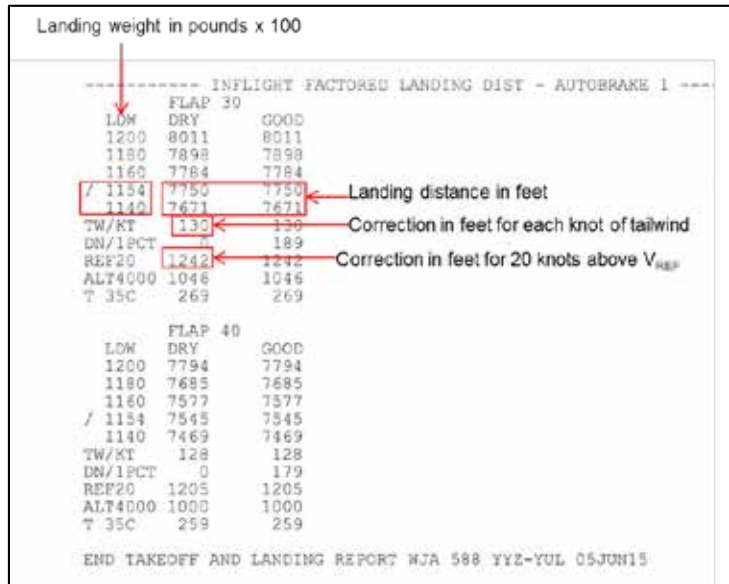
According to the TLR, the factored landing distance was 7750 feet for the dispatch-planned landing weight of 115 400 pounds, with the autobrake system set to 1 and the flaps at 30° (Figure 2). The lowest landing weight indicated on the TLR was 114 000 pounds – 500 pounds over the actual landing weight. At that weight, the TLR indicated a factored landing distance of 7671 feet. These landing distances were valid for dry runways and for wet runways with a braking action report (BAR) of good. If the BAR were medium, an autobrake setting of 2, 3, or MAX was to be used; if the BAR were poor, an autobrake setting of 3 or MAX was to be used.

Figure 2. Takeoff and landing report included in the flight-release package (Source: WestJet, with TSB annotations)

The TLR also indicated that 130 feet should be added for each knot of tailwind, and 1242 feet for 20 knots above the V<sub>REF</sub>. Given that the aircraft crossed the threshold at V<sub>REF</sub> + 20 with a tailwind component of 6 knots, the landing distance without the 15% safety margin, at a landing weight of 114 000 pounds, would have been approximately 8692 feet.<sup>22</sup> However,

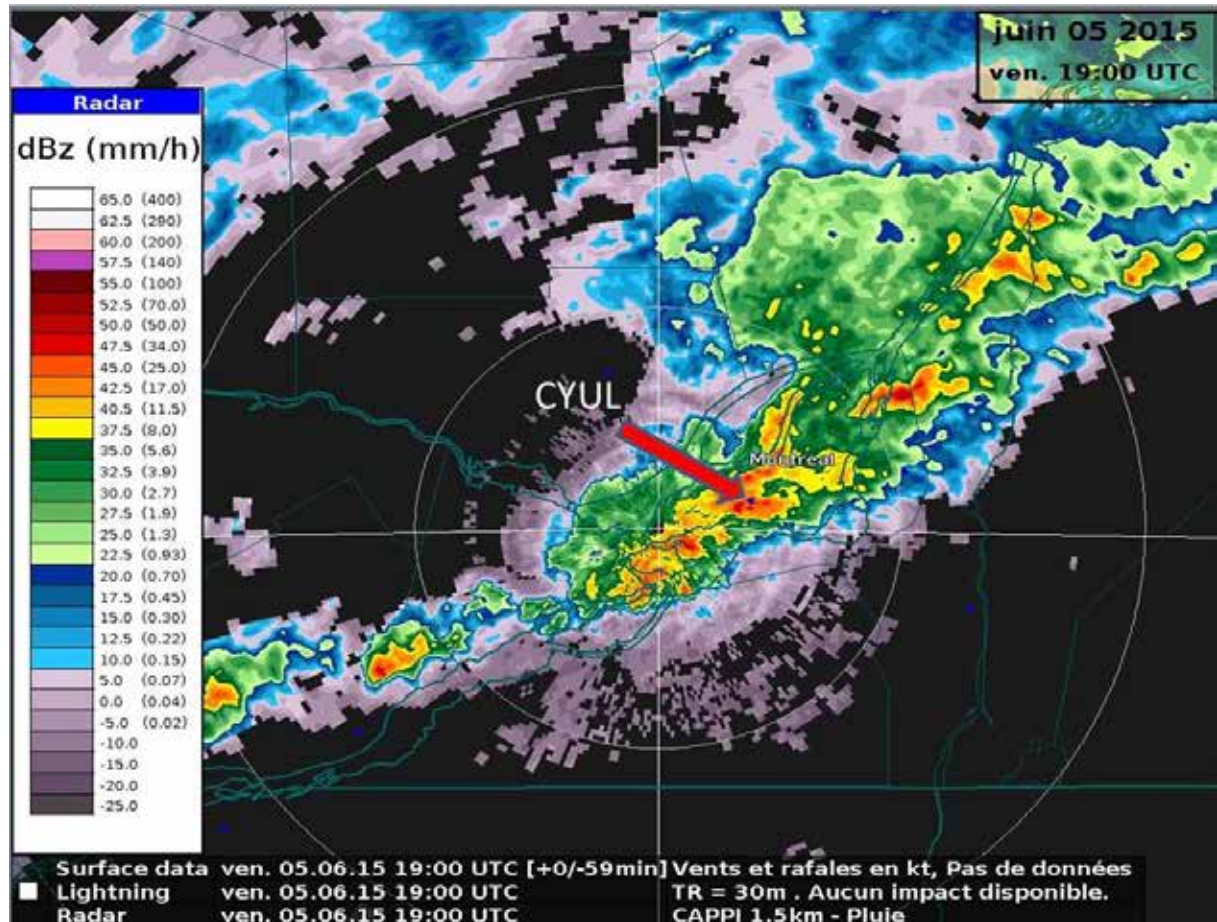
between 1450 and 1510. (CYUL is denoted by a blue dot as indicated by the red arrow in Figure 3.) A dBZ<sup>41</sup> value of approximately 45 was observed in the vicinity of CYUL at 1500, which gives an approximate precipitation rate of 25 mm per hour.

Figure 3. Radar image showing precipitation band less than 2 minutes after the occurrence (Source: Environment Canada, with TSB annotations)
