AVIATION INVESTIGATION REPORT

A16W0126

Loss of power and collision with trees

Bell 206B (Helicopter), C-GHHU

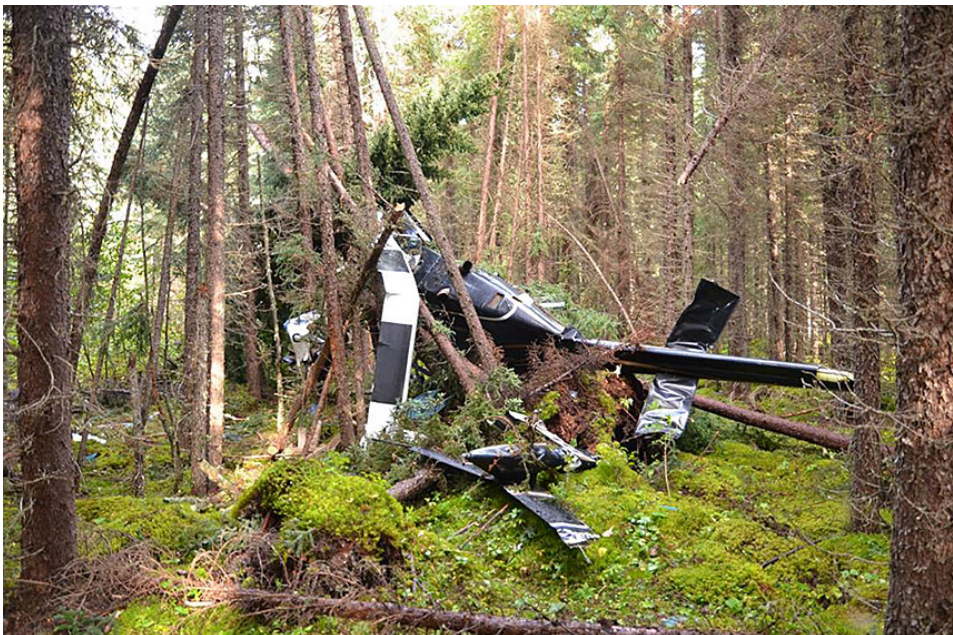
Figure 3. View of C-GHHU from aft left (severed vertical fin visible to the left of tail boom)

All of the helicopter's components were located and identified within a 50-foot radius of the aircraft (Figures 3 and 4). The helicopter's forward section and cockpit were destroyed. The cabin sustained substantial impact damage, particularly on the left side of the fuselage. The fuel cell was punctured during the impact sequence and was leaking. The main-rotor head was intact, with its 2 rotor blades still attached. Both main-rotor blades sustained minor damage consistent with low N_R , indicating that no power was being produced at the time of impact.

The tail-rotor was intact. One blade was straight with no damage to its skin. The other blade had sustained impact damage and was bent in 2 locations. The damage observed on both tail-rotor blades was consistent with low tail-rotor rpm, indicating that no power was being produced at the time of impact.

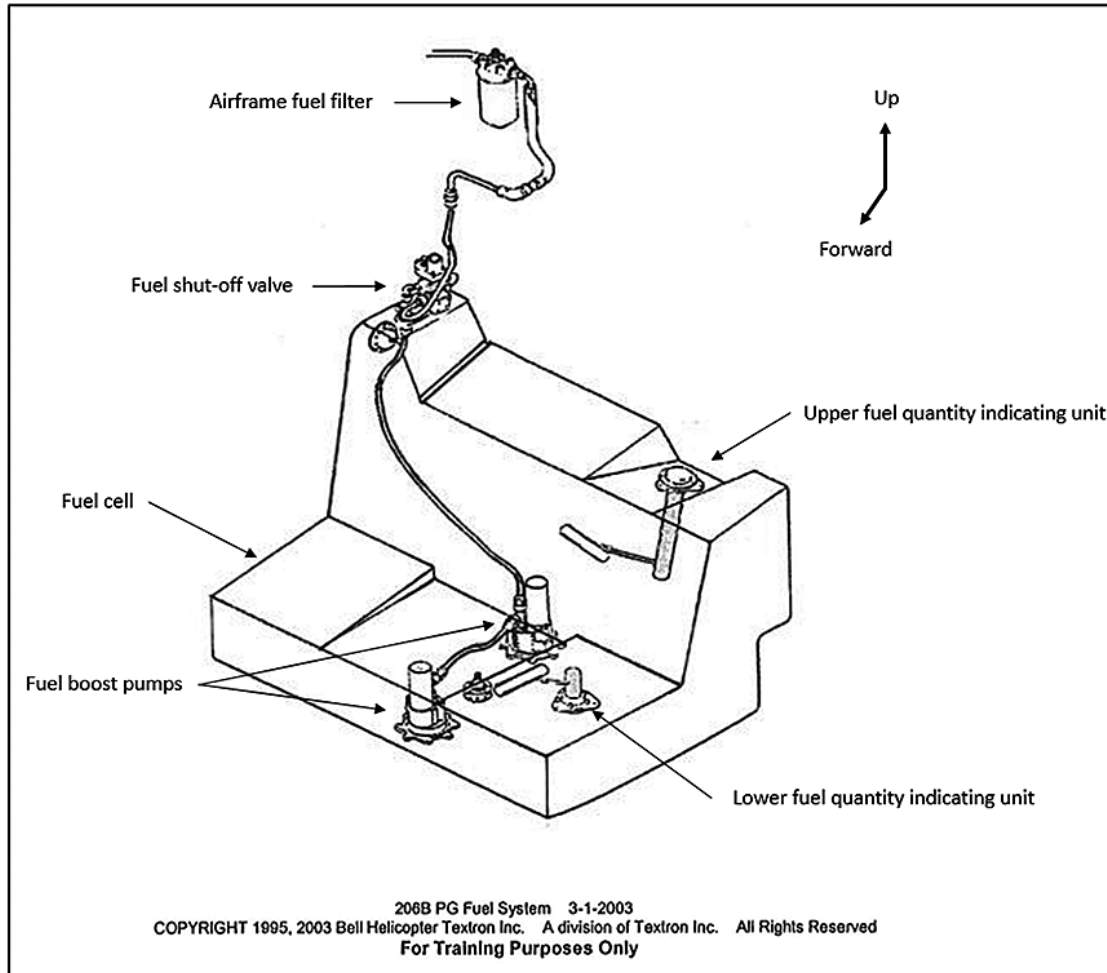
Appendix A – Bell 206B helicopter fuel system

The Bell 206B helicopter's fuel system can be susceptible to unporting when operating with less than 20 USG and acceleration forces are present. The TSB laboratory conducted further analysis of potential unporting at various fuel levels. With 10, 15, and 20 USG of fuel in the tank, the minimum lateral acceleration required for the fuel displacement to cause fuel unporting would be 0.12g, 0.21g, and 0.32g, respectively. These forces can be due to turbulence or pilot flight control inputs. The greatest susceptibility occurs when 1 or both of the boost pumps are inoperative. The manufacturer states that, in these circumstances, 10 USG are unusable.

While the helicopter was making a left turn, it is likely that acceleration forces caused 1 or both of the boost pumps to unport. The introduction of air into the combustion chamber interrupted fuel flow, resulting in an engine flame-out.
