## **AIR TRANSPORTATION SAFETY INVESTIGATION REPORT A18P0177**

### **RUNWAY INCURSION AND RISK OF COLLISION**

Pacific Coastal Airlines Ltd., Beechcraft 1900C, C-GIPC

City of Trail airport vehicle (Chevrolet Silverado 1500)

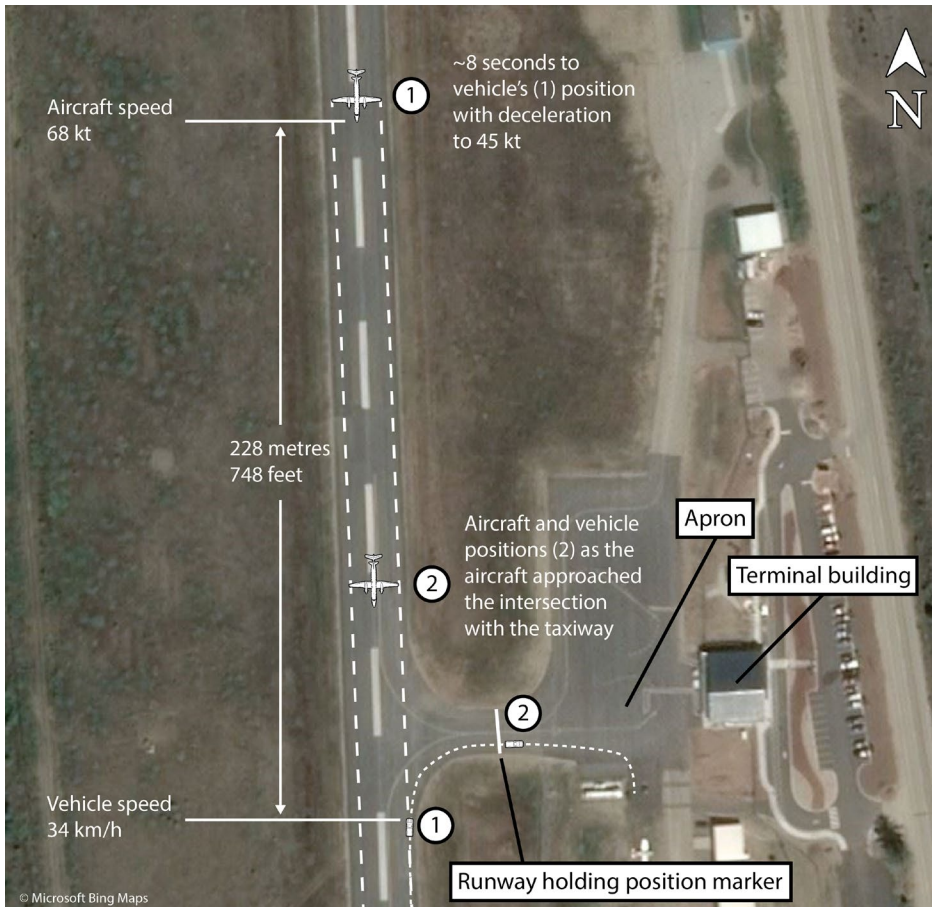
At 1117, the snowplow driver stopped at the runway holding position marking for Runway 16/34 (Figure 1). He used the mandatory frequency (MF) to contact the flight crew, requesting the aircraft's arrival time. The flight crew responded that its estimated time of arrival was in 5 minutes. The snowplow driver informed the flight crew that he would be on the runway to remove an area of slush near the intersection with the taxiway. The flight crew acknowledged this communication, and the snowplow driver entered the runway moments later.

At 1122:21, the aircraft touched down on Runway 16 at a speed of 113 knots. Immediately after touching down, the flight crew applied initial reverse to begin slowing the aircraft. As the crew looked down the runway, they observed the truck on the runway and applied full reverse and maximum braking. The aircraft began to skid as a result of the heavy braking; however, the crew was able to maintain control.

Figure 1. Aircraft and vehicle positions when the aircraft was applying full reverse (1) and as it approached the intersection with the taxiway (2) (Source: Microsoft Bing Maps, with TSB annotations)

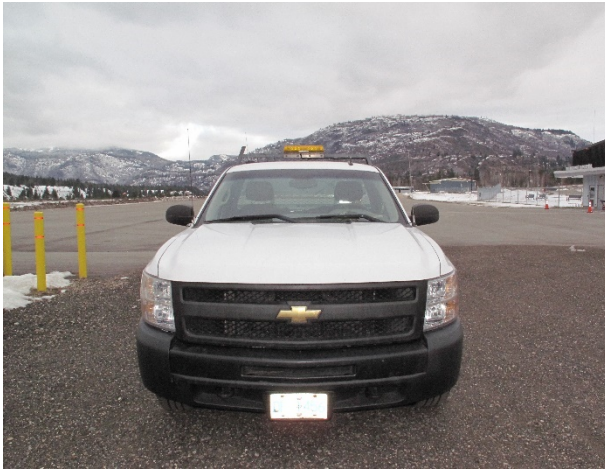
Figure 2. The occurrence vehicle, referred to by Trail Airport as Airport 2 (Source: TSB)

The airport vehicle was equipped with an amber beacon affixed to a rack installed above the airport vehicle cab (Figure 2). The beacon met the applicable standard for lighting of mobile objects.<sup>38</sup> During the occurrence, the airport vehicle was operating with the beacon on and functioning.

The paint colour and markings on airport vehicles help flight crews see them. The occurrence airport vehicle was painted white and had black accents, and the ground surrounding the runway was snow-covered. The airport vehicle's flashing beacon and daytime running lights were on. However, under the prevailing visual conditions, the markings and colour were insufficient to make the vehicle conspicuous to the flight crew. It is unknown whether the flight crew would have been able to see the airport vehicle on the runway if it had had its full headlights on.

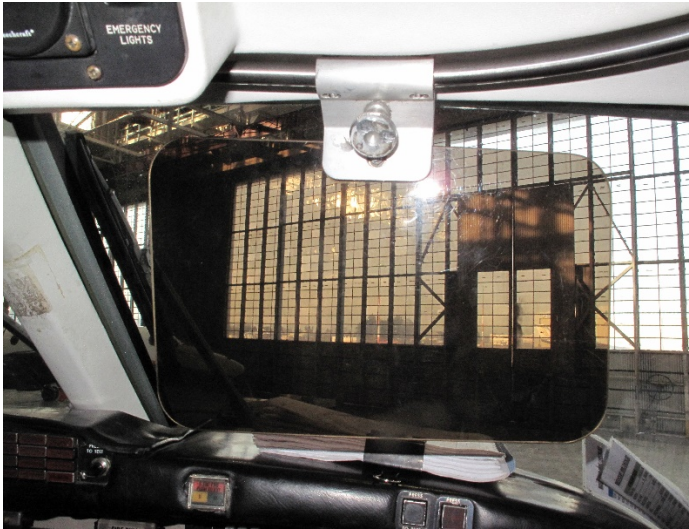
Figure 3. The sun visor in the occurrence aircraft (Source: TSB)

During the aircraft's approach, the sun, low on the horizon, reflected off the wet runway, creating a solar glare condition that diminished the flight crew's ability to detect the airport vehicle on the runway. Specifically, the glare made it difficult for the flight crew to see the entire length of the runway.

3. The sun, low on the horizon, reflected off the wet runway, creating a solar glare condition that diminished the flight crew's ability to detect the airport vehicle on the runway.
