AIR TRANSPORTATION SAFETY INVESTIGATION REPORT A19Q0015

RUNWAY INCURSION

Aéroports de Montréal

Montréal/Pierre Elliott Trudeau International Airport, Quebec

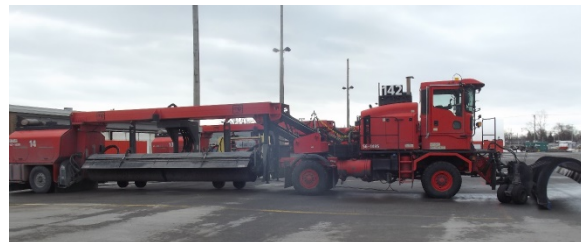
Figure 1. Snowplow-sweeper CHA142, an HT tractor with plow and XT tow-behind broom (Source: TSB)

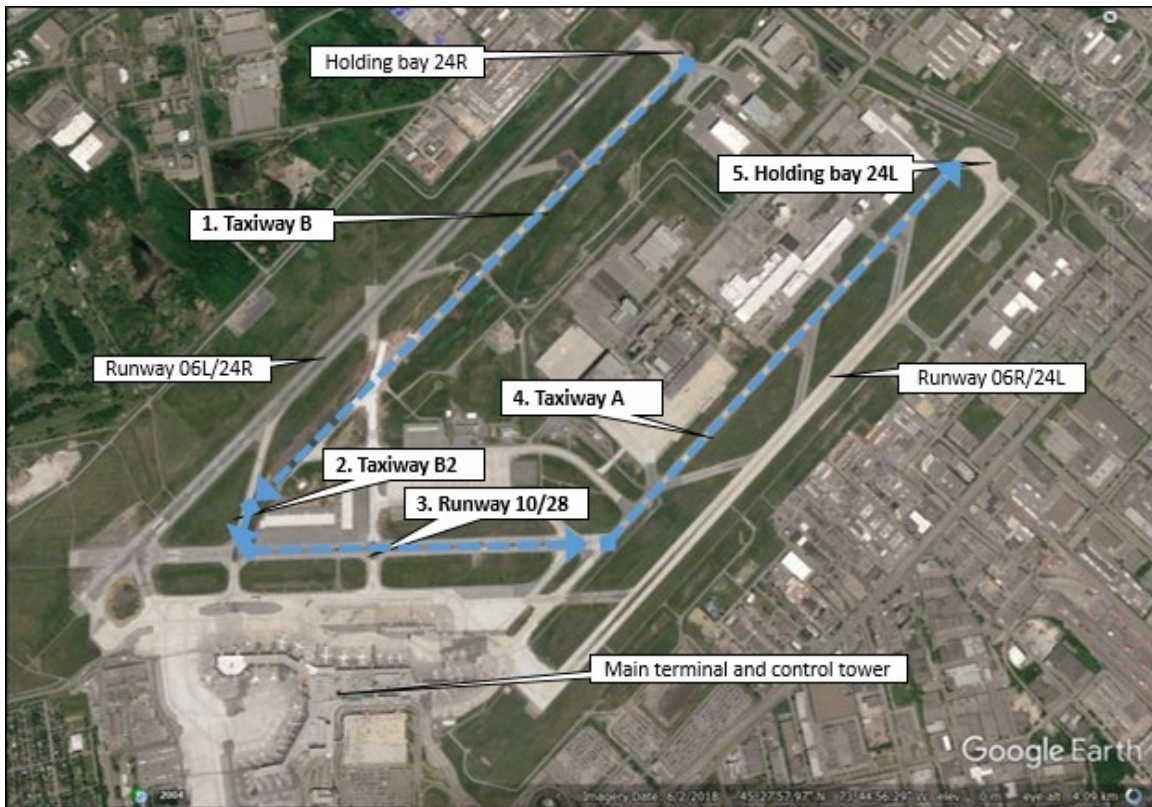
At approximately 1110, the team leader informed the ground controller that the convoy had cleared and exited Runway 24R. The team leader was the last to exit the runway, in accordance with ADM procedures.⁷ The ground controller then instructed the team leader and the convoy to proceed via Taxiway B onto Taxiway B2, Runway 10/28, Taxiway A, and finally to holding bay 24L (Figure 2) without any intermediate stops.

Figure 2. Aerial view of CYUL showing the route taken by the convoy (Source: Google Earth, with TSB annotations)

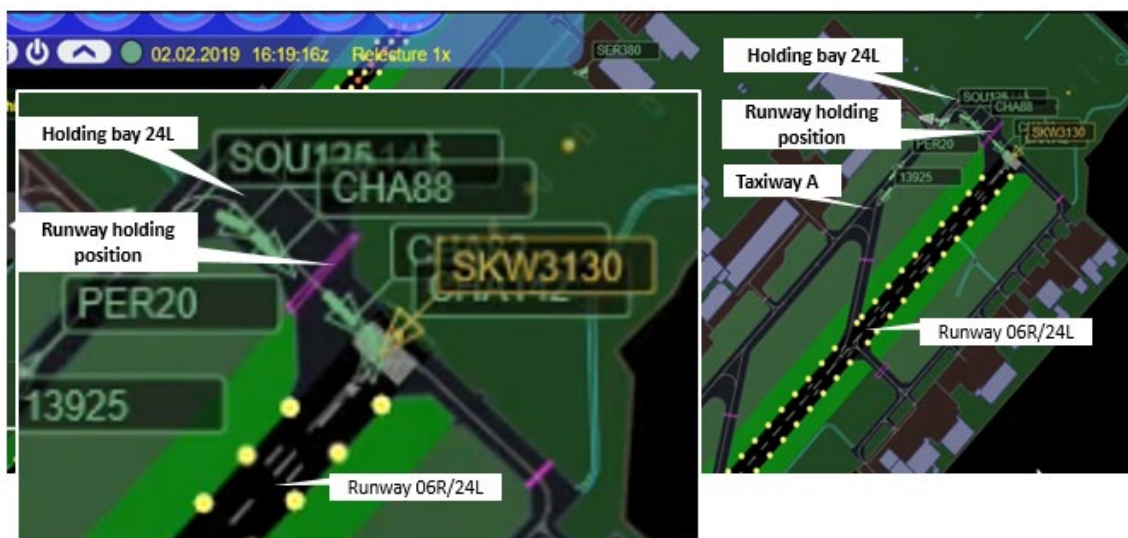
At 1119:16, the convoy lead reached the runway centreline, and the aircraft flew directly over his vehicle (Figure 3).

Figure 3. Screen shot of NAV CANADA Webview media player showing holding bay 24L and Runway 24L. The inset image shows the aircraft (SKW3130) overflying the convoy. The screenshot was captured as the radar target identifier for SKW3130 appeared over CHA142 and CHA82. The CHA81 radar target was not visible. (Source: NAV CANADA, with TSB annotations)

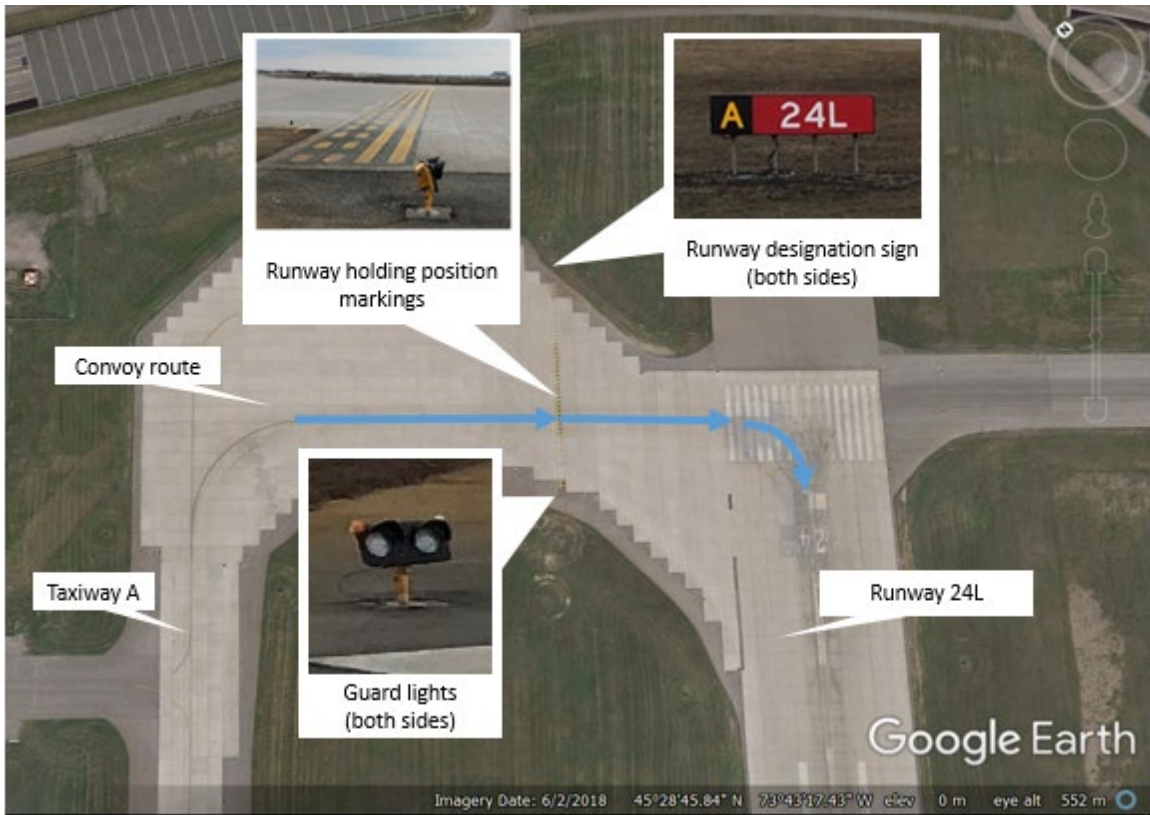
Runway holding position markings, commonly referred to as “hold lines,” are 4 yellow parallel lines (2 solid and 2 dashed lines) highlighted with a black background. They mark the holding position and span the width of the taxiway.

Figure 4. Aerial view of holding bay 24L, with inset images showing the runway holding position lighting, signage, and markings (Main image source: Google Earth, with TSB annotations. Inset images source: Aéroports de Montréal)
