AIR TRANSPORTATION SAFETY INVESTIGATION REPORT A19Q0153

LOSS OF CONTROL AND COLLISION WITH TERRAIN AT NIGHT

Cargair Ltd.
Cessna 172M, C-GSEN
Racine, Quebec
04 September 2019

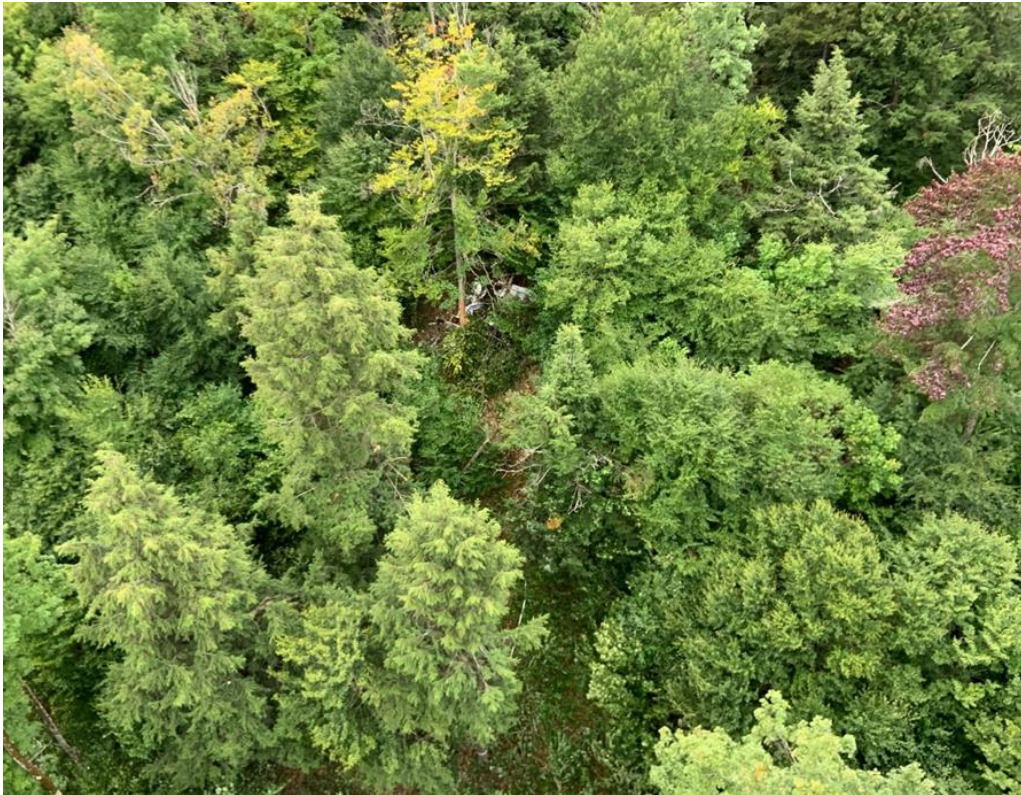
The wreckage of the occurrence aircraft was located 3 days later, on 07 September 2019, in a heavily wooded area near Racine, Quebec (Figure 1), at an elevation of 887 feet ASL. The aircraft had struck trees and had been destroyed by impact forces. The pilot received fatal injuries on impact. There was no post-impact fire. No signal was detected from the emergency locator transmitter (ELT).

Figure 1. Aerial view of the wreckage site (Source: Sûreté du Québec)

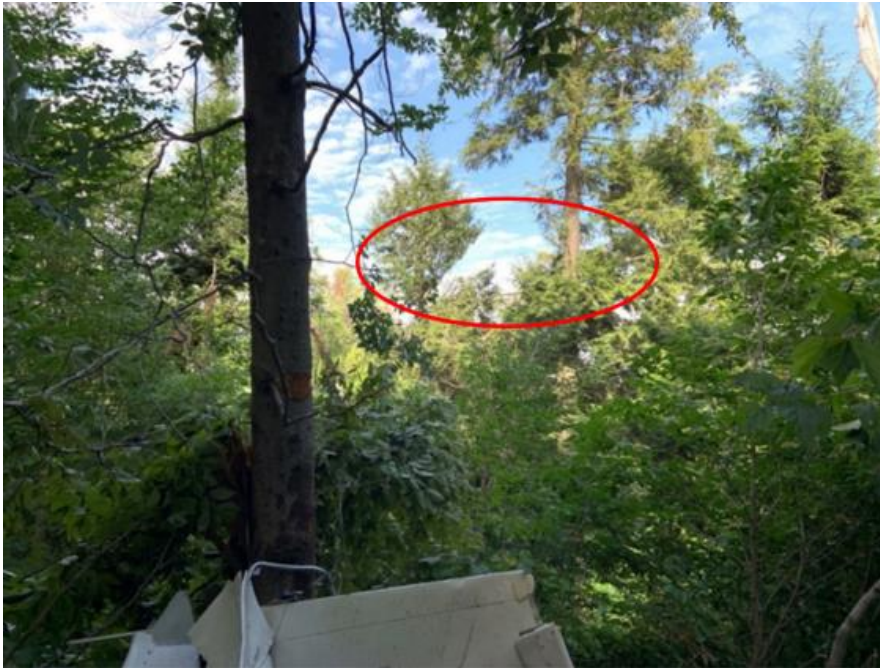
The accident site was in a heavily wooded area near Racine, Quebec. The aircraft's wings first struck 2 tall evergreen trees. Damage to the trees indicate that the aircraft was travelling at high velocity in a nose-down, banked attitude before it struck them (Figure 3).

Figure 3. Damage to trees caused by the occurrence aircraft looking back towards the direction of flight (Source: Sûreté du Québec, with TSB annotation)

After the first strike, the aircraft collided head on with a hardwood tree. The aircraft's fuselage wrapped around the tree's trunk before striking the ground, inverted, on the opposite side. All flight control surfaces were accounted for and came to rest scattered within a restricted perimeter from the point of impact, indicating that the aircraft broke up on impact and not in flight. There were no signs of pre-impact failures of material or component malfunctions.

Damage to the propeller as well as the number and proximity of the propeller marks on the tree's trunk were consistent with power being produced at the time of impact. The throttle was found to be in the full-power position.

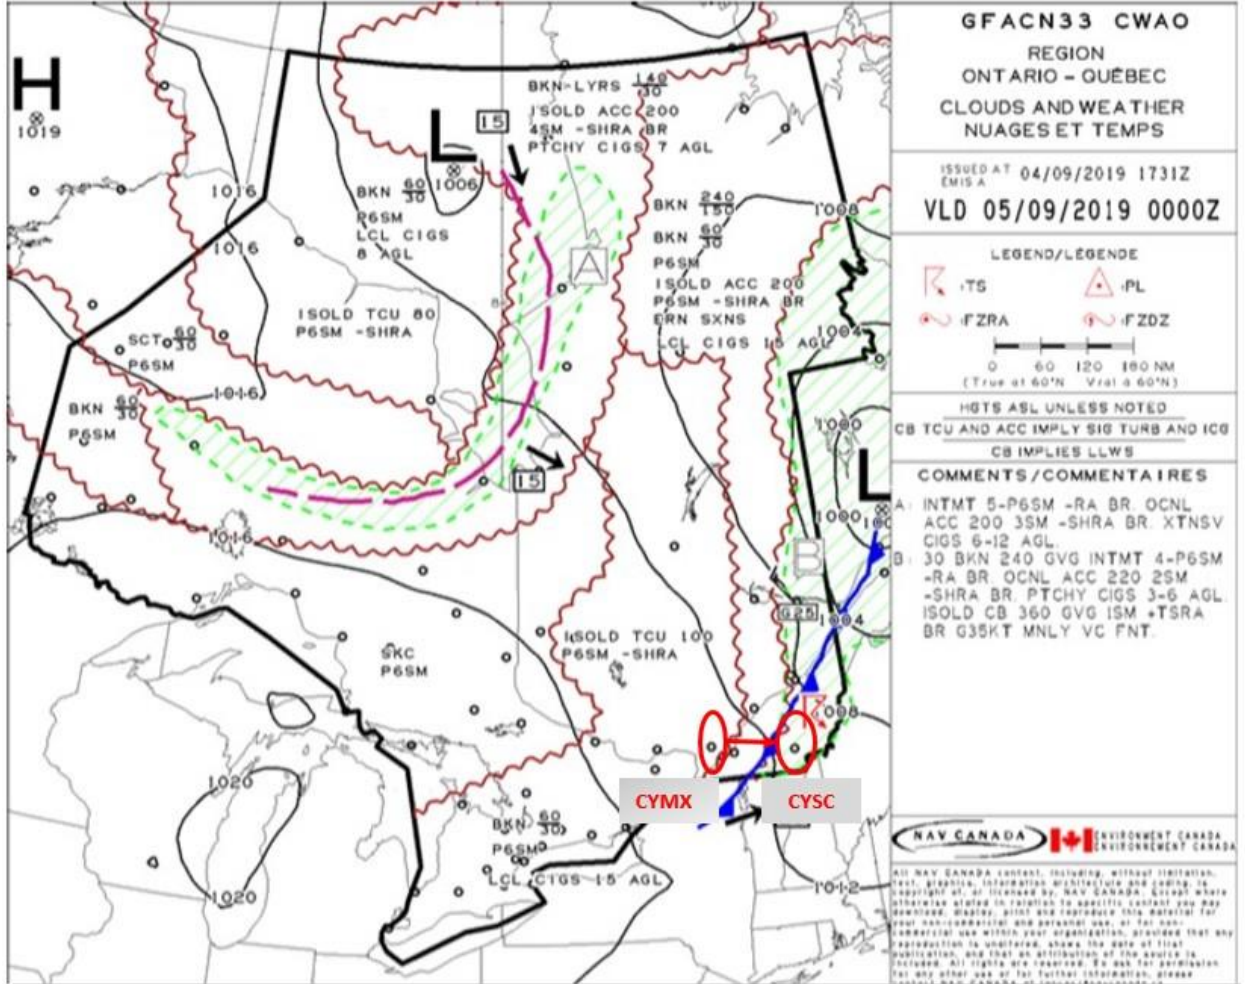
Appendix A – Graphic Area Forecast (GFA) Clouds and Weather Chart – GFACN33 issued at 1331 Eastern Daylight Time

Graphic area forecasts (GFAs) show the general upcoming weather conditions for a given geographic area.⁹ On the day of the occurrence, a clouds and weather chart issued at 1331 and valid at 2000, showed a low-pressure system located near Baie-Comeau, in eastern Quebec, with a cold front extending south into the U.S., moving eastward at 20 knots. The cold front was forecast to be west of CYSC at 2000 (Appendix A).

Cloud ceilings reported in the METARs and TAFs were mainly VFR. However, both of the graphic area forecasts (GFA) relevant for the time period indicated that, in the vicinity of, and behind the cold front, broken ceilings at 3000 feet above sea level (ASL), which was below the planned flight altitude of 3500 feet ASL, could be expected. Additionally, local or patchy ceilings of 1500 feet above ground level (AGL) were forecast. This information was available to the flight instructor and pilot while reviewing the weather. The investigation could not determine which GFA, if any, was reviewed prior to the flight.
