Air Transportation Safety Investigation Report A20P0071

LOSS OF CONTROL DURING REJECTED TAKEOFF

Privately registered
Cessna 140, C-GOFK
Stave Lake abandoned aerodrome, British Columbia
27 July 2020

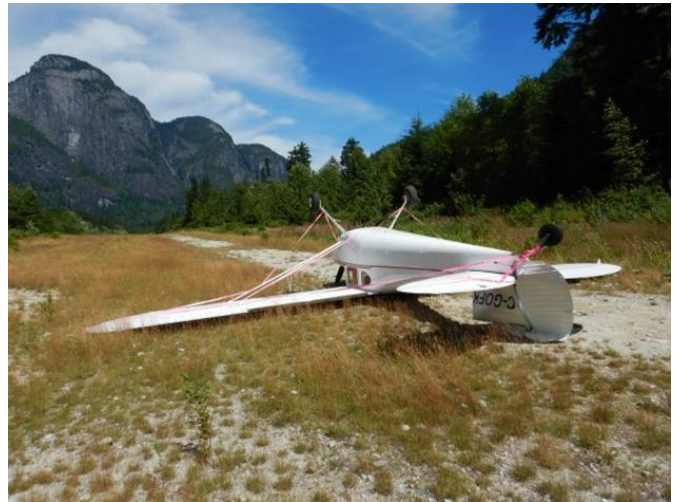
The aircraft did not become airborne. When the aircraft was approximately 200 feet from the end of the runway and at approximately 40 mph, the takeoff was rejected. While braking, the aircraft rapidly nosed over and came to rest inverted on the runway. The pilot in the left seat sustained minor injuries and the PIC, who was the pilot flying, was fatally injured. The aircraft sustained substantial damage (Figure 1). There was no post-impact fire.

Figure 1. Wreckage site (Source: TSB)

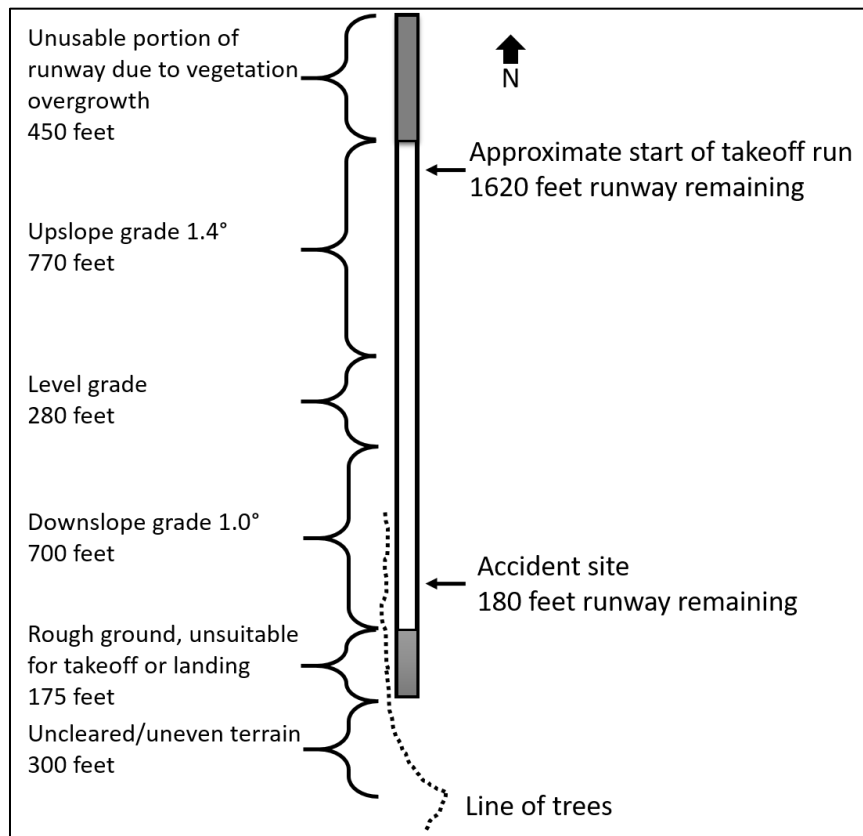
The Stave Lake abandoned aerodrome is located 20 NM north of Mission, at an elevation of 350 feet above sea level (ASL). The gravel airstrip is approximately 2375 feet long and 50 feet wide, with a usable length of approximately 1750 feet oriented in a north-south direction (Figure 2). The first 450 feet of the northern end of the runway cannot be used because of vegetation overgrowth, and the last 175 feet of the southern end of the runway is rough ground. There is a line of trees approximately 80 feet high located 300 feet beyond the southern end of the runway. For aircraft departing southbound, the runway slopes up at 1.4° for 770 feet, remains level for 280 feet, and then slopes down at 1.0° for 700 feet.

On the day of the accident, there were numerous areas of grass covering more than half of the runway's width, with much of the grass taller than 8 inches. The remaining width, approximately 20 feet of the eastern side of the runway, was rough loose gravel.

Figure 2. Diagram of the gravel airstrip at the Stave Lake abandoned aerodrome (Source: TSB)

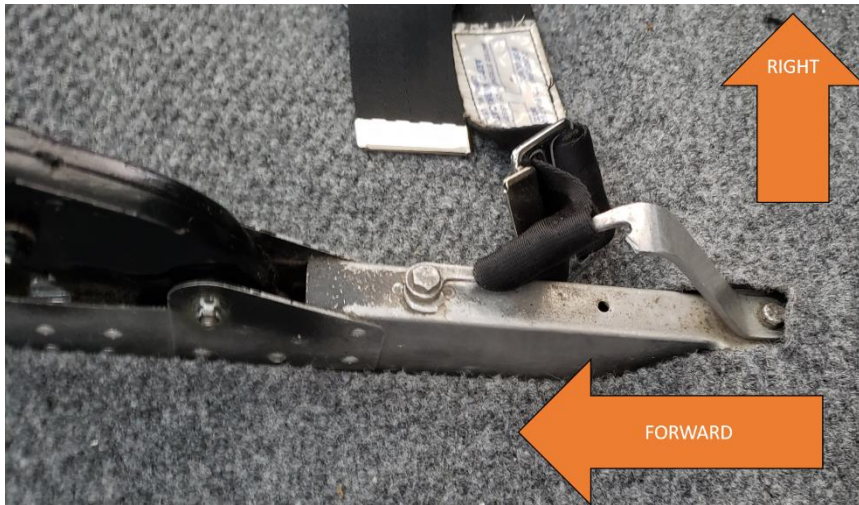
Figure 3. Lap belt centre bracket on the occurrence aircraft (Source: TSB)

At the time of the occurrence, both occupants were wearing their safety belts.¹⁰ The lap belt and shoulder harness used by the pilot in the left seat were intact and secure. However, the inboard portion of the lap belt for the pilot in the right seat was found detached from the lap belt's centre bracket, which was found broken (Figure 4). The broken centre bracket allowed the PIC to become unrestrained during the accident. During the examination of the wreckage, the investigation noted that the lap belt worn by the pilot in the left seat was twisted where it attached to the bracket, indicating that the pilot in the left seat had been using a portion of the lap belt intended for the right seat occupant.

After the 2014 accident, Textron Aviation Inc., which was now the type certificate holder, issued a Single Engine Service Bulletin (SEB-25-03)¹² on 17 February 2015, affecting Cessna 120 aircraft (serial numbers 8000 through 15075) and Cessna 140 aircraft (serial numbers 8000 through 15075). This required that, at the next 100-hour or 12-month (annual type) inspection, the lap belt centre bracket be inspected to determine if the latest type of lap belt centre bracket (in steel alloy) was installed, and if not, to replace the aluminum centre bracket with the new steel one (part number 0425132).

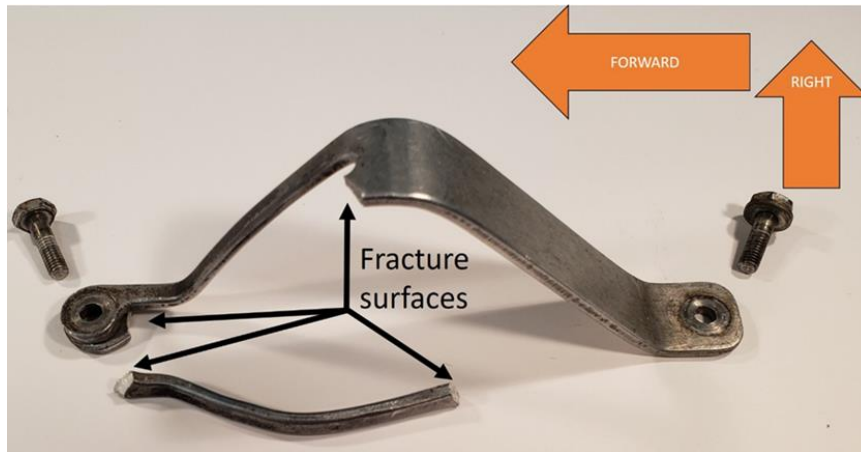
The lap belt centre bracket was removed from the aircraft and sent to the TSB Engineering Laboratory in Ottawa, Ontario. It was determined that the bracket failed due to shearing overstress during the accident. The bracket did not have a part number. However, the TSB's compositional analysis is consistent with the bracket likely being an original aluminum component manufactured for this type of aircraft.

Figure 4. Fracture surfaces on the lap belt centre bracket (Source: TSB)

This lap belt centre bracket was used in both Cessna 120 and 140 aircraft. During the manufacturing life of both aircraft, the Cessna Aircraft Company issued an engineering drawing change notice in which the bracket material was changed from aluminum alloy (Alclad 2024-T3) to steel alloy (SAE 4130), increasing the yield strength of the component by approximately 40%.
