## **AIR TRANSPORTATION SAFETY INVESTIGATION REPORT A20Q0013**

### **HARD LANDING AND AFT FUSELAGE STRIKE**

Air Inuit Ltd.  
de Havilland DHC-8-314 (C-GXAI)  
Schefferville Airport, Quebec  
20 January 2020

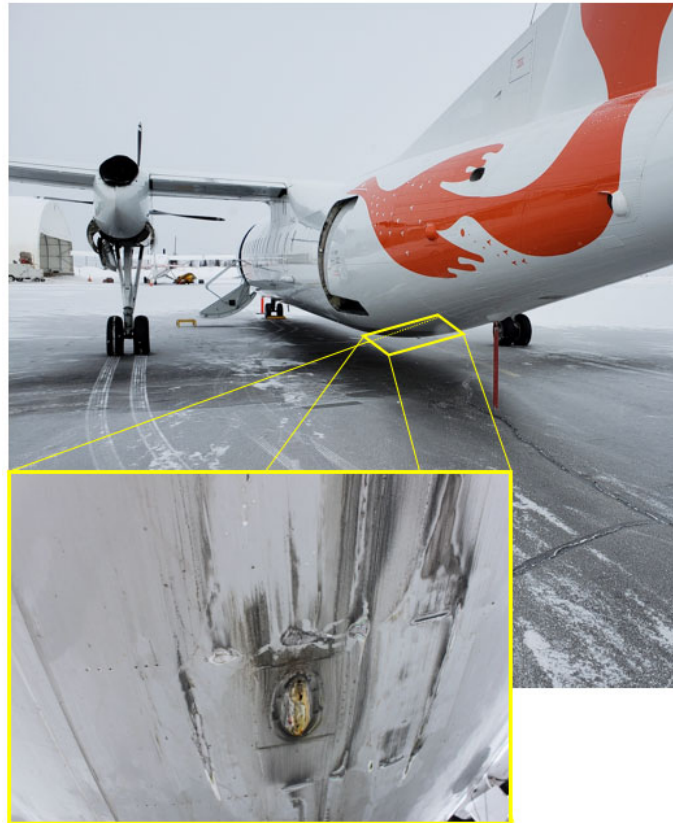
The aft fuselage had friction damage, and the structure was dented. The skin, frame, structural stiffeners, and longerons in the lower part of the fuselage were damaged. The fuselage runway contact sensor was torn from its mount (Figure 2).

The flight data recorder indicated that, upon landing, the vertical acceleration recorded was 2.37 times the force of gravity ( $g$ ). According to the aircraft manufacturer, a level 1 hard landing inspection was required before the aircraft could be returned to service.<sup>6</sup> This inspection was performed by Air Inuit’s approved maintenance organization (AMO). A ferry flight was then conducted to bring the aircraft to the repair centre at the Trois-Rivières Airport, Quebec.

Figure 2. Rear view of another DH8C and view of the damage to C-GXAI (Source: TSB)

The instinctive reaction to increase the pitch attitude, combined with the hard landing, resulted in the aft fuselage striking the runway, causing major damage to the aircraft's structure.

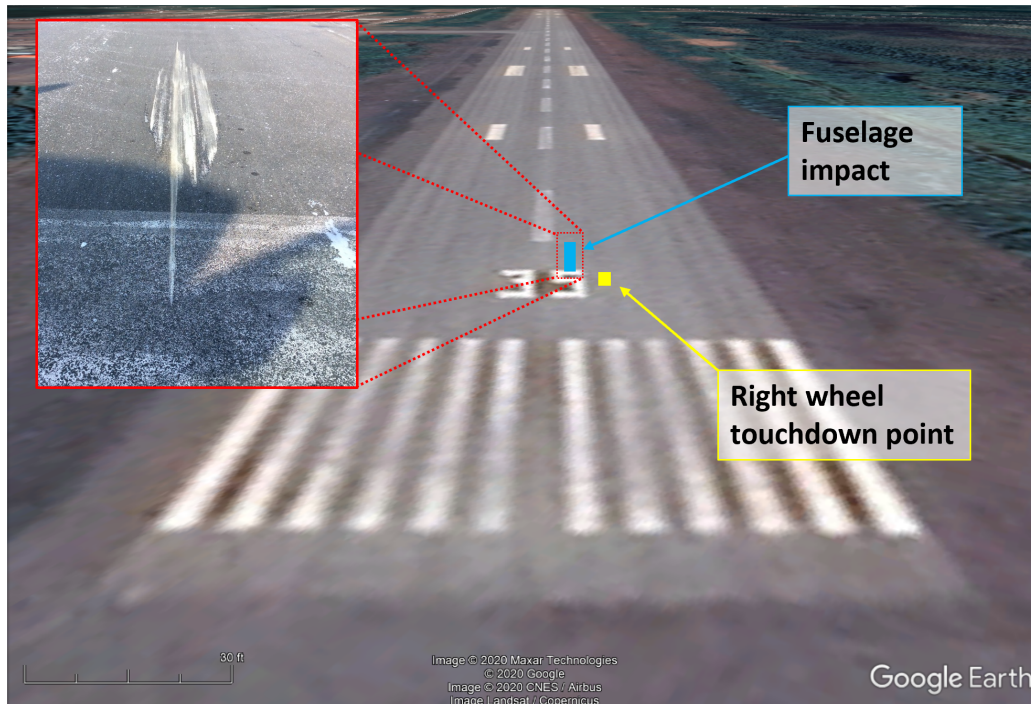
Figure 3. Wheel touchdown and fuselage impact points (Source of main image: Google Earth, with TSB annotations. Source of inset image: Schefferville Airport manager)

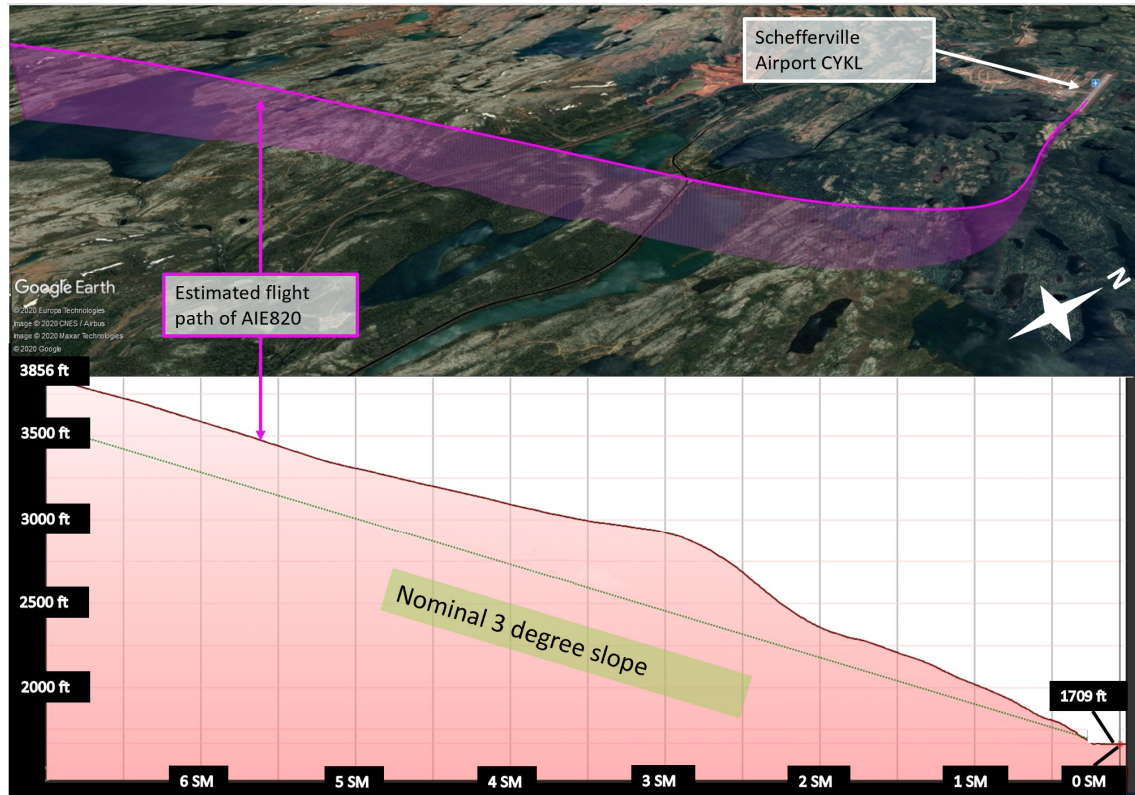
Because the FDR model used in the occurrence aircraft does not record the position from the global positioning system (GPS), the TSB Engineering Laboratory compared the data from the radio altimeter with the topography of the terrain to establish an estimated descent path. The laboratory created a visualization of the aircraft’s vertical path in relation to the nominal 3° slope (Figure 4).

Figure 4. Estimated flight path of AIE820 (altitude above sea level, in feet, and remaining distance of the approach path, in statute miles) (Source: Google Earth, with TSB annotations)
