Air Transportation Safety Investigation Report A20W0035

LOSS OF CONTROL AND COLLISION WITH TERRAIN

RS Ultra Kangook MF powered paraglider (basic ultralight), C-ILQJ
Gibbons, Alberta, 4.5 NM NW
13 May 2020

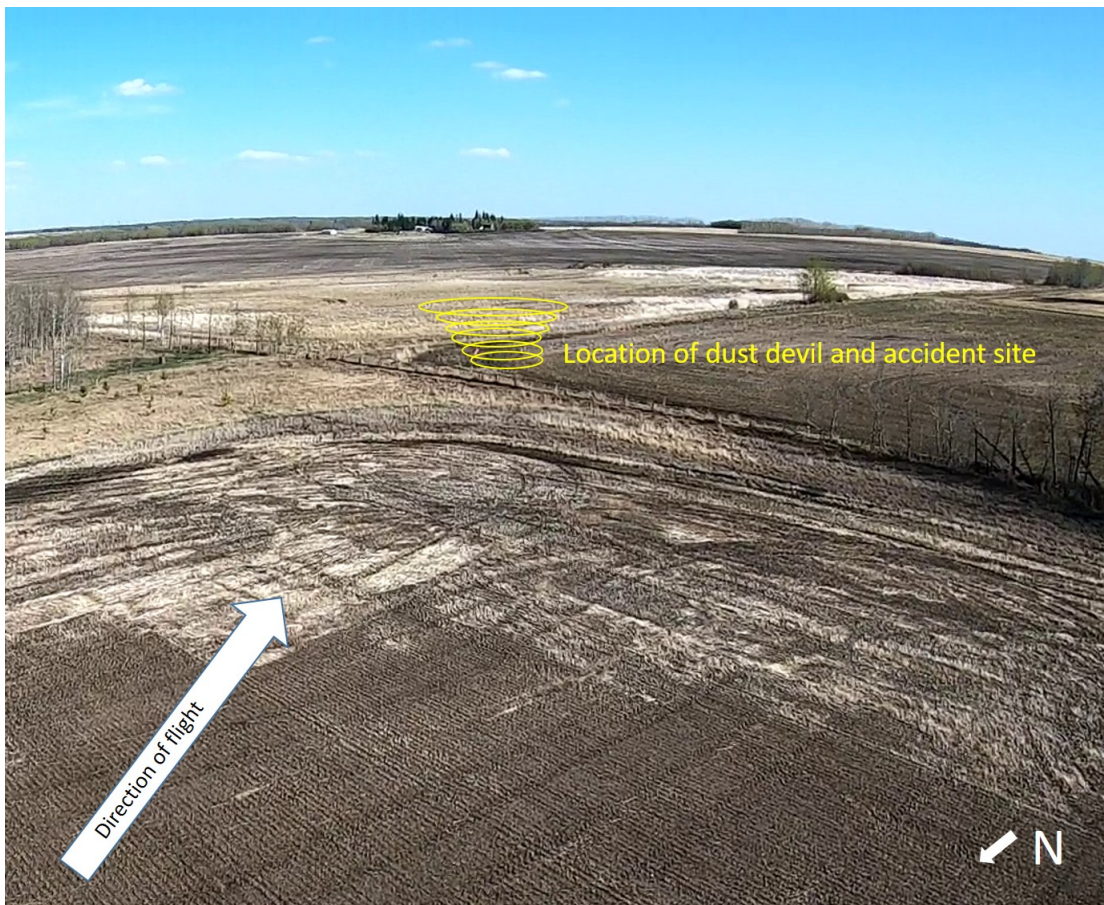
One minute before the accident, the pilot performed an approach to the take-off area in a southeasterly direction. Just before touchdown, power was applied and a go-around to the south was commenced. When it was approximately 75 feet above ground level, the aircraft flew through a dust devil (Figure 2). Without input from the pilot, the aircraft's climb rate suddenly increased, the aircraft rolled sharply to the right, and the paraglider lines wrapped around the pilot, the trike, and the turning propeller, eventually collapsing the entire canopy. At approximately 1745, control was lost and the aircraft impacted the ground, fatally injuring the pilot.

Figure 2. Still image from action video recorded on 13 May 2020, approximately 3 minutes before the accident, showing the location of the dust devil and the accident site, looking southeast (Source: Pilot's action video camera, with TSB annotations)

Encountering meteorological events such as dust devils can present a significant hazard to paraglider operations. Paraglider pilots need to be aware of the conditions that can be conducive to the formation of these phenomena, and avoid operating in these conditions where possible.
