Air Transportation Safety Investigation Report A2100006

LOSS OF CONTROL AND COLLISION WITH TERRAIN

Privately registered
Blackshape S.P.A. Prime BS100, C-GPOT
Ottawa/Carp Airport, Ontario
10 February 2021

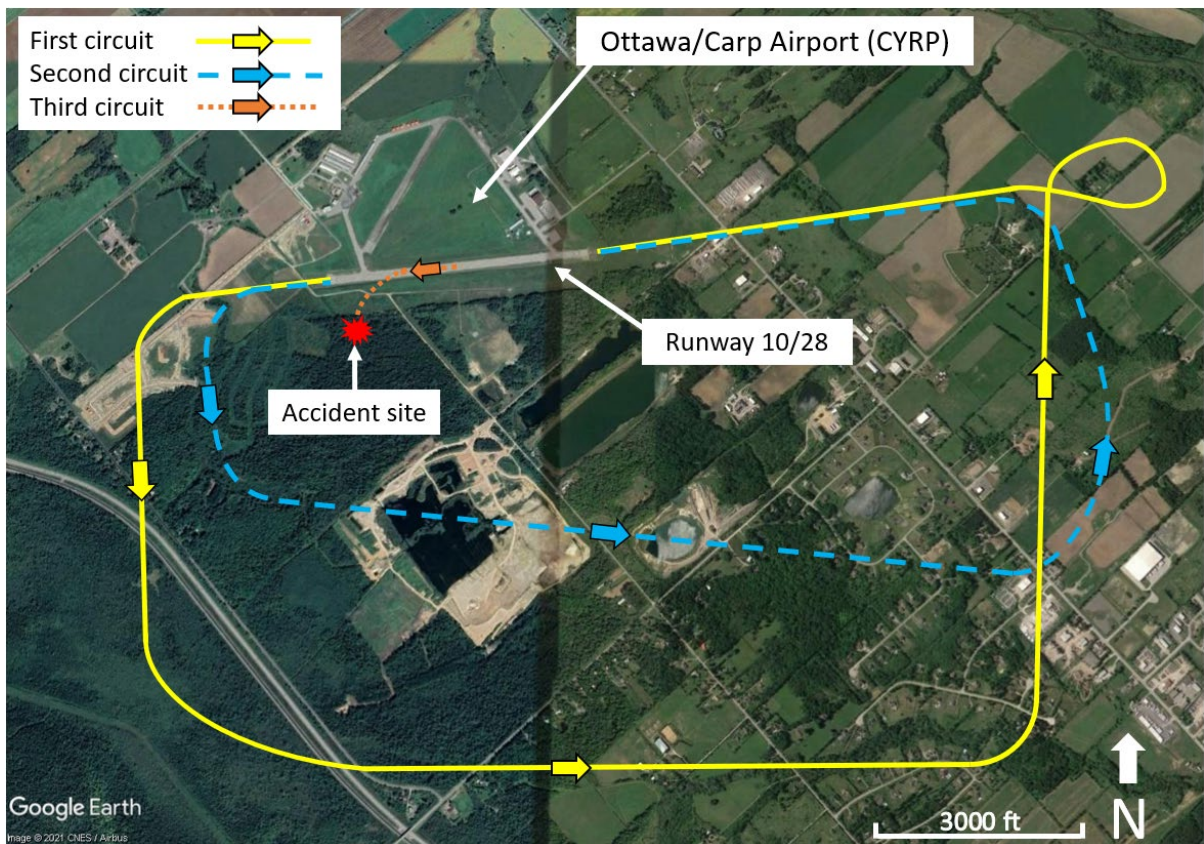
At approximately 1300, when the aircraft was approximately 787 feet (240 m) south of the runway and still in the left turn, a loss of control occurred and the aircraft entered a near-vertical descent, impacting the ground in a wooded area (Figure 2). The exact altitude at which the loss of control occurred could not be determined; however, based on primary radar data supplied by NAV CANADA, it was determined that the loss of control happened at an altitude below 550 feet above ground level (AGL).

Figure 2. Map showing the occurrence aircraft's circuits and the accident site (Source: Google Earth, with TSB annotations)
