AIR TRANSPORTATION SAFETY INVESTIGATION REPORT A21P0111

COLLISION BETWEEN AN AIRCRAFT AND A WATER TAXI

Tofino Air
de Havilland DHC-2 MK. I (Beaver), C-FMXR
and
Eagle Adventures Water Taxi
Water taxi C12997BC (*Rocky Pass*)
Tofino, British Columbia
18 October 2021

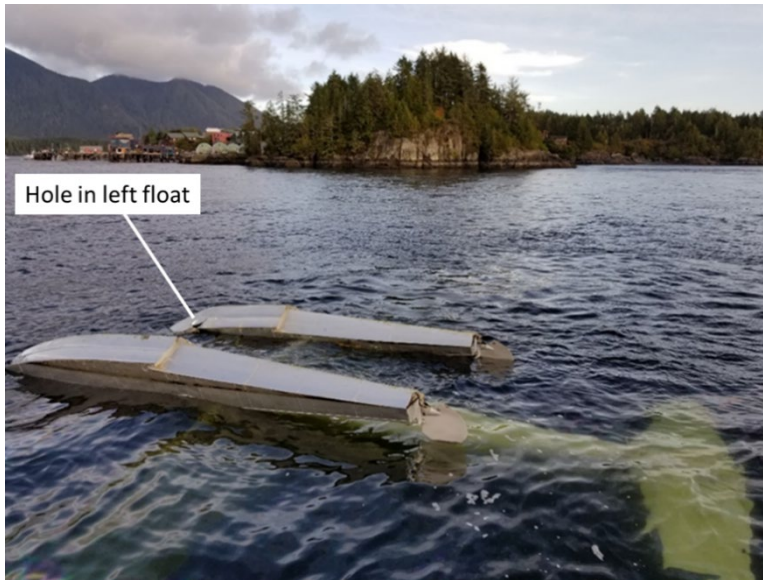
Figure 4. Aircraft just before it was pulled to shore (Source: Royal Canadian Mounted Police)

The rear-left float strut was disconnected and there was damage to the rear spreader bar. There was significant damage and wrinkles to the outboard and inboard skins of the left float.

The skin on the bottom of the left float was severely wrinkled, creating a hole on the bottom of the float. This hole allowed water to enter the left float (Figure 4).

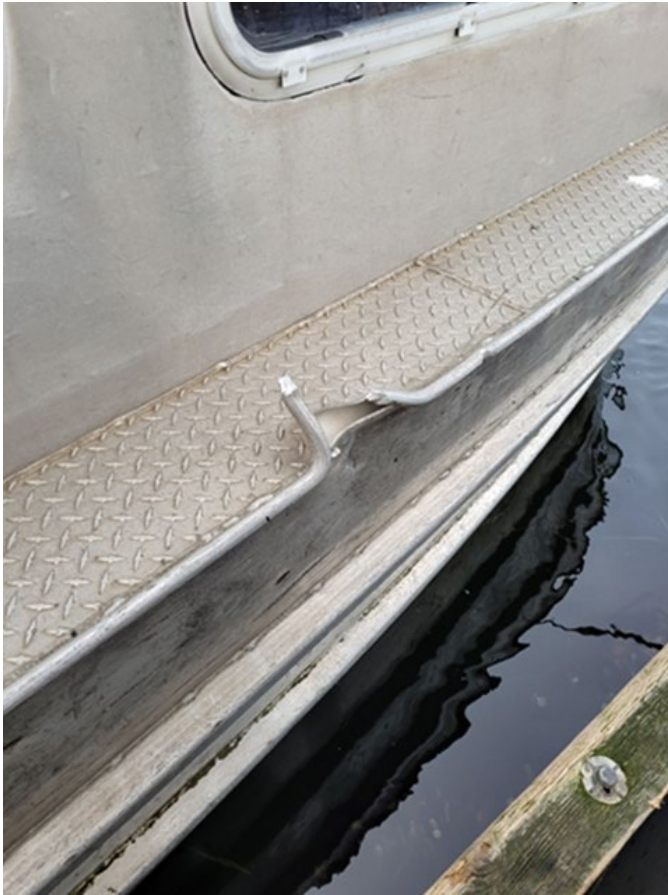
Figure 5. Damage to the vessel's starboard side hull (Source: Vessel owner)

The starboard side of the *Rocky Pass*'s hull sustained scrapes and gouges above the waterline as a result of the aircraft's propeller striking it (Figure 5). The hull remained intact, and the vessel did not take on any water.

The aircraft's propeller also caught a rubber bumper that was suspended over the vessel's starboard side by a rope. The rope was attached to the railing atop the cabin. The rope was pulled tight with significant force until it broke. The railing was bent from the force of the propeller pulling on the bumper. The bumper was not recovered.

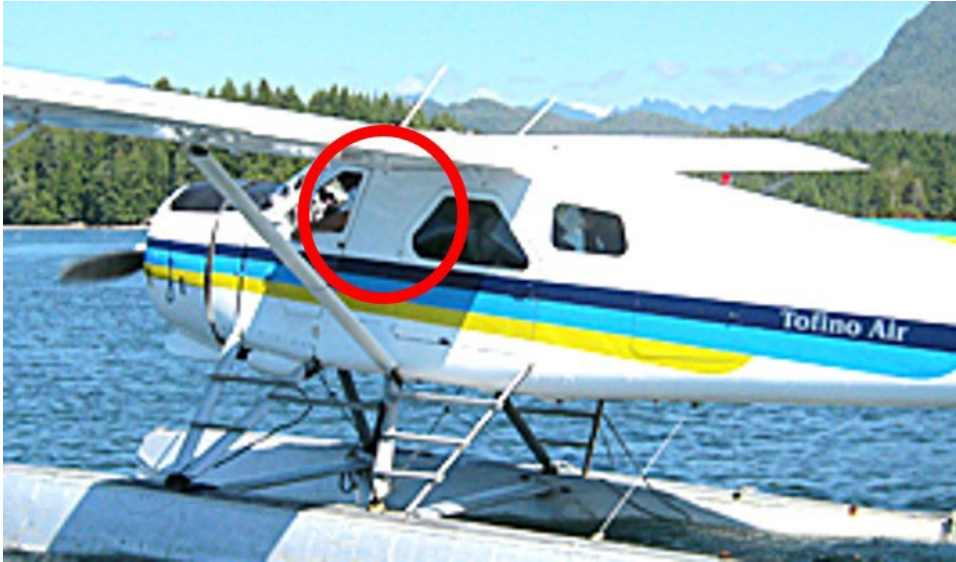
Figure 8. Occurrence aircraft structure (picture taken in 2010, with previous paint scheme) (Source: Tofino Air, with TSB annotations)

The DHC-2 fuselage has a structure between the 2 forward-most windows on the left side (Figure 8). Pilots who have their seats set to the full-aft position, as was the case in this occurrence, sit beside this structure, which can limit the view to the left of the aircraft.

During the touch-down phase, the pilot's attention, which was primarily focused straight ahead, combined with the little or no relative movement of the vessel in the left windscreen and the obstructions caused by the aircraft's nose and left window post, reduced the likelihood of detection of the vessel.

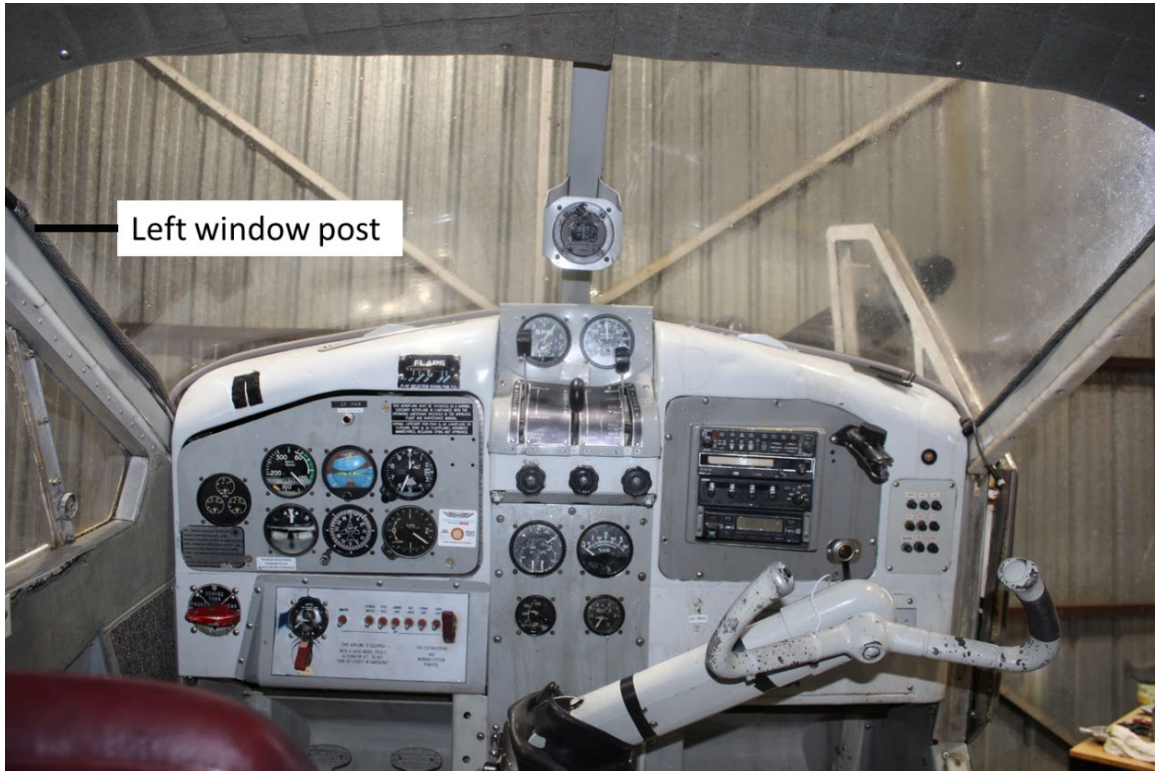
Figure 9. Occurrence aircraft cockpit (Source: TSB)

Aircraft windscreen configurations can also limit a pilot's field of view and interfere with the pilot's ability to detect objects (Figure 9). As part of the analysis done by the TSB laboratory, it was determined that during the short-final and touch-down phase, the vessel would likely have been visible to the pilot in the bottom of the left windscreen for approximately 25 seconds as it moved from behind the left window post to the middle of the left windscreen. The vessel would have appeared to remain stationary in the middle of the left windscreen for 12 seconds, until the collision occurred.
