AIR TRANSPORTATION SAFETY INVESTIGATION REPORT A22Q0084

COLLISION WITH CABLE

Privately registered
Bellanca 7GCBC (Citabria), C-GOQZ
Shawinigan, Quebec
17 July 2022

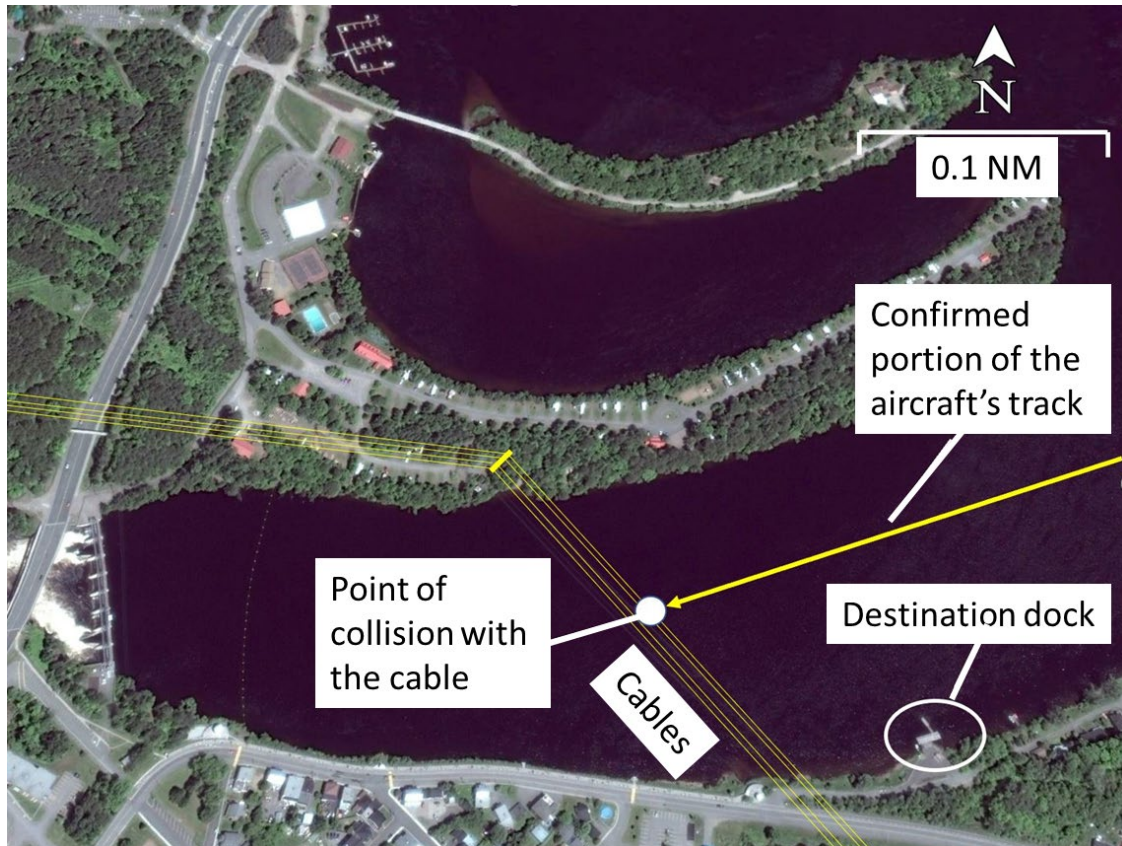
The accident occurred over the Saint-Maurice River in Shawinigan, not far from the destination dock, where a Hydro-Québec power line crosses the river, 3.5 NM west of a hydro dam. While flying over the landing site, the aircraft struck the lower cable on this power line (Figure 1).

Figure 1. Image of the occurrence site, the aircraft's known route, and the point of collision with the cable (Source: Google Earth, with TSB annotations)

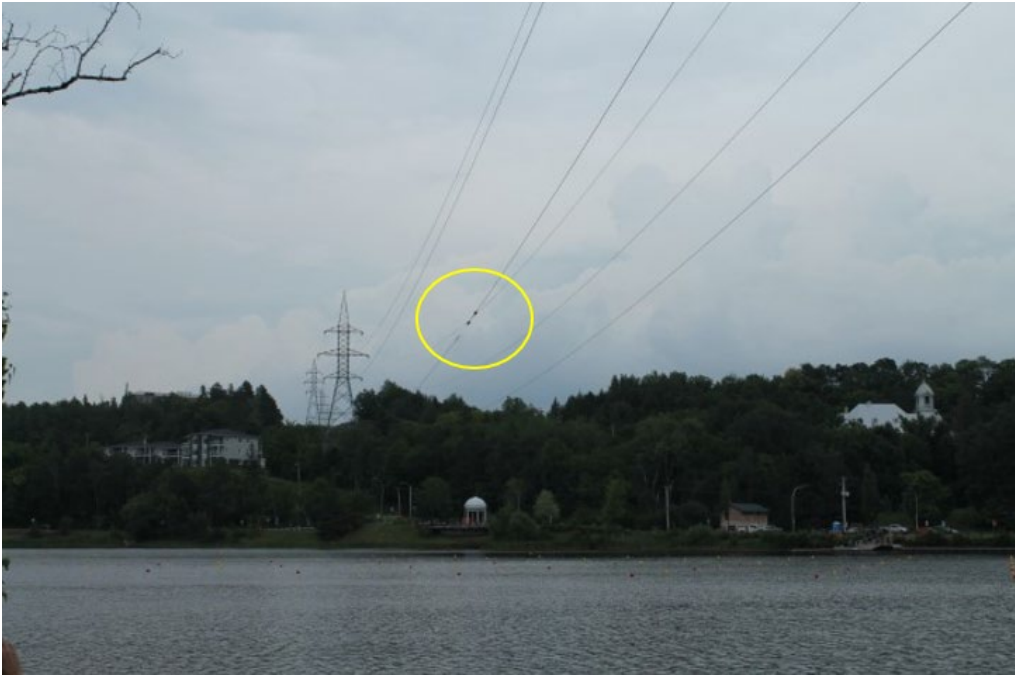
The damage to the lower cable matched the damage to the aircraft wreckage (Figure 2). Clear signs of contact with the cable were visible on the propeller blades, the left windshield post (Figure 3) and the left-wing strut (Figure 4).

Figure 2. Photo of the damage to the lower cable of the power line (Source: TSB)

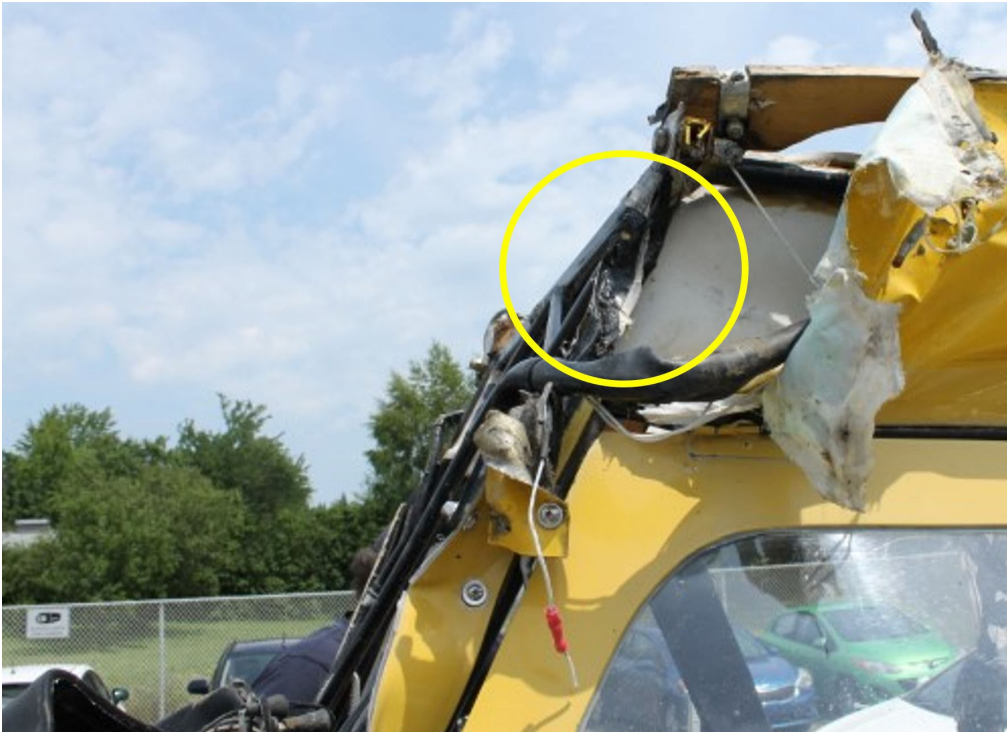
Figure 3. Photo of the damage to the left windshield post caused by the collision with the cable (Source: TSB)

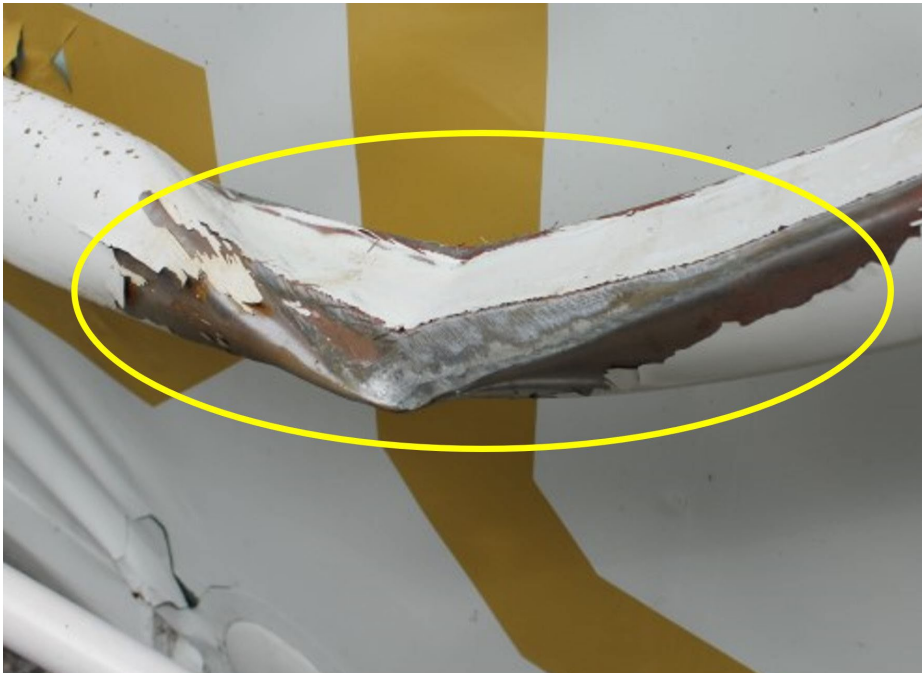
Figure 4. Photo of the damage to the left-wing strut caused by the collision with the cable (Source: TSB)
