# AIR TRANSPORTATION SAFETY INVESTIGATION REPORT A23O0108

## GROUND PERSONNEL ENTANGLEMENT WITH EXTERNAL LOAD

G4 Drilling Canada Ltd.  
and  
Expedition Helicopters Inc.  
Airbus Helicopters AS350 BA, C-FHAU  
Wawa, Ontario, 25 NM W  
20 August 2023

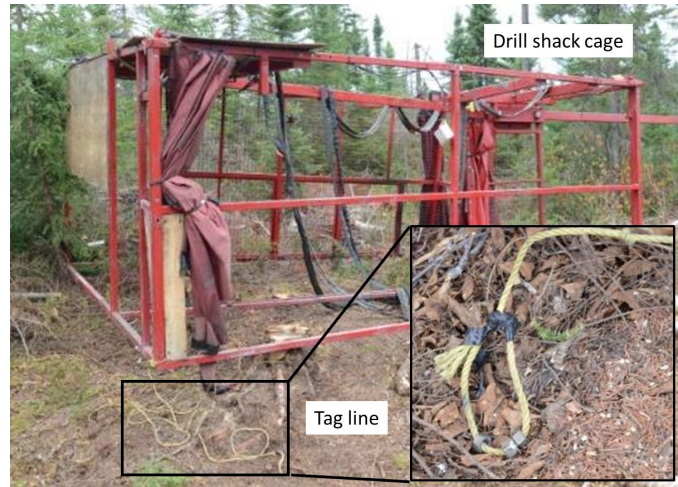
The foreman and the assistant foreman were stationed at the old site, preparing and attaching the drilling equipment to the longline, while the driller and helper were at the new site receiving, positioning, and detaching the drilling equipment from the longline. By approximately 1630, only the drill shack cage remained to be moved (Figure 2). This cage was to be placed over the drill and equipment on the drilling platform at the new site.

When the cage is carried by longline, the pilot cannot control the rotation of the cage during the transfer or during the descent into position, so the ground crew uses tag lines<sup>6</sup> (Figure 2, inset) to help guide and position the cage down onto the platform.

Figure 2. Drill shack cage with tag line (inset) (Source of main image: Ministry of Labour, Immigration, Training and Skills Development, with TSB annotations. Source of inset image: Ontario Provincial Police)

G4 has modified its tag lines such that the thickness and rigidity of the line do not allow it to coil upon itself, making it more difficult to catch or entangle a person handling the line or equipment on the ground.

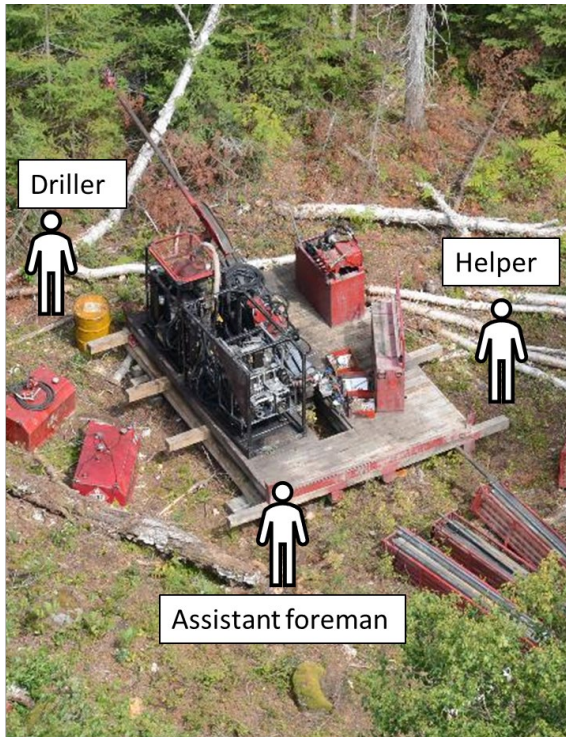
At approximately 1700, the pilot positioned the helicopter into the wind and lowered the cage over the drill. The driller and helper each held 1 tag line and the assistant foreman held 2 tag lines (Figures 3 and 4). When the pilot looked down through the vertical reference window, he could see the driller and the helper only, because a piece of plywood on top of the cage was blocking his view of the assistant foreman.

Figure 3. Photo of the new site, with approximate positions of the ground crew members (Source: Ontario Provincial Police, with TSB annotations)

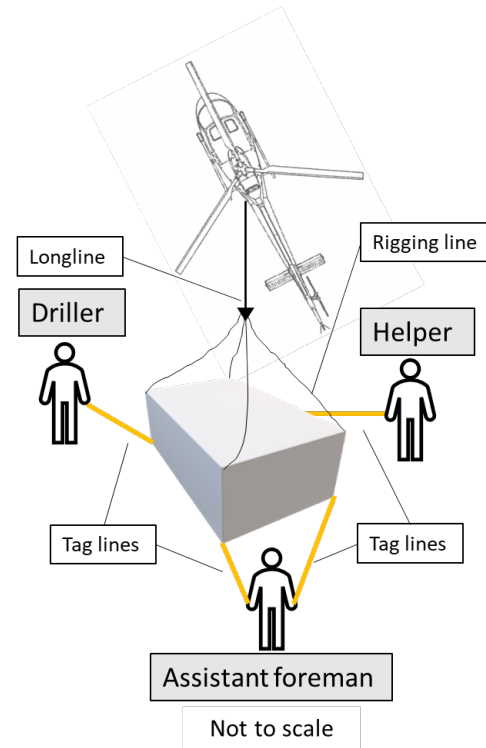
Figure 4. Diagram showing the cage, the helicopter (as it would have been oriented 100 to 150 feet overhead), and the tag lines held by the ground crew members (Source: TSB)

When it is not possible to position the load by hand, tag lines are used to help the ground crew while the load is being lowered to the ground. In this occurrence, closed weighted loops were made on the end of each tag line. The investigation determined that some G4 ground crew members put their hand in the loop or wrapped the tag line around an arm, wrist, or hand when handling the tag line attached to a load. Although the company did not have a standard procedure on how to use tag lines, this technique was a common practice with company crews. The investigation was unable to determine if the assistant foreman used this technique.
