AIR TRANSPORTATION SAFETY INVESTIGATION REPORT A23W0100

COLLISION WITH TERRAIN

Synergy Aviation Ltd.
Robinson Helicopter Company (RHC) R44 II, C-GNEC
Grande Cache, Alberta, 30 NM ENE
25 August 2023

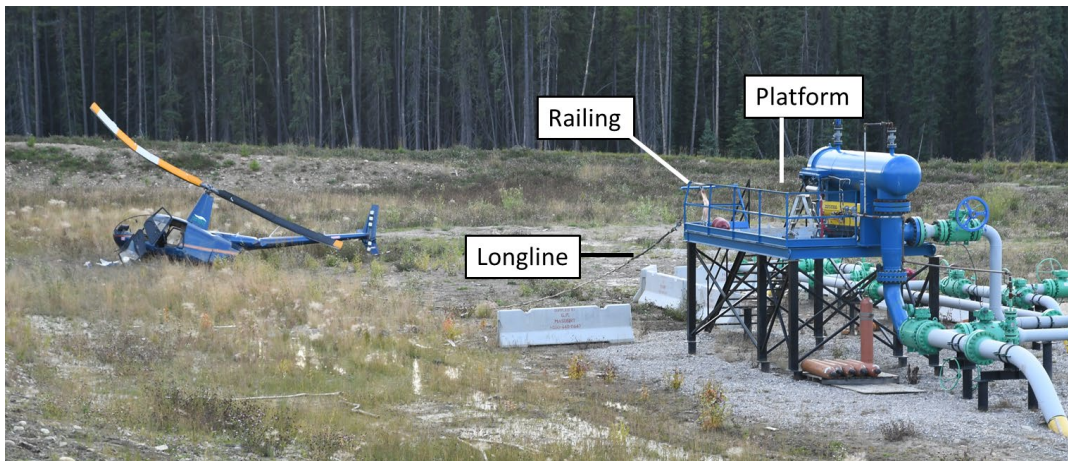
Figure 2. Accident site looking west (Source: TSB)

As the pilot attempted to maintain control of the helicopter, the main rotor rpm began to decay. Given the likelihood of a crash, the pilot steered the helicopter away from the piping and tanks, subsequently colliding with terrain at 0931. The longline remained attached to the helicopter and the work platform railing (Figure 2).

When investigators arrived at the accident site, the lanyard that had snagged on the railing of the work platform was still attached (Figure 4). There was little damage to the front of the helicopter. The helicopter had impacted the ground on its right side. The main rotor blades were distorted from impacting the ground while turning. The fuselage was significantly damaged. There were no signs of pre-existing mechanical problems with the helicopter.

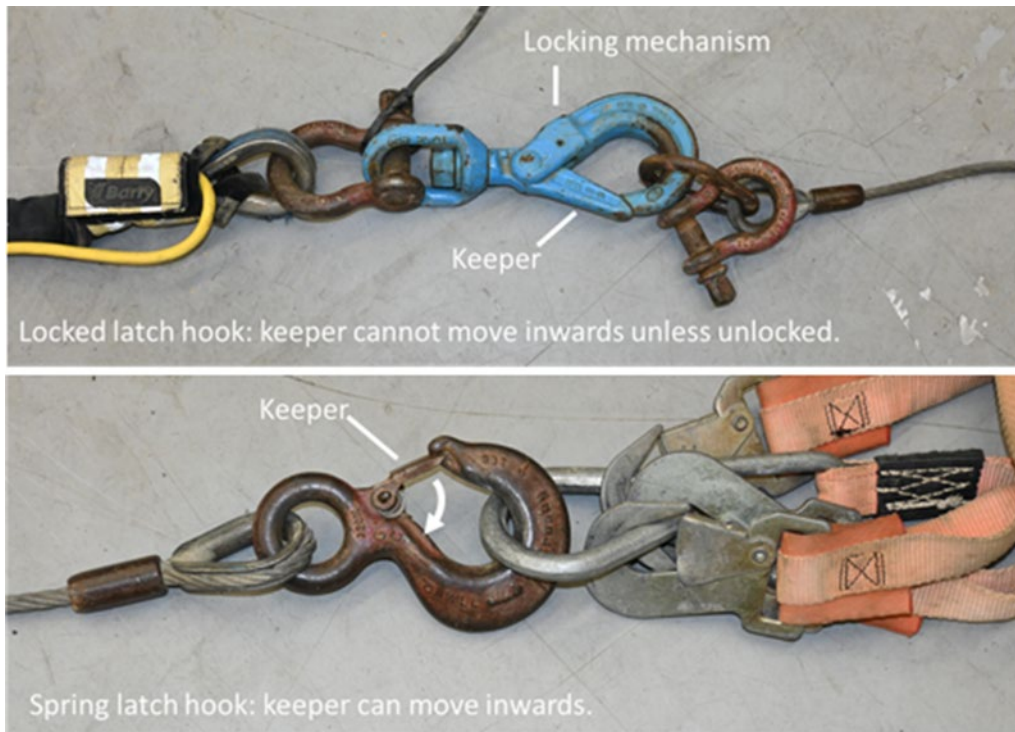
Figure 3. Comparison of locked latch hook (top) and spring latch hook (bottom) (Source of both images: TSB)

The longline was equipped with a locked latch hook. This type of hook has a locking mechanism that prevents the hook's keeper from opening, which can mitigate the risk of snagging (Figure 3, top image). The end of the steel lanyard that was attached to the locked latch hook had a spring latch hook installed (Figure 3, bottom image). This type of hook does not have a mechanism to prevent the hook's keeper from opening, and this is the hook that became snagged on the platform's railing.

- All loads are to be set and removed from the ground adjacent but clear of the platforms.
- All lanyards with the spring latch systems are to be removed from service and replaced with a locked latch style hook with a manual release.
- All longline operations require the pilot to remove the aircraft door to ensure the best visibility of the external load and/or end of the longline.
- A review of all operations associated with the pilot operating contracts as well as site hazard identification.

It is important for operators that conduct external load operations to use equipment that mitigates or eliminates snagging risks.

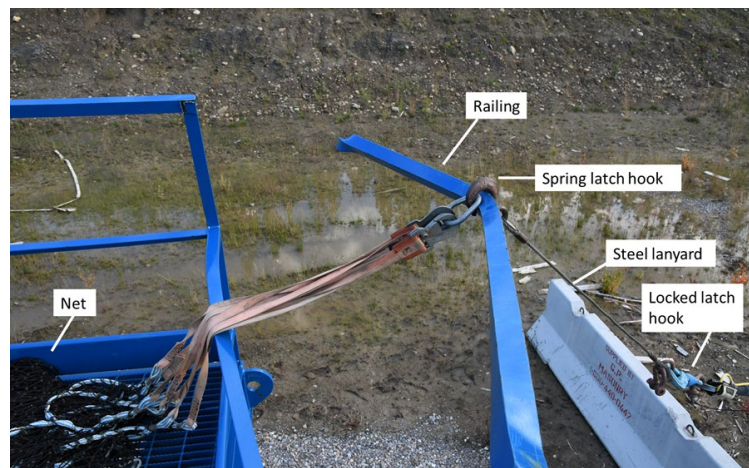
Figure 4. Image of hook and railing (Source: TSB)

During the transition to forward flight, the helicopter did not respond to the pilot's flight control inputs. Unknown to the pilot, the longline had snagged a railing on the work platform.
