## **AVIATION OCCURRENCE REPORT**

### **COLLISION WITH SNOWBANK**

**TRURO FLYING CLUB  
CESSNA AIRCRAFT COMPANY C152 C-GREJ  
DEBERT, NOVA SCOTIA  
17 DECEMBER 1994**

**REPORT NUMBER A94A0242**

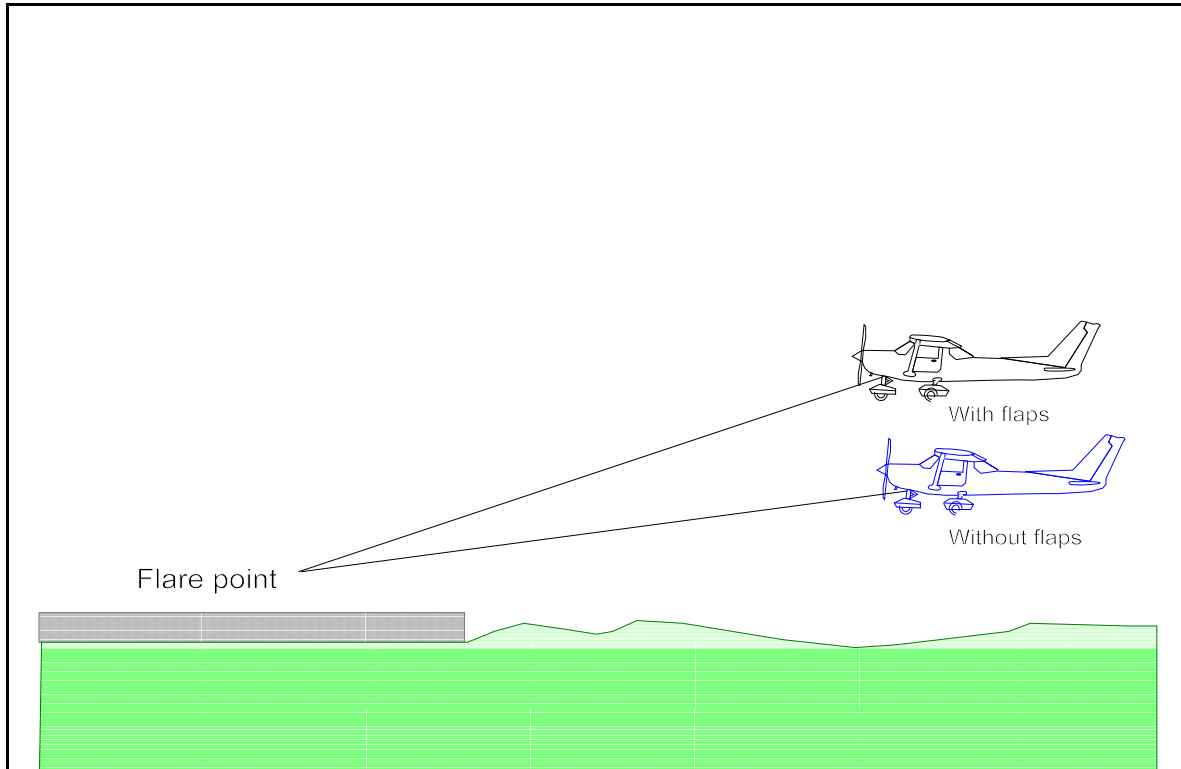
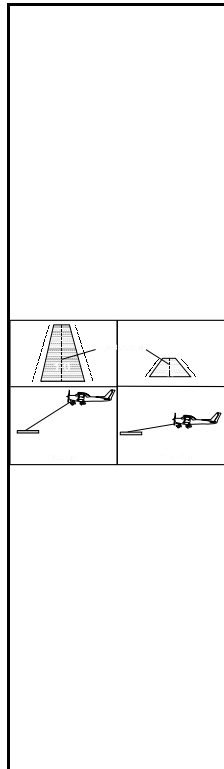
*Appendix A - Approach Perspective*

One method of achieving this [the visual maintenance of the desired approach slope at a constant angle] is by using the perspective phenomenon. A runway appears to change its shape as the pilot's observation point changes. For example, seen from final approach a runway will appear wider at the approach end than at the opposite end. When a constant approach angle is maintained, the apparent configuration of a runway will also remain constant.

If the approach angle is made steeper, the runway will appear to grow longer and narrower. If the approach angle is made more shallow the runway appears to grow shorter and wider.
