AVIATION OCCURRENCE REPORT

ENGINE FAILURE ON INITIAL CLIMB

**AMPHIBEC (ULTRALIGHT) C-FPXF
RIVIÈRE-DU-LOUP, QUEBEC
11 JANUARY 1994**

REPORT NUMBER A94Q0003

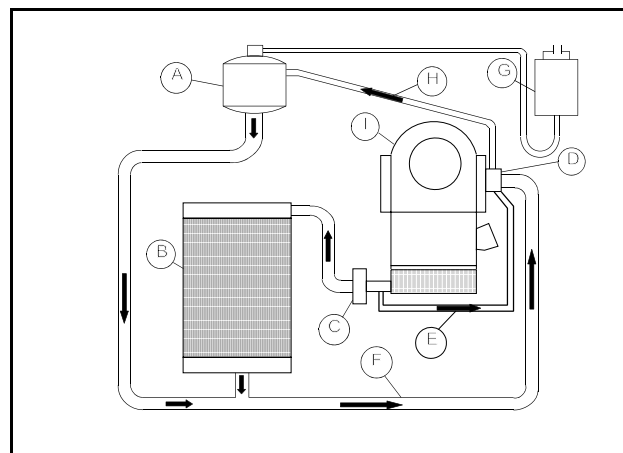
Figure 1 - Aviation Normand Dubé Inc. cooling system

The installation diagram¹ normally supplied by Aviation Normand Dubé Inc. with its cooling system components (see figure 1) shows a bypass hose (E) returning coolant to the water pump (D). This reduces the temperature differential of the coolant between the cylinder head outlet and the hose returning to the engine.

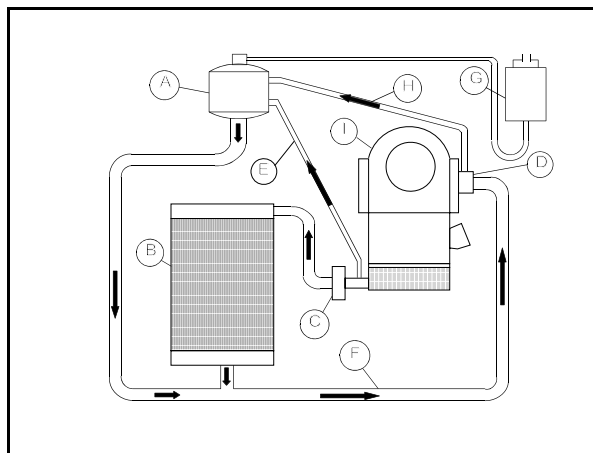
Figure 2 - Cooling system as installed on the aircraft

However, the cylinder head (I) on the aircraft (see figure 2) was not designed to be fitted with an integrated thermostat. The bypass hose (E) was not installed in accordance with the installation diagram supplied by Aviation Normand Dubé Inc. Instead, the bypass ran back to the expansion tank (A), which increased the temperature differential of the coolant between the engine outlet and pump return (D).

In addition, the aircraft was fitted with an oversized radiator (B). With a cooling surface 20 to 50 per cent greater than that of the radiators built and recommended by the engine manufacturer, the oversized radiator contributed to excessive engine cooling.

The incorrect installation of the bypass hose and the oversized radiator resulted in a decrease in the temperature of the coolant being returned to the engine.

Nevertheless, the result was that coolant was returned to the engine at a lower temperature, and the temperature differential of the coolant between the engine outlet and the pump return became greater. During operations at very low ambient temperatures, this cooling system, with its increased efficiency, would lower the temperature of the coolant by more than 40 degrees Fahrenheit before the coolant returned to the engine block.
