## **AVIATION OCCURRENCE REPORT**

### **LOSS OF CONTROL - STALL**

**CHAMPION 7GCB CITABRIA C-GGTD  
BOILY LAKE, QUEBEC  
24 JULY 1994**

**REPORT NUMBER A94Q0131**

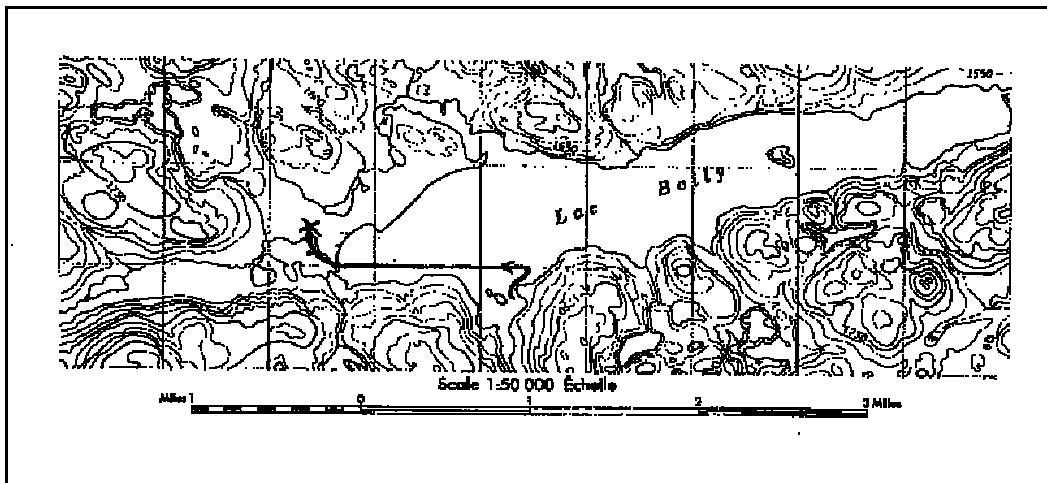
**Figure 1 - Flight Path of C-GGTD**

and that he would not be able to clear the hill on the climb-out trajectory. He then initiated a steep right turn at low altitude to return to the lake for a landing. During the turn, the aircraft's nose pitched downward, and the aircraft descended, struck some trees, then struck the ground in a steep nose-down, left-wing-low attitude. A fire broke out after the aircraft came to rest on the ground.

With an available take-off distance of 5,000 feet and a 15-knot head wind, the aircraft should have been capable of easily clearing the hill. But overloading, downdrafts, and the drag caused by the folding canoe on the right float reduced the take-off and climb performance of the aircraft to the point where it was unable to clear the hill. The pilot then initiated a steep right turn at low altitude to return to the lake for a landing, but he did not maintain the required speed in the turn, and the aircraft stalled. In a level turn, stalling speed increases in proportion to the bank angle of the aircraft. The greater the angle of bank, the higher the stalling speed.
