AVIATION OCCURRENCE REPORT

CONTROLLED FLIGHT INTO TERRAIN

**BEARSKIN LAKE AIR SERVICES LTD.
BEECHCRAFT A100 C-GYQT
BIG TROUT LAKE AIRPORT, ONTARIO 3 mi NW
21 FEBRUARY 1995**

REPORT NUMBER A95C0026

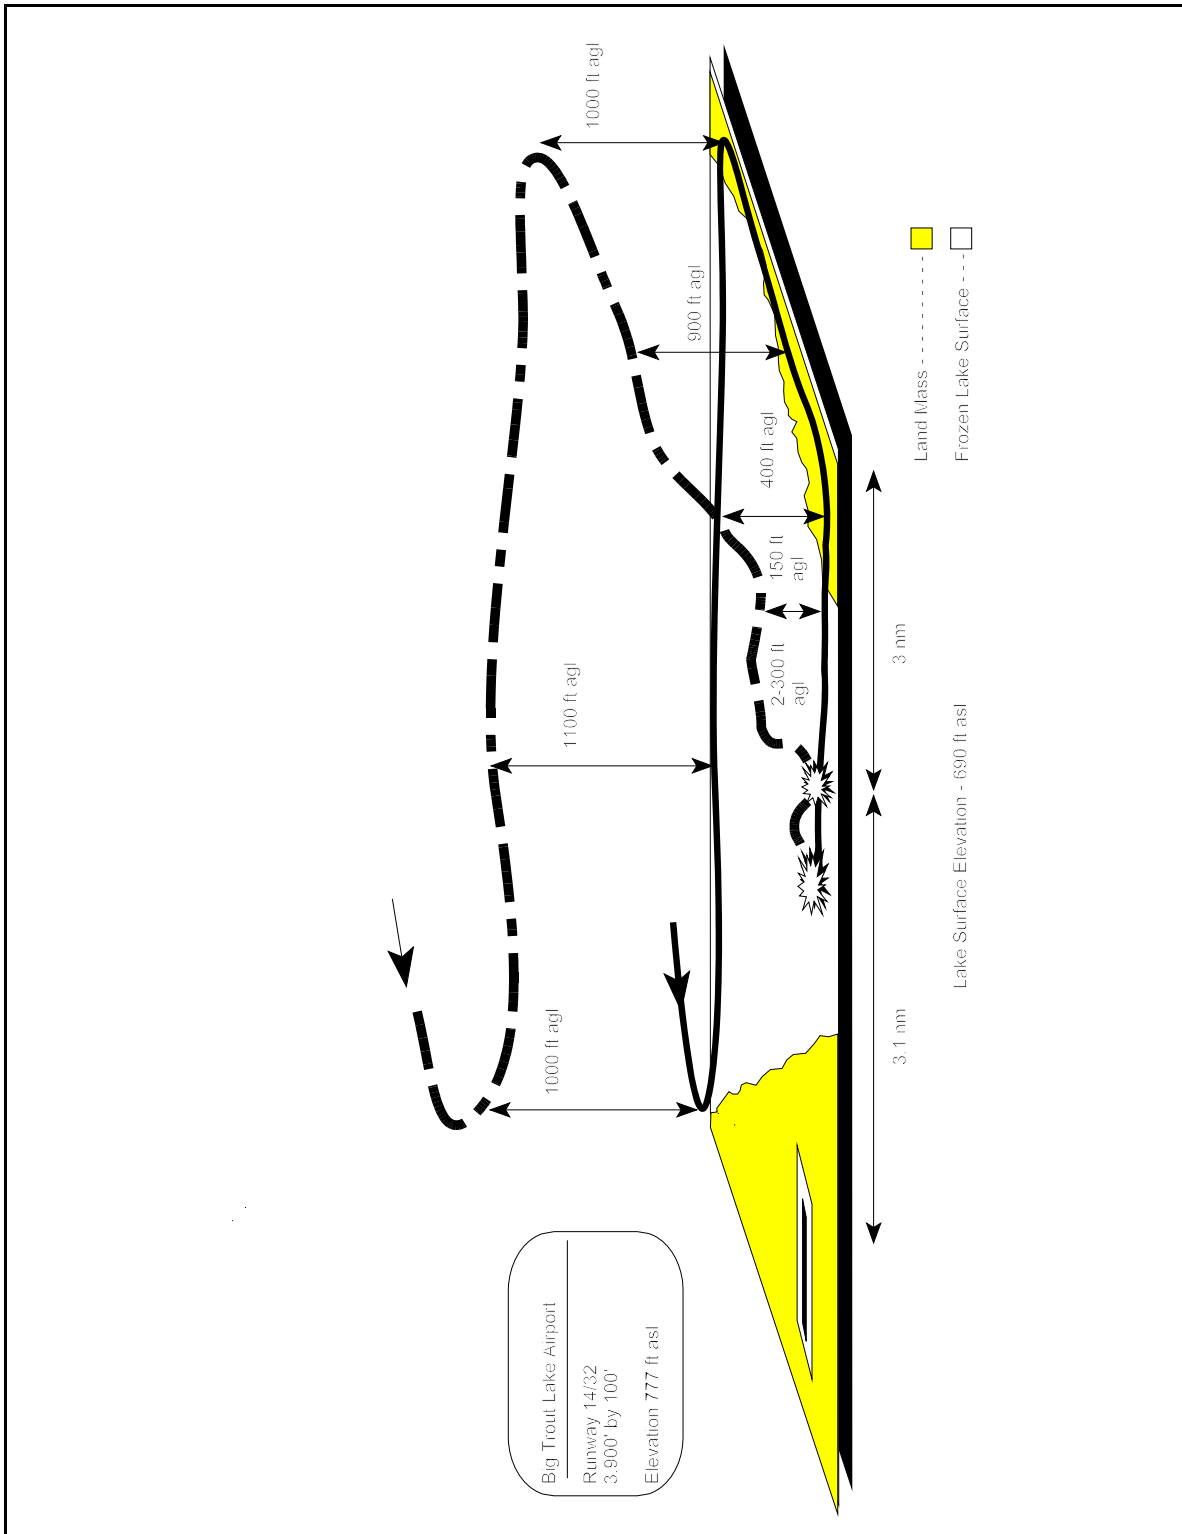
Appendix A - Approach Profile

The crew descended to 150 feet agl approximately 4.5 miles from the end of the landing runway and maintained 200 to 300 feet agl for some 50 seconds prior to impact. Given the weather conditions of one mile visibility in snow that were reported by the crew, and the monochromatic appearance of the snow-covered surface of the lake, the crew's decision to continue to fly visually at this altitude exposed the crew to the risk of experiencing whiteout conditions. The captain was aware of the danger, and intended to revert to an instrument approach if whiteout were encountered. Although the decision to fly close to the lake surface reduced the margin of safety and the time available to react to any loss of situational awareness in whiteout conditions, the decision did not contravene ANOs or the company SOPs.
