AVIATION OCCURRENCE REPORT

LANDING GEAR FAILURE - CAPSIZING

**ENTERLAKE AIR SERVICES LTD. (SELKIRK AIR)
BEECH AIRCRAFT CORPORATION 3T BEECH 18 C-FSFH
BRADBURN LAKE, MANITOBA
05 JUNE 1995**

REPORT NUMBER A95C0110

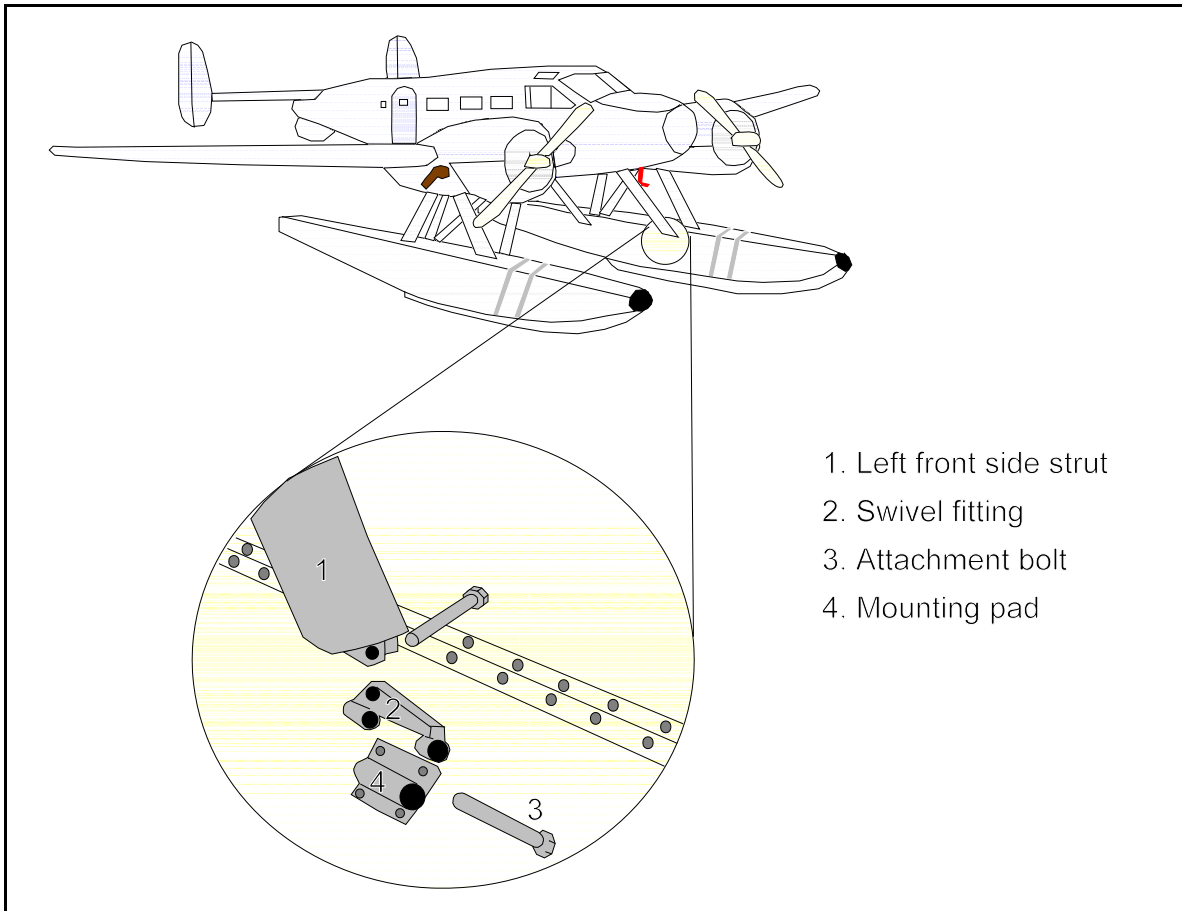
Appendix A - Float Strut Detail

Examination of the aircraft after the occurrence revealed that the left float's front and rear vertical struts were still attached to the float, but their top fittings (at the aircraft nacelle) were twisted and showed signs of overload failure. The eyebolt fitting of the diagonal side strut failed at the swivel fitting where it attaches to the float. The rear side strut upper attachment bolt at the fuselage was twisted, and the rear swivel fitting bolt, by which the swivel and the diagonal strut are attached to the rear float mount pad, was broken. The mounting pad on the float showed signs of metal smearing. The front side strut was still attached to the fuselage; the attaching bolt was in place and the fitting showed little damage. The float end of the front side strut incorporates a swivel fitting, which attaches to a mounting pad on the float. Neither the front left swivel fitting nor the corresponding mounting pad showed evidence of damage or distortion; the mounting bolt and nut were not recovered.

Because the eyebolt fitting connecting the diagonal strut to the rear swivel fitting was found bent and broken in overload, with no pre-existing damage, it is likely that the fitting failed during the float separation sequence, but did not initiate the failure.

After examination of the front swivel fitting and mounting pad, the Engineering Branch concluded that the attaching bolt probably did not break, but moved out of position, either because the nut was not installed or because it came off during service. Given that the pilot reportedly checked the float fittings before departing the first flight of the day, it is likely that the bolt moved out of the fitting during the two flights completed on the day of the occurrence. Because of the low-wing design of the aircraft, the location of the main entry/exit door, and the seaplane landing gear configuration, a defect in the area of the forward float fittings would be less noticeable than in other aircraft designs. In light of the lack of damage to the front diagonal strut fittings and the overload failure damage found in the other float fittings, it is likely that the departure of the bolt from the front swivel fitting initiated the sequence of failures that resulted in the separation of the float from the aircraft during the occurrence.

Because the bolt and nut connecting the front swivel fitting to the float mounting pad were not recovered, no definitive statement can be made about the type of nut that was installed. However, 9 of the 10 float fitting bolts for which castellated nuts were specified were recovered with fibre locking nuts, and it is possible that this bolt was also secured with a fibre locking nut. Several of the left float fittings that were recovered had less than one thread of bolt extension past their fibre-locking nuts, and it is possible that the missing bolt lost its nut because the nut did not lock securely, and departed from the bolt in service.
