**AVIATION OCCURRENCE REPORT**

**ENGINE POWER LOSS - MECHANICAL MALFUNCTION**

**SKYTECH AVIATION LTD.  
BELL 206B JETRANGER (HELICOPTER) C-GXNM  
DRYDEN, ONTARIO 4 mi NW  
07 JULY 1995**

**REPORT NUMBER A95C0149**

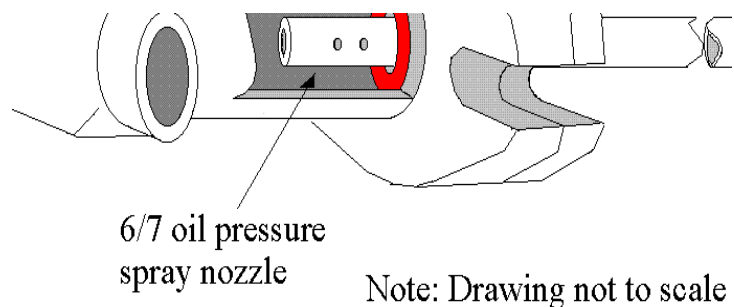
A connector assembly (part number 6848194C), commonly referred to as the tee-fitting, supplies pressure oil to the number 6/7 bearing pressure oil nozzle and to the pressure oil supply line for the number 8 bearing. The inlet to the tee-fitting is protected by a filter screen. At installation, the upper portion of the 6/7 bearing pressure oil nozzle is inserted into the base of the tee-fitting, producing a standpipe inside the tee-fitting. As a result, a recess is formed between the standpipe and the inner walls of the fitting. (See Figure 1.)

The TSB Engineering Branch determined that the 6/7 bearing pressure oil nozzle was blocked by a particle of hard carbon. A piece of hard carbon was also found in the oil supply line for the number 8 bearing. Both carbon particles were too large to have passed through the inlet screen of the tee-fitting. Inspection of the tee-fitting revealed a build-up of hard carbon in the area between the standpipe and the inner wall at the base of the tee-fitting. The degree of carbon build-up was excessive for the time-in-service since the DIL 155 inspection. Using the electron scanning microscope (SEM), a sample of the carbon taken from the base of the

tee-fitting was compared with the carbon particles. It could not be conclusively determined that the two particles had come from the base of the tee fitting; however, the carbon particle from the pressure nozzle displayed a uniform curvature with a radius that matched the radius of curvature of the interior passageway of the base of the tee-fitting. Energy dispersive X-ray analysis of the three carbon particles showed that they were probably derived from the same combusted material and/or combustion reaction. The carbon particle that blocked the 6/7 bearing pressure oil nozzle most probably originated in the base of the tee-fitting.

The design of the tee-fitting and standpipe assembly is conducive to the formation of carbon between the inner wall of the tee-fitting and the standpipe of the 6/7 bearing pressure oil nozzle, where oil becomes trapped. A hard carbon deposit had built up in this area of the tee-fitting. The carbon build-up was considered excessive for the hours of operation since the completion of the heavy maintenance inspection.

The carbon particle which blocked the 6/7 bearing pressure oil nozzle displayed characteristics similar to the composition of the carbon that had formed inside the base of the tee-fitting, and the particle had a uniform curved surface that compared with the inside diameter of the tee-fitting wall. Therefore, it is likely that the carbon originated in the tee-fitting, then broke loose and moved to block the nozzle. Although the manufacturer's data indicate that build-up of carbon in this area has not previously resulted in engine failure, it is concluded that it likely did in this case.

The current inspection and cleaning instructions may not ensure complete removal of carbon from the recessed area inside the base of the tee-fitting. Solvents may not dissolve all carbon, and reaming of the outflow port with a hand-held drill bit will not reach the area that needs to be cleaned. Considering the degree of carbon build-up in the base of the tee-fitting and the short operating time since accomplishment of the DIL 155 inspection, it is probable that the carbon was not fully removed during the overhaul process.

An Aviation Safety Information letter was sent to TC outlining the particulars of the carbon build-up inside the base of the pressure oil tee-fitting as identified during this investigation.
