**ENGINE FIRE AND EVACUATION**

**AIR CANADA  
MCDONNELL DOUGLAS DC-9-32 C-FTMD  
VANCOUVER INTERNATIONAL AIRPORT, BRITISH COLUMBIA  
27 JUNE 1995**

**REPORT NUMBER A95P0138**

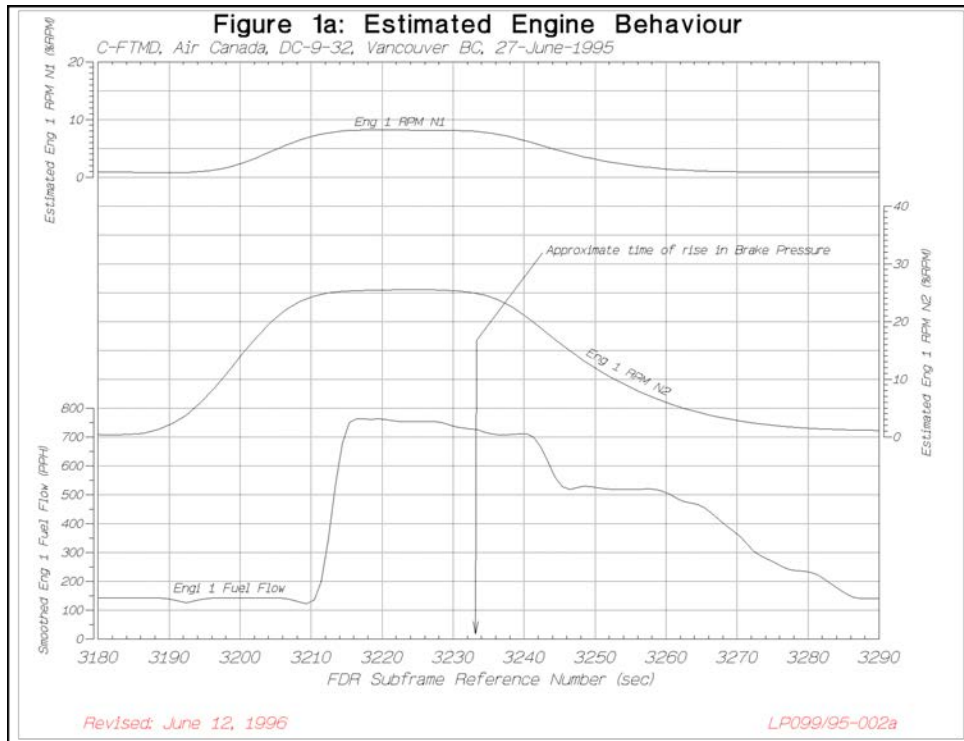
Figure 4 - FDR Data of the Left Engine Start

After the captain engaged the starter, the N2 increased and stabilized at about 25 per cent; the fuel flow then increased to about 750 pounds per hour (pph) in about a second, and stabilized at that value. FDR data recorded before this incident showed that the fuel flow on start normally rises to about 750 pph in 1 to 2 seconds. There was no further change in the N2 rpm or fuel flow. About 11 seconds after the captain moved the fuel control lever to ON, he informed the first officer that there was no ignition and continued to motor the engine. Both pilots later reported that the captain moved the fuel control lever to OFF at this time. Moving the fuel control lever to OFF cuts off the fuel supply to the engine and inhibits the ignition system. By design, the FDR does not record the movement of the fuel control lever; the sound of the fuel lever being moved may have been recorded on the CVR. Spectral analyses of certain recorded sounds were conducted by the National Research Council and the TSB Engineering Branch; they assessed that the sounds were dissimilar to the fuel control lever being shut off and locked in position.

At the same time that the captain informed the first officer that there was no ignition on the left engine (FDR ref. 3224), the ground crewman advised the cockpit on the intercom system that push-back was complete and requested the brakes be set. Eight seconds later, the captain replied that the brakes had been set. FDR data (3232) showed that the brake pressure rose to about 1,300 psi, and that pressure was maintained for the duration of the recorded data. Analysis of the FDR data showed that the N2 rpm began to drop immediately before the brakes were set.

After peaking at about 750 pph, the fuel flow dropped slowly to 700 pph over 26 seconds. The fuel flow then dropped markedly to maintain about 525 pph, before gradually decreasing to the original static value. Concomitant with this latter decrease in fuel flow, the N2 rpm also decreased. FDR data also revealed that on each previous engine shutdown from an N2 of about 56 per cent, the recorded fuel flow values characteristically decreased from a steady 800 pph to the original static value within about 7 seconds of the fuel control lever being moved to OFF. As well, the N2 rpm reduced to 20 per cent in about 15 seconds, and to zero in another 45 seconds.

Because the recorded FDR data did not show the characteristic and rapid decrease in fuel flow to the left engine normally seen when the fuel control lever was selected OFF, it is concluded that the fuel lever was not moved to the OFF position during the starting sequence.
