AVIATION OCCURRENCE REPORT

A97H0002

RISK OF COLLISION

12 MARCH 1997

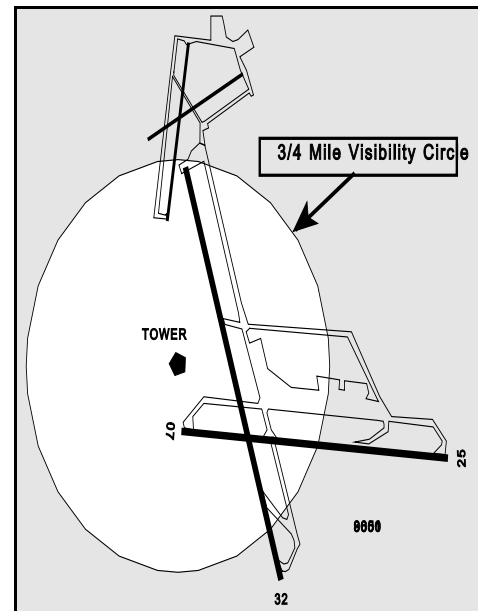
Figure 1 - Ottawa/MacDonald-Cartier International Airport5

The Ottawa/MacDonald-Cartier International Airport has two main runways, used primarily by commercial carriers, and two secondary runways at the northwest end of the field, used mainly by small aircraft and the resident flying schools. The orientation and length of the major runways are depicted on the accompanying diagram. The distance from the tower to the threshold of runway 25 is approximately 8,100 feet. A visibility of 3/4 mile prevents the airport controller from seeing the threshold and first half of runway 25, as depicted by the shadowed area.

The runways and taxiways were generally covered by a light coat of snow because of a local snow shower at the time of occurrence. The snow blended the airfield surface with that of the surrounding area. Moreover, the upper surface of the Regional Jet was painted white, and the flight crew of ANU403 reported that the white aircraft on the snow-covered threshold was difficult to discern.
