AVIATION OCCURRENCE REPORT

A9800190

STALL/COLLISION WITH TREES ON TAKE-OFF

PIPER PA 28-151 C-GDVL
ESPANOLA WEST, ONTARIO

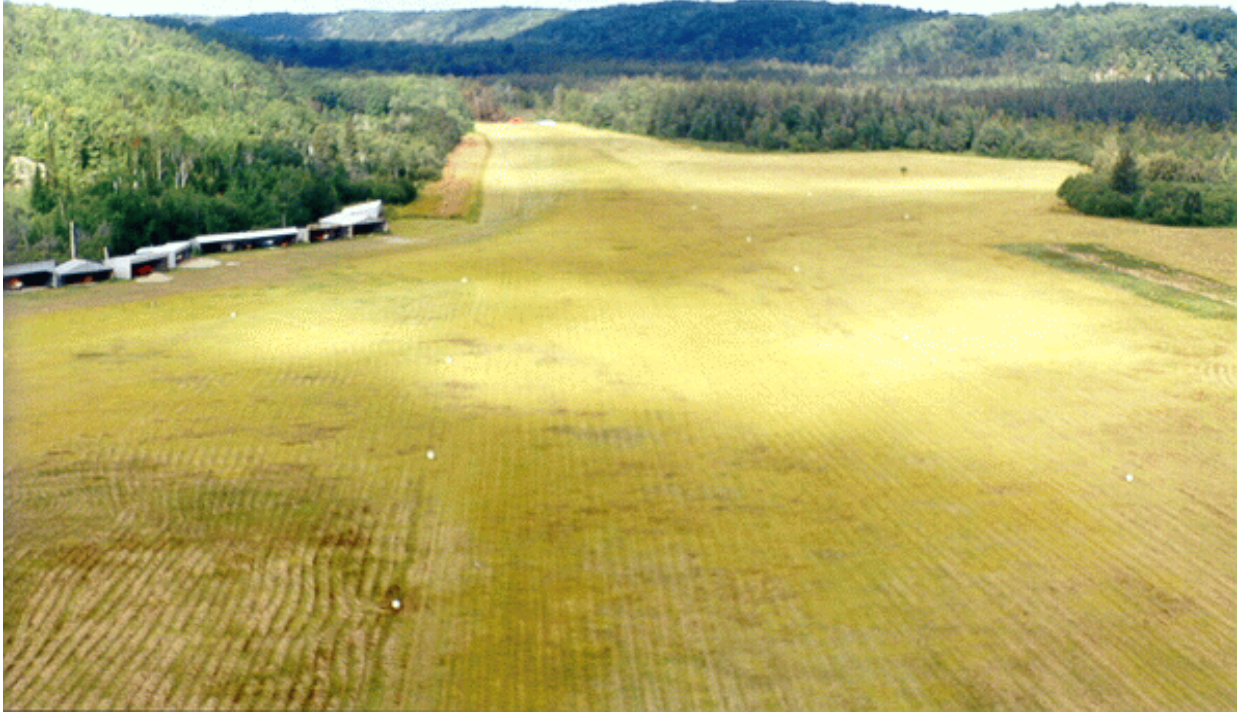
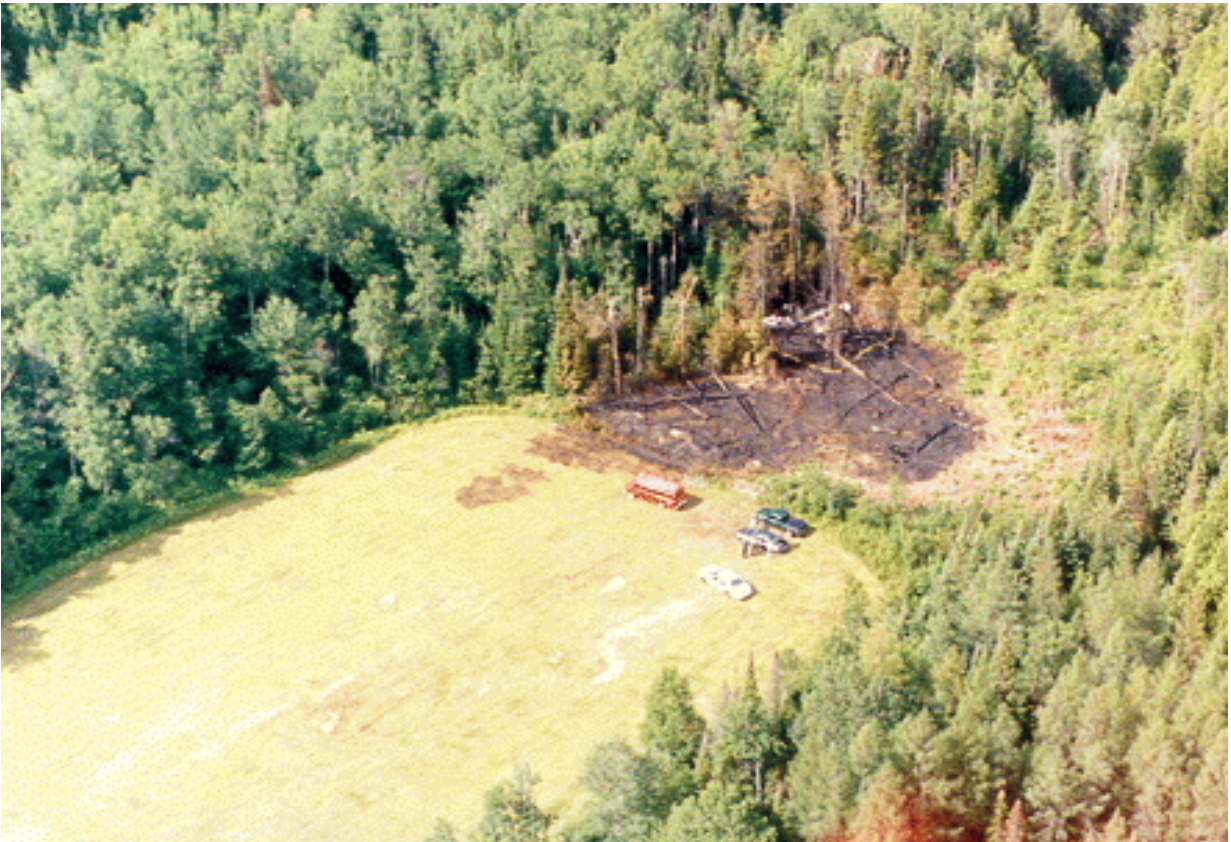
Appendix A - Runway and Crash Site

The runway, approximately 250 feet wide and 2 900 feet long, was surrounded by trees and was oriented on a heading of 283 degrees magnetic. There were patches of ground on the runway surface where the soil was very soft. The grass had been cut recently and was two to three inches long. It was learned from an operator familiar with the airport that their tricycle-equipped aircraft were not permitted to use the airstrip after rain had fallen because the soil becomes very soft when wet. Higher ground is located at the end of the departure runway and to the west. (See Appendix A.)

Information gathered at the scene indicated that the aircraft, while flying straight ahead, first struck two trees with the left wing, which yawed the aircraft to the left, then it struck more trees while travelling sideways from left to right. The aircraft struck the ground still travelling from left to right and came to rest in an upright position with the right wing failed at the root and supported by a tree trunk. An intense fuel-fed fire erupted on or immediately after impact. The most intense fire was in the cabin of the aircraft and broke out before the occupants exited the aircraft.
