AVIATION INVESTIGATION REPORT

A98Q0194

LOSS OF CONTROL

BRITTEN-NORMAN BN2A-26 C-FCVK

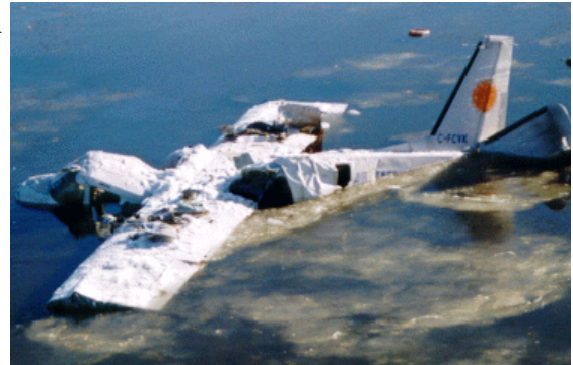
From this information it can be determined that the water in the cabin was at most 50 inches deep. The damage to the wings and the stabilizer indicates that the aircraft was banked 19° to the left when it struck the surface of the water. Examination of the floor of the aircraft and the tail skid revealed that the aircraft had a nose-up angle of approximately 3° at the time of impact. The tail fin was intact; there was no sign of the deformation or distortion normally associated with a violent impact. The damage to the landing gear indicates that the aircraft was side-slipping to the left at the time of impact.
