MARINE INVESTIGATION REPORT

M02N0007

FIRE AND SINKING

OF THE SHRIMP FACTORY FREEZER TRAWLER *KATSHESHUK*
BELLE ISLE, NEWFOUNDLAND AND LABRADOR 76 NM ENE

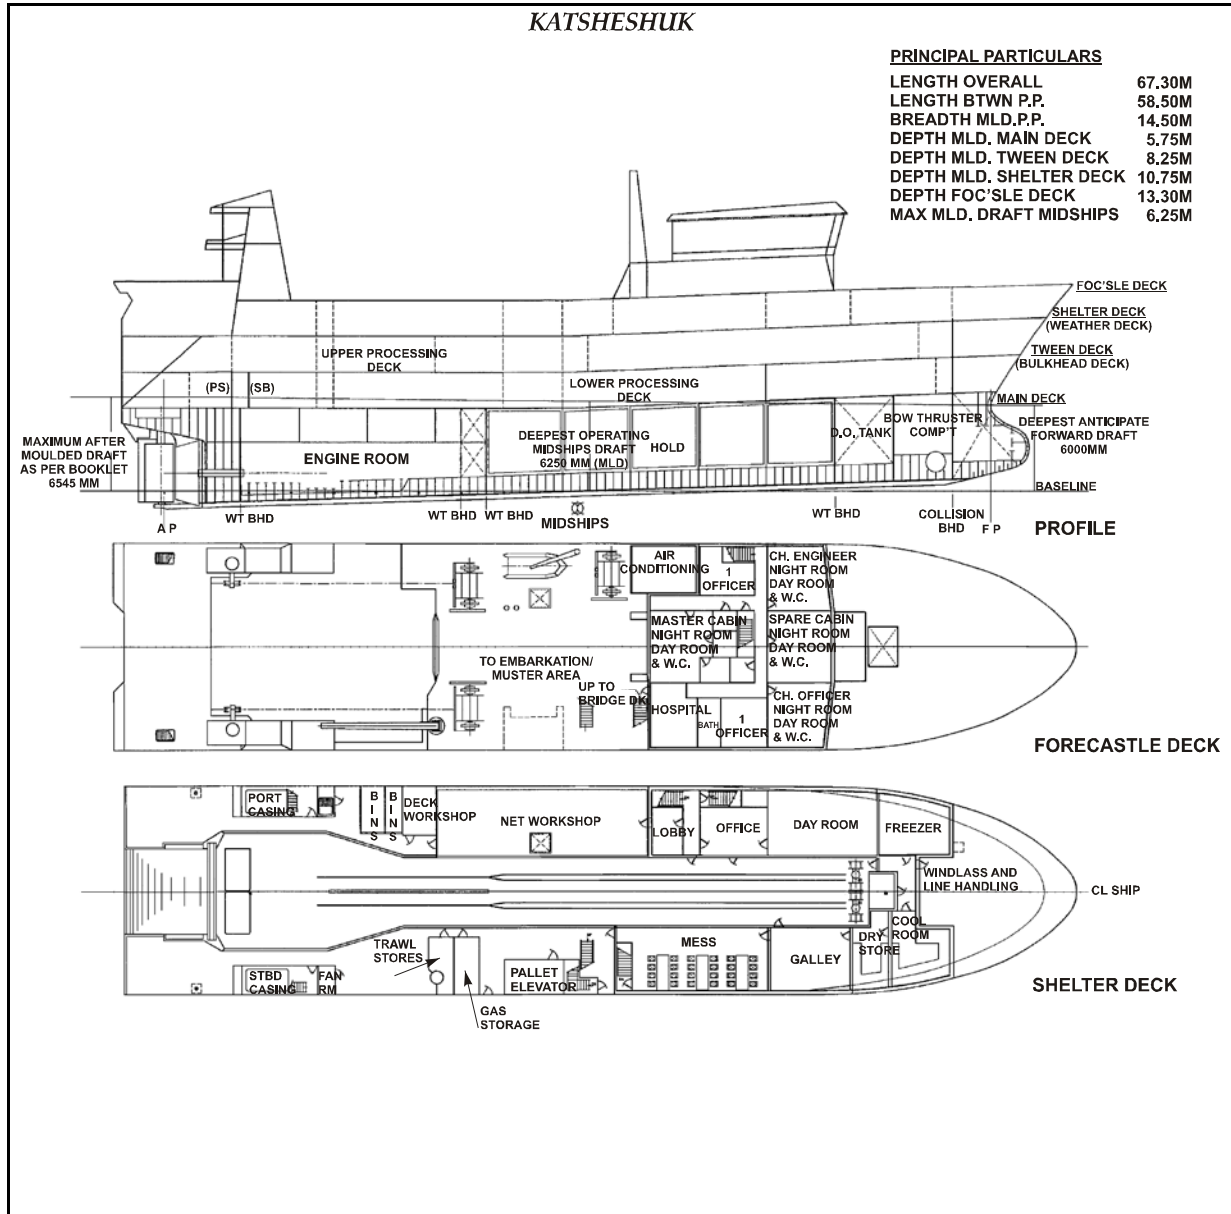
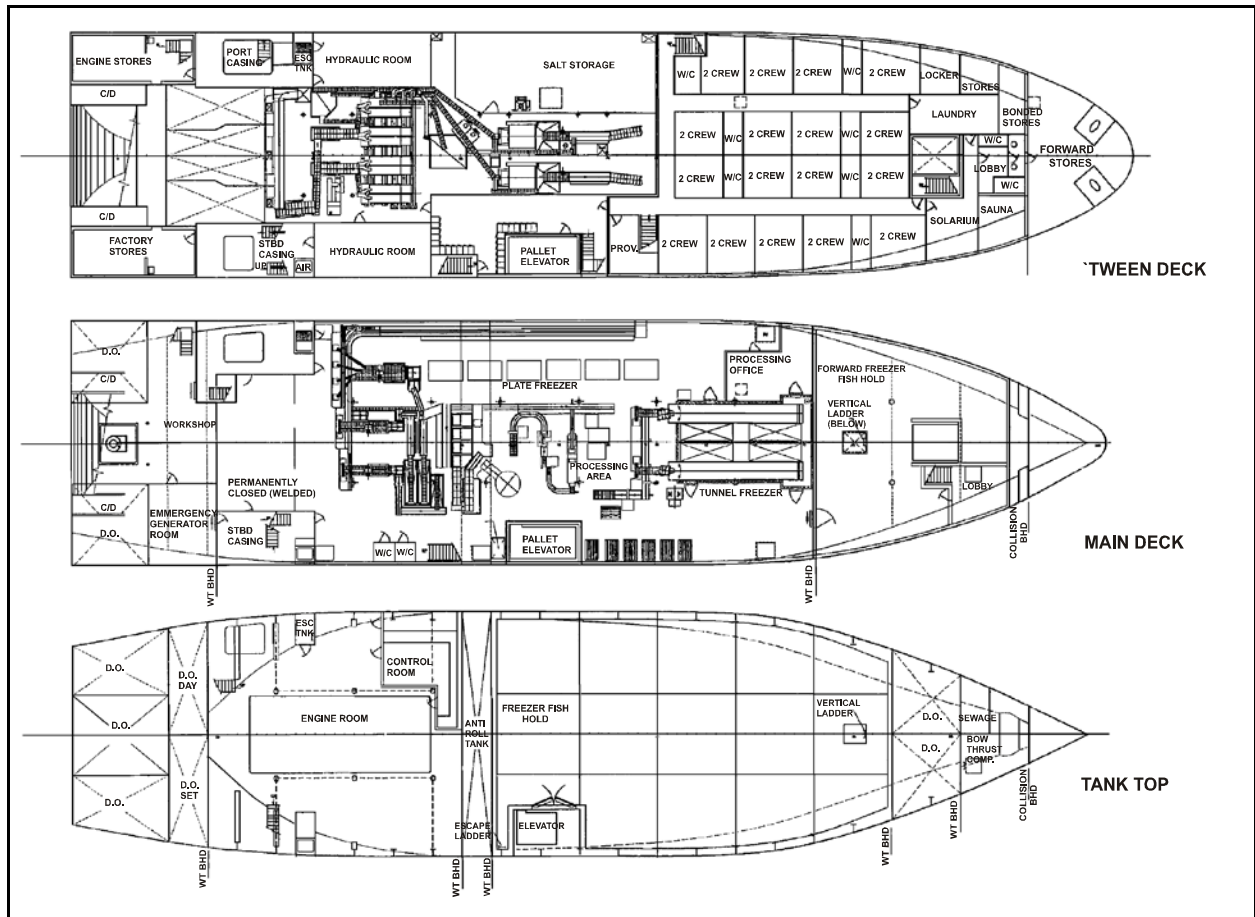
Figure 1 (cont'd)

transverse watertight bulkheads, five of which extended from the keel up to the main deck level, while the sixth extended up to the shelter deck as a collision bulkhead. A seventh watertight bulkhead extended from the main deck up to the 'tween deck and was used to divide the forward freezer hold from the lower processing area. A watertight inner bottom, enclosing double-bottom tanks extended for the length of the fish hold, while the hull

in way of the main engine room was of part double-bottom construction (see Figure 1).

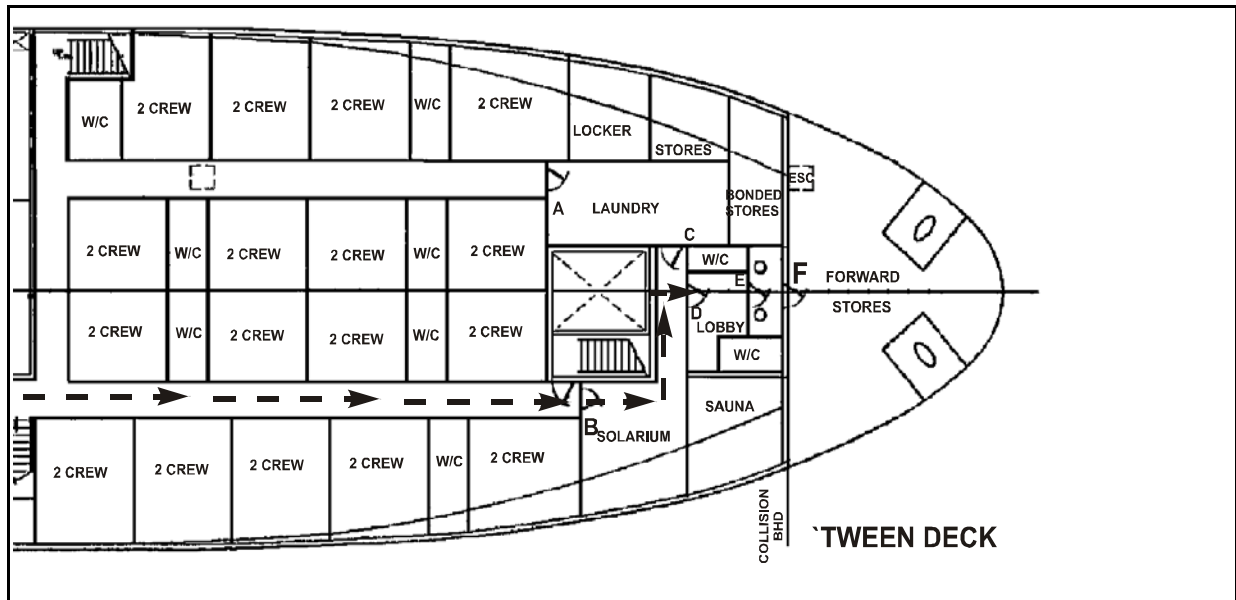
While up forward and unknown to the first fire party, a second fire party was being assembled in the starboard alleyway (see Figure 3b). This team consisted of a fire lead wearing jeans, a short sleeve shirt and a SCBA accompanied by a hose party. As the first fire party was pulling back, the second fire party opened door B leading to the solarium and the fire lead felt some heat. He introduced water into the solarium for about a minute before deciding to pull back to get a safety line. On the second trip forward, the fire lead made it to door D and when he opened it, a white flame shot out over his head and hit the deckhead. He opened up his hose at the fire, but was quickly forced back by debris falling from the deckhead. The second fire party then retreated to the after cross-alleyway also leaving some doors in the open position.

⁴ Due to reduced visibility, the fire lead could not definitively determine which door he opened, however since weathertight door F was normally left open, it was most likely door E.

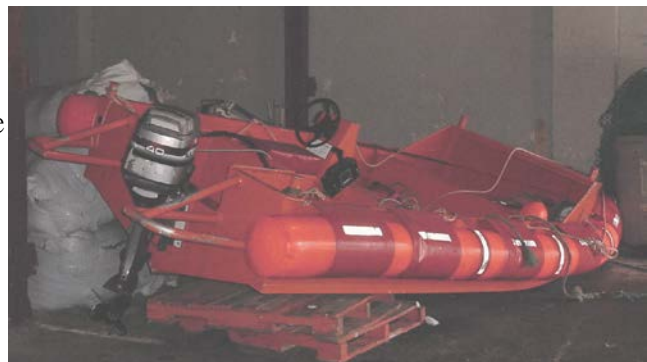
At approximately the same time and roughly 45 minutes after the fire was discovered, the master decided to evacuate all non-essential personnel to the other fishing vessels in the area. An attempt was made to raise the vessel's rescue boat (see Photo 2) using the port boat davit, but the crew could not get it to operate. As a result, they used the cargo crane on the starboard side. The crew evacuated using the vessel's own rescue boat by boarding the rescue boat on the forecandle deck and then being lowered to the water.

The operational issues with the port boat davit during the evacuation could not be determined.

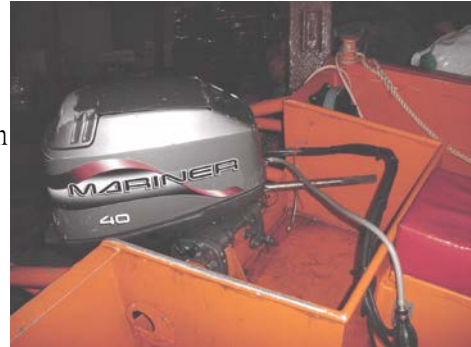
The *Katsheshuk* had a 5.4 m rescue boat equipped with a 40 HP outboard motor which formed part of the vessel's safety equipment.¹¹ The remote steering control on the rescue boat was reported to have been unserviceable since mid-January 2002. To allow for steerage, an improvised tiller arm (see Photo 5) had been jury-rigged to the outboard motor. This ad-hoc arrangement required the rescue boat to have two operating personnel, one to steer the vessel and a second to operate the throttle.

1. The steering control for the rescue boat had been unserviceable for two months at the time of the occurrence.
