**MARINE INVESTIGATION REPORT
M05C0019**

STRIKING

**BULK CARRIER *FEDERAL SAKURA*
SOUTH SHORE CANAL
ST. LAWRENCE SEAWAY
03 JUNE 2005**

Report Number M05C0019

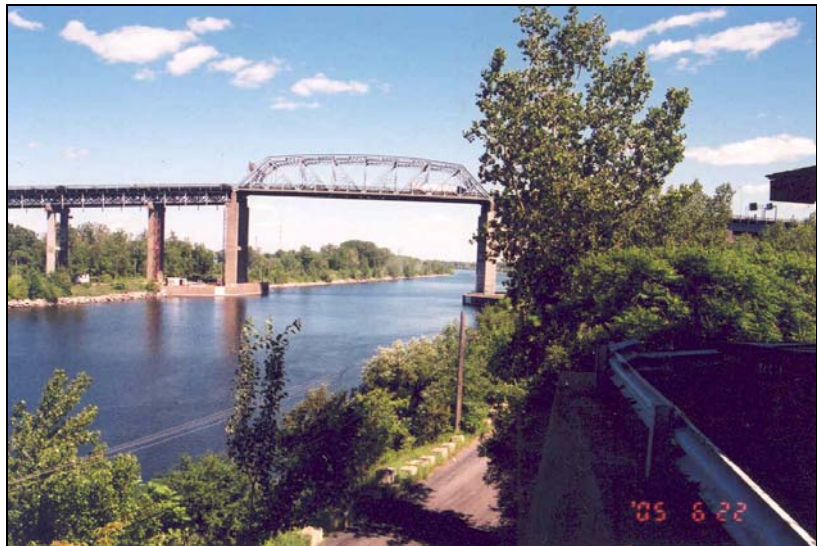
Photo 1. View of the Honoré-Mercier Bridge (Bridge 6) from the control tower

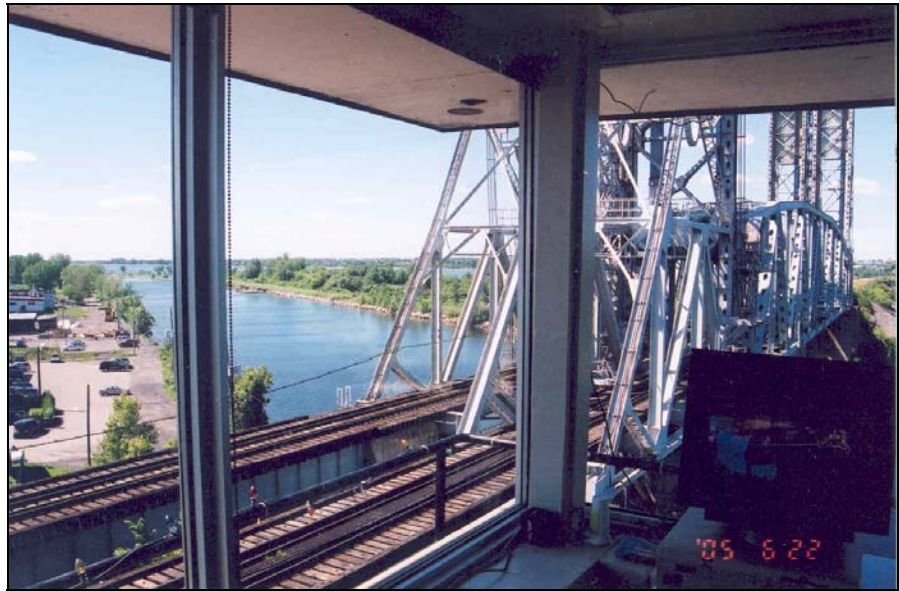
Photo 2. View of bridges 7A and 7B from the control tower

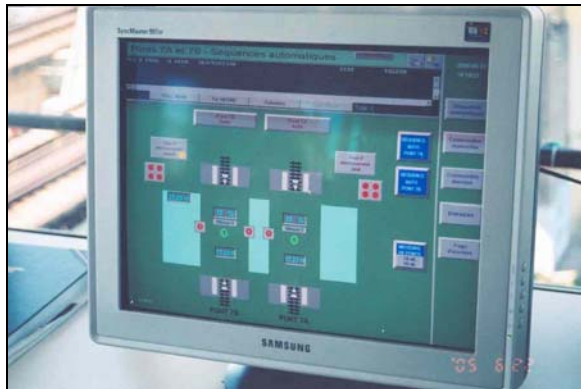
Photo 3. Computer console used to operate bridges 7A and 7B

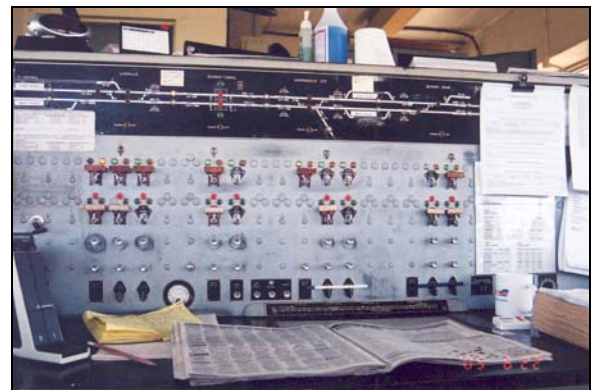
Photo 4. Mimic panel used to interlock and switch tracks

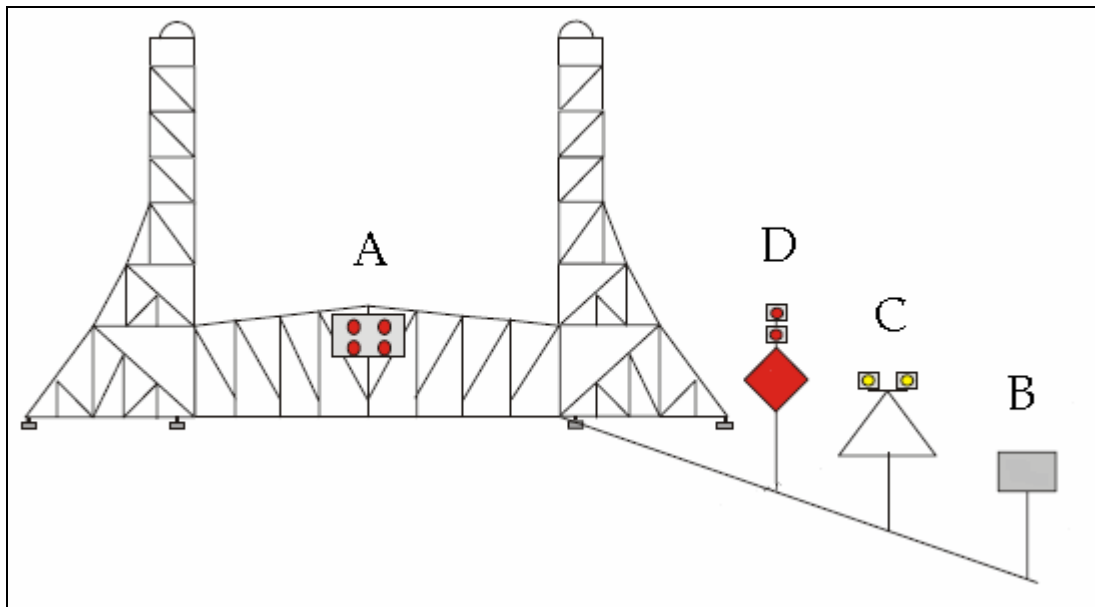
Figure 1. Lights and signs at bridges: (A) Navigation lights, (B) Whistle sign, (C) Caution sign, (D) Limit of approach sign

The whistle sign (B) serves as a reference point for the beginning of the operation of the bridge. When the approaching vessel is at or just before the whistle sign, the bridge operator activates the signal light system, thus indicating to the vessel that the bridge has recognized its approach. Distance from whistle sign to above and below bridges 7A and 7B are 0.75 and 0.71 nautical mile (nm) respectively.

The caution sign (C) serves as a reference point for the bridge operator and the vessel. The bridge operator must have the bridge in the fully raised position to pass a vessel not later than when the stem of the vessel is at the caution sign. If the bridge is not fully raised by the time the vessel is at the caution sign, the vessel is to take whatever evasive action deemed necessary to bring the vessel to a stop without passing the limit of approach (L/A) sign. Distance from caution sign to above and below bridges 7A and 7B is 0.55 and 0.50 nm respectively.

The L/A signs (D) serve as a reference for the vessel only. No vessel is to pass the limit of approach sign until the bridge is fully raised and the GREEN navigation lights are displayed. Distance from L/A sign to above and below bridges 7A and 7B are 0.03 and 0.03 nm respectively.
