MARINE INVESTIGATION REPORT
M08C0058

CAPSIZING AND SUBSEQUENT SINKING

WORKBOAT *BONNIE MOUSE*
OFF GEORGE ISLAND, LAKE WINNIPEG, MANITOBA
21 OCTOBER 2008

Report Number M08C0058

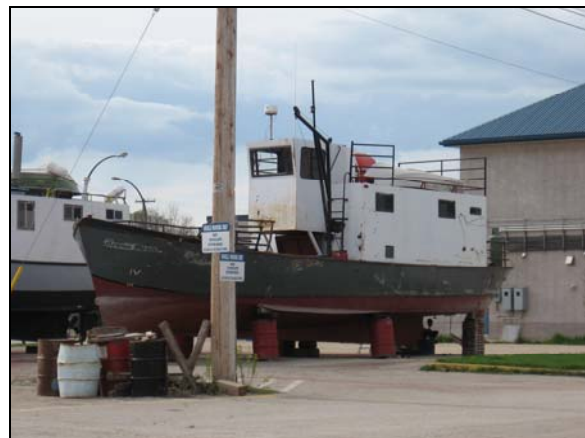
Photo 1. The *Bonnie Mouse*

The *Bonnie Mouse* was a steel vessel of closed construction built in 1974.

The vessel had a raised centreline wheelhouse located amidships. Slightly below the wheelhouse and connected to it by a few steps was an accommodation area extending the entire breadth of the vessel and bounded fore and aft by steel bulkheads fitted with non-watertight doors. There were three hatches

The exterior decks were enclosed by a continuous, solid bulwark, which lacked the required freeing ports or scuppers. A fire pump and a bilge pump were located on the aft deck.

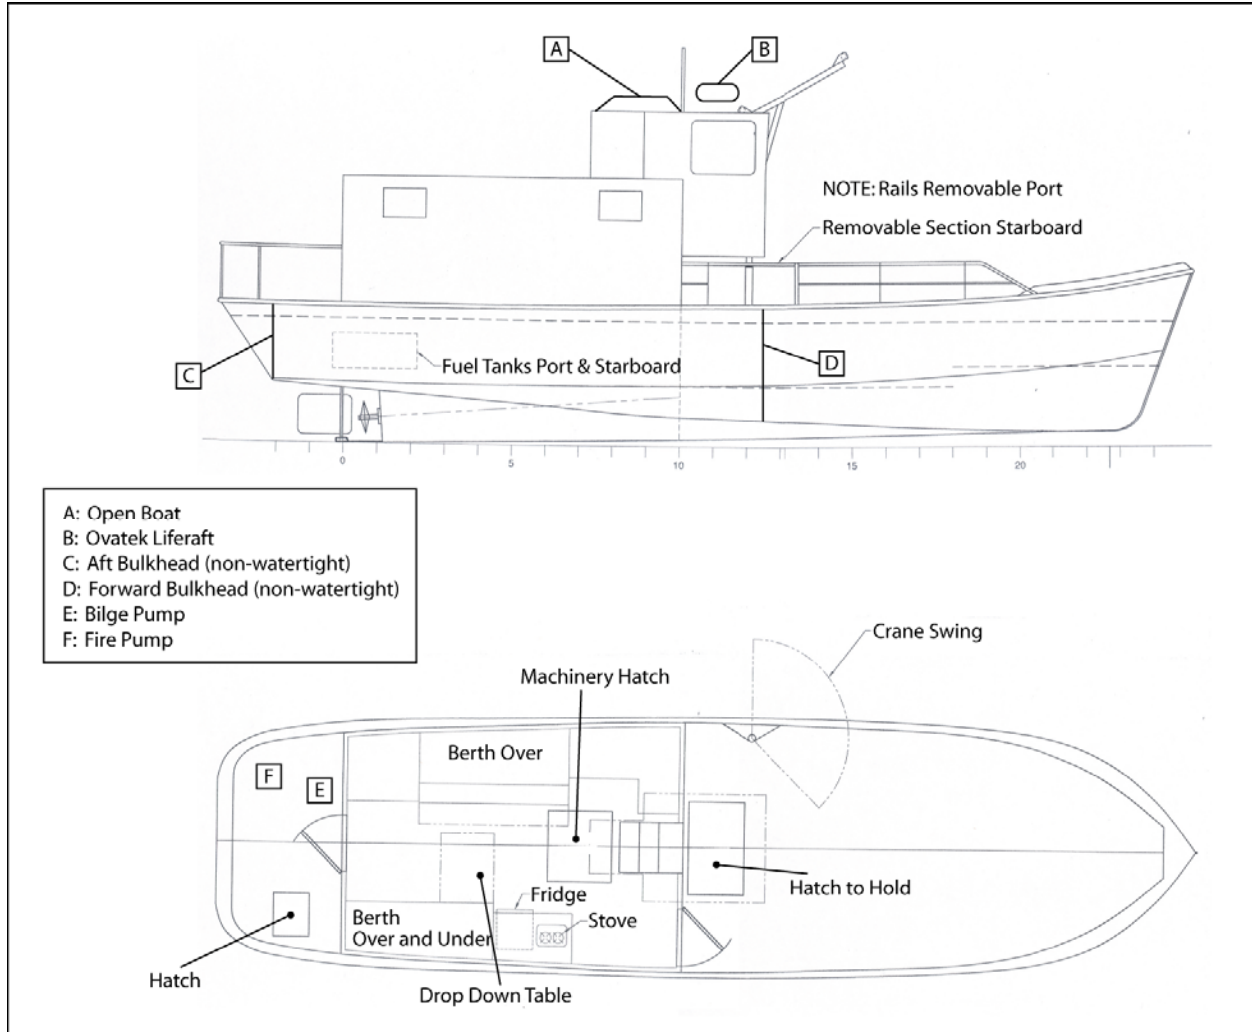
Appendix B – General Arrangement of Vessel

on the main deck leading to spaces below. One on the forward exterior deck led to a gear stowage locker. One in the accommodation led to the machinery space, as did another on the aft exterior deck.

In this occurrence, the vessel's bulwarks were solid and there were no freeing ports or scuppers to allow water to drain. Neither were the hatch covers watertight – with the result that shipped water accumulated on deck, where it was able to downflood into the hull.
