**MARINE INVESTIGATION REPORT
M11N0047**

STRIKING

**SUPPLY VESSEL *MAERSK DETECTOR* AND
MOBILE OFFSHORE DRILLING UNIT *GSF GRAND BANKS*
GRAND BANKS OF NEWFOUNDLAND
24 NOVEMBER 2011**

Report Number M11N0047

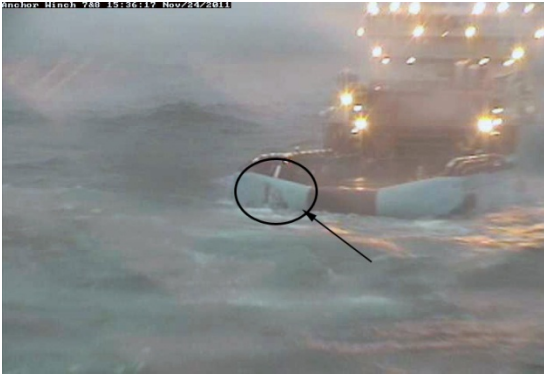
The *Maersk Detector* was holed on the port stern, and 3 frames buckled in the number 23 ballast tank (Photos 3 and 4), resulting in the release of fresh drill water into the ocean.

Photo 3. Area of damage on the *Maersk Detector*.²¹

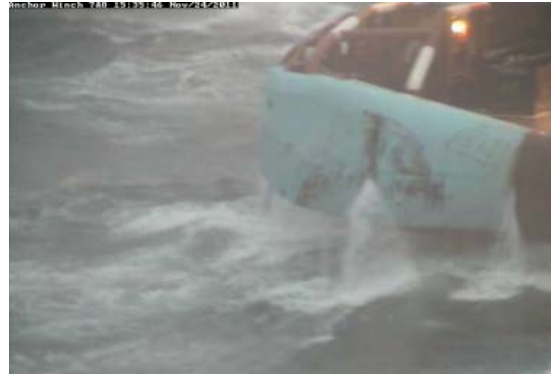
Photo 4. Close-up of damaged area.²²

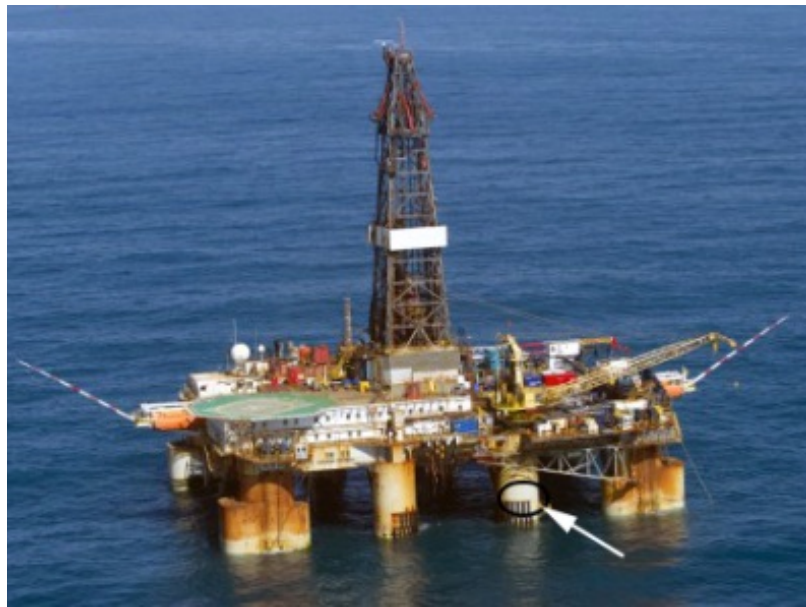
The *GSF Grand Banks* was holed in an empty void tank on the port aft intermediate column just below the 27 m watertight flat in way of the aft end of the fendering system (Photo 5). The rig was deballasted about 3 m in draft to stop the ingress of water. The tank was about 11.25 m in depth and was filled to about 0.4 m prior to deballasting.

Photo 5. Location of damage to *GSF Grand Banks*. (Source: Provincial Aerospace Limited)

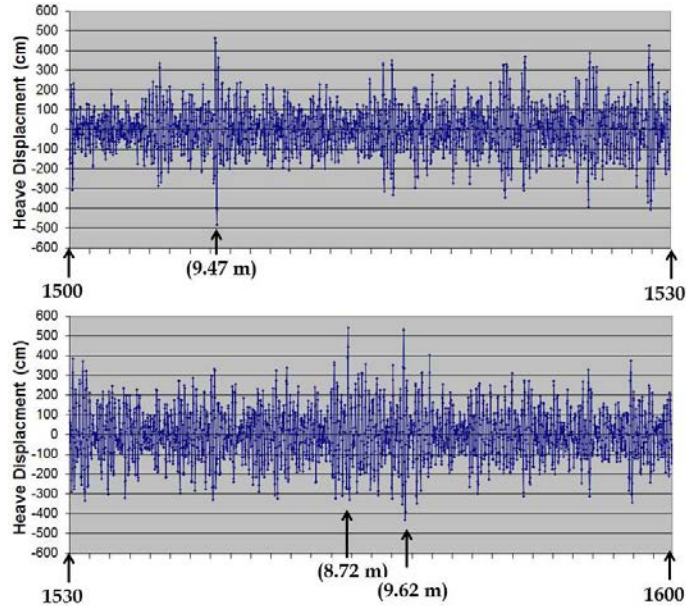
Figure 3. Wave height measured by waverider buoy between 1500 and 1600. ²⁵

As the waves were coming from the south, the waverider buoy recorded the wave heights after they had been experienced at the rig. The travel time of a wave with an 8-second period from the rig to the waverider buoy is approximately 14 minutes. ²⁶ If the waves maintained their characteristics throughout, then the measurement of the waves at the buoy would be indicative of the waves experienced at the rig 14 minutes earlier. The wave heights of 8.72 m and 9.62 m were measured at the waverider buoy 14 and 16 minutes after the striking occurred. It is therefore possible that one or more similar waves were experienced by the vessel immediately before it struck the rig.

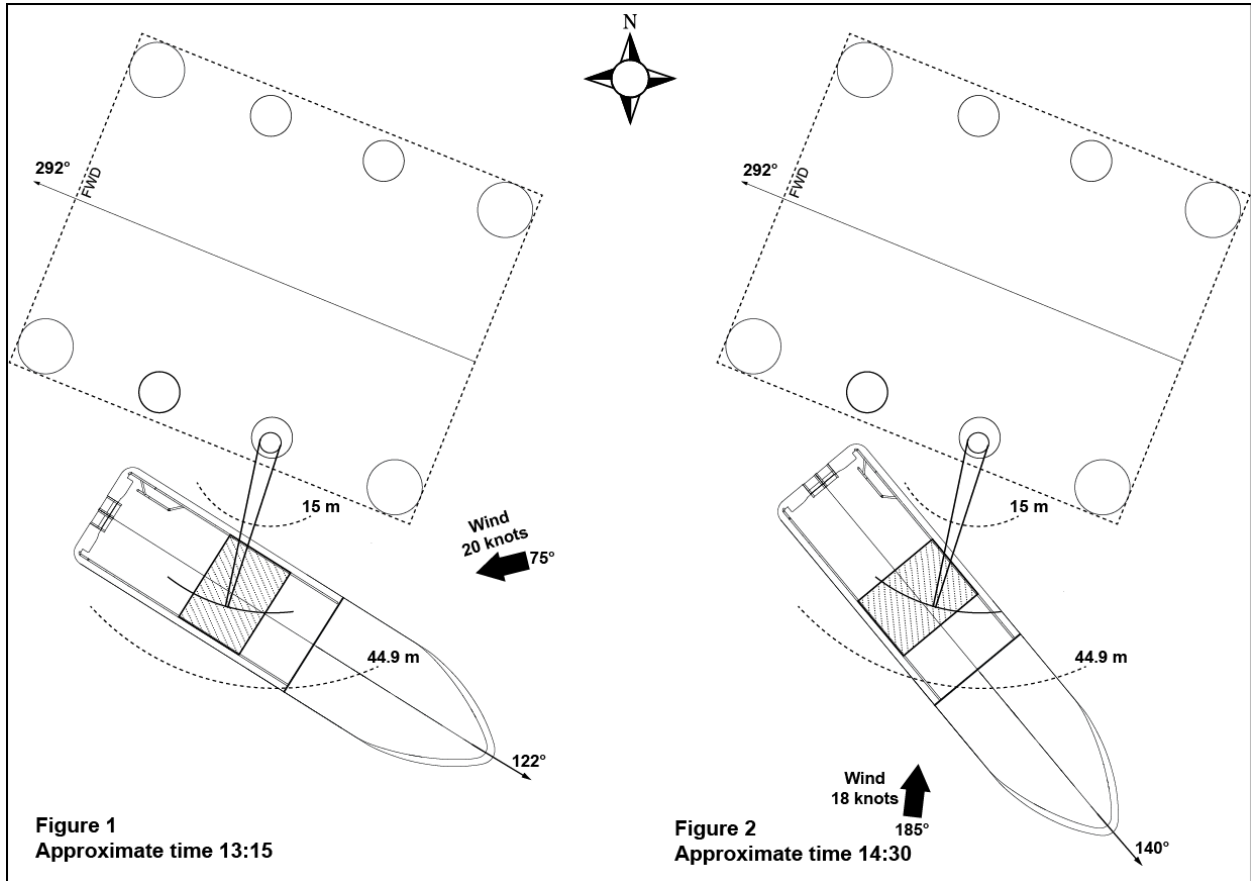
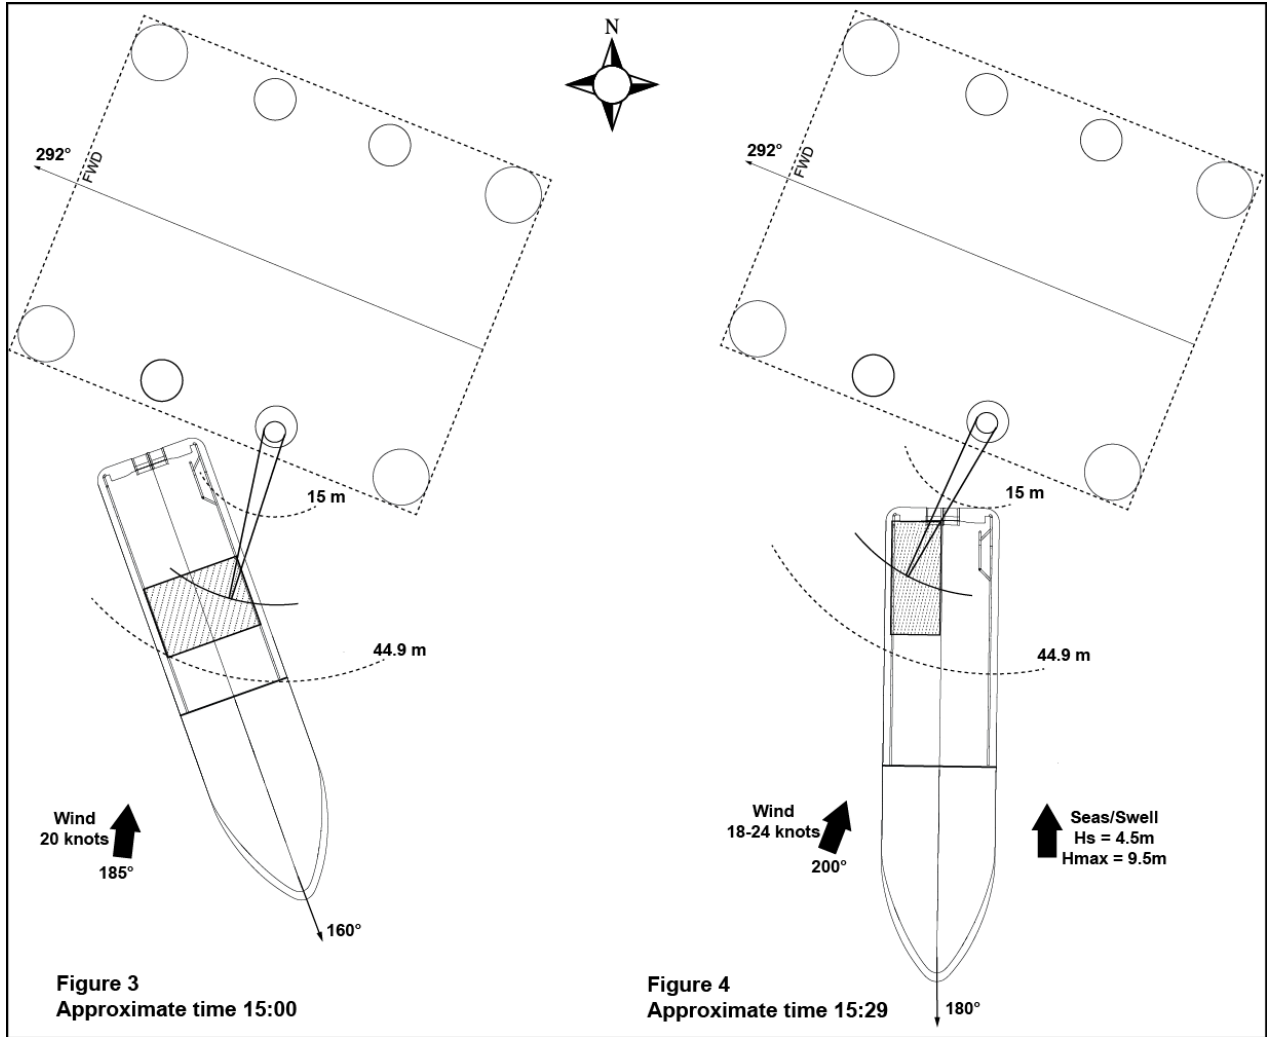
Appendix D – Positions of Maersk Detector and GSF Grand Banks

At about 1315, the *Maersk Detector* was about 15 m off the lee side of the rig on a heading of 122°true (T) (Appendix D, Figure 1) and around 1330 commenced loading containers on deck. Between 1330 and 1400 the wind shifted from a northerly to the southeasterly direction, with the rig port side changing accordingly from lee side to weather side. ¹⁶ There was no formal briefing or risk assessment conducted for this weather-side operation.

By 1500, the vessel's heading had been changed to 160°T, putting the wind at around 25° off the starboard bow (Appendix D, Figure 3). The master contacted the BCR, using channel 6 VHF radiotelephone, to obtain the sea state information. The master was informed that the Hs was 3.5 m.
