Transportation Safety Board
of Canada

MARINE INVESTIGATION REPORT

M12N0003

**LARGE FISHING VESSEL *KATSHESHUK II*
65 NAUTICAL MILES NNE OF CAPE FREELS,
NEWFOUNDLAND AND LABRADOR
10 FEBRUARY 2012**

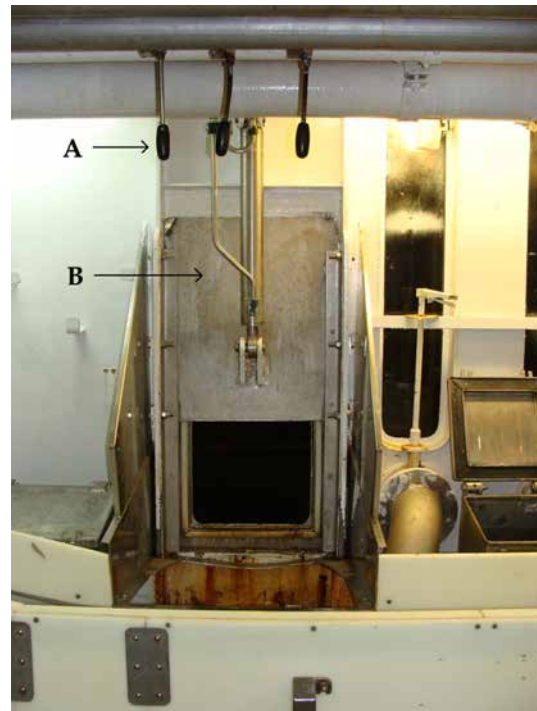
There were 2 means of access to the shrimp-holding tanks: via the hatches on the main deck or through the 40 cm by 40 cm spaces made when the hydraulically-operated shutter doors were fully open. The 5 kg processor, dressed in full oilskins, used the shutter door openings to enter and clean the tanks for expediency and because the deck crew were working in the vicinity of the hatches on the main deck. During the cleaning process, he used these openings several times, sometimes to retrieve cleaning supplies and other times to egress for breaks.

Photo 2. Hydraulically-operated shutter door
A: Hydraulic lever; B: Shutter door

Following the safety committee meeting, the 5 kg processor resumed cleaning the holding tanks, and, upon completion, he exited the tanks and approached the factory foreman to request they be inspected. Both men entered the starboard holding tank via the shutter door opening; the inspection was carried out and the job approved. The 5 kg processor then started to exit the tank feet first and on his back. When the 5 kg processor was partway through the opening, he had to manoeuvre his body over the conveyor belt located just ahead of the shutter door. Once clear, he stood up and turned to see the factory foreman following him; the foreman had chosen to exit headfirst and face down. The foreman's head had just cleared the opening when the shutter door closed on his neck, killing him.

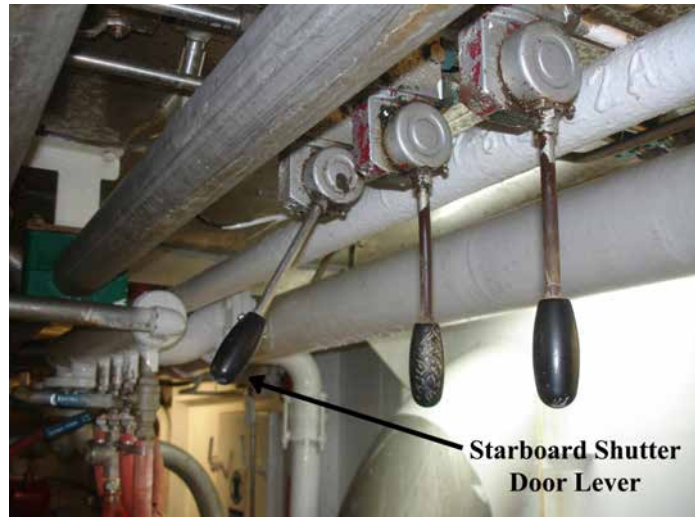
The Transportation Safety Board (TSB) investigation examined the hydraulic lever³ (Photo 3) that controlled the starboard shutter door. The lever was designed to automatically return to the neutral position after it had been activated in either the “open” or “close” direction. When the hydraulic lever was functioning as intended, the shutter door would incrementally drop about 5 cm each time the lever was activated and released. However, the action of the lever spring was compromised and it did not recoil; no force was generated to automatically return the lever to the neutral position when it was released, as it was designed to do. The TSB determined that the position of the nut on the threaded lever allowed the lever to protrude into the hub assembly and displace the coil spring laterally and upward.

Photo 3. Hydraulic lever in the “close” position

As such, when the lever was activated in the “close” position and then released, it did not automatically return to the neutral position. In contrast, when the lever was activated in the “open” direction, it returned to the neutral position as designed. The normal reporting procedure for a defect like this was to verbally inform the immediate supervisor, who in turn would inform the engineering staff. The engineering staff would then either address the defects immediately or fill out a work order for shore-based support. The continuous malfunction of the lever was not reported to the engineering staff or shore management and therefore was not addressed either on board or ashore. Some of the crew had known of this problem for more than 6 months.

It was determined that the hydraulic lever had stopped functioning as intended more than 6 months prior to the accident. The normal procedure for reporting defects in shipboard equipment was to verbally inform the immediate supervisor, who in turn would inform the engineering staff. The engineering staff would then fill out a work order to submit at the end of the trip for defects requiring shore-based support. Repairs not requiring shore-based support would be addressed immediately by the engineering staff. However, because the continuous malfunction of the hydraulic lever was not assessed and identified as a safety hazard and did not affect functionality during regular fishing operations, it was not reported or addressed either on board or ashore.

1. The company's safety management system (SMS) did not identify the hazards associated with accessing the holding tanks via the shutter doors.
2. The company provided no procedures for the safe use of the shutter doors as a means of access for cleaning the holding tanks.
3. The 5 kg processor did not receive any familiarization or briefing on the hazards present in the after part of the factory and was unaware of the risks involved with the hydraulic lever.
4. The factory foreman lost his life while exiting the holding tank when the hydraulic lever for the shutter door was inadvertently activated.
5. The spring in the hydraulic lever was compromised and would not automatically return the lever to the neutral position.

Following the occurrence, the company replaced the defective hydraulic lever and, by order of the Occupational Health and Safety (OHS) division of Service Newfoundland and Labrador, the company:

- repaired the hydraulic lever in question and installed new locking pins, warning signage, locking isolation valves, and protective steel bars around the hydraulic levers, as well as an additional emergency shut-off switch to the hatch doors;
- installed a holding tank hatch door for access from the main deck for cleaning;
- investigated its other vessels and made modifications to its other shrimp trawler to ensure safety measures were in place in respect of the holding tank door system; and,
- completed a detailed hazard assessment in response to the incident that was particularly focused on the task of cleaning the shrimp holding tank and associated areas and functions on board the vessel.
