MARINE INVESTIGATION REPORT
M13L0067

GROUNDING

PASSENGER VESSEL *LOUIS JOLLIET*
OFF SAINTE-PÉTRONILLE, ÎLE D'ORLÉANS, QUEBEC
16 MAY 2013

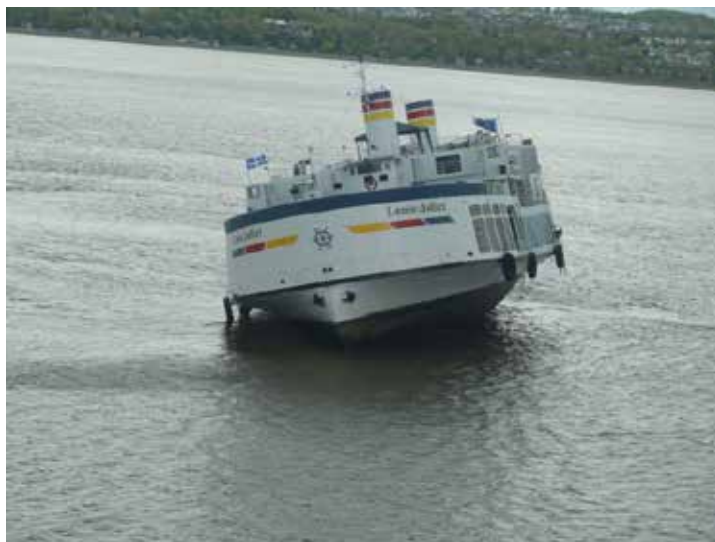
Photo 2. The grounded *Louis Jolliet* (Source: Veronique Gagnon, Department of Fisheries and Oceans)

The vessel continued, and, at approximately 1434, was travelling at a speed of approximately 10 knots and a course over ground of approximately 027°T. The chief mate, who had continued looking out for the range, glanced at the echo sounder and noticed that the water depth was decreasing. He then glanced at the ECS and alerted the master, whereupon the master stood up, looked out, and ordered the rudder hard to port. The chief mate put the helm to port, at which time the vessel struck the bottom and grounded in position 46°51.05' N, 071°08.69' W (Photo 2, Appendix B).

After the evacuation, it was determined that there had been damage to the hull at 2 locations in the bottom of the pump room, each allowing a small ingress of water. The vessel was refloated by the rising tide, and it returned to dock under its own power at approximately 2200.

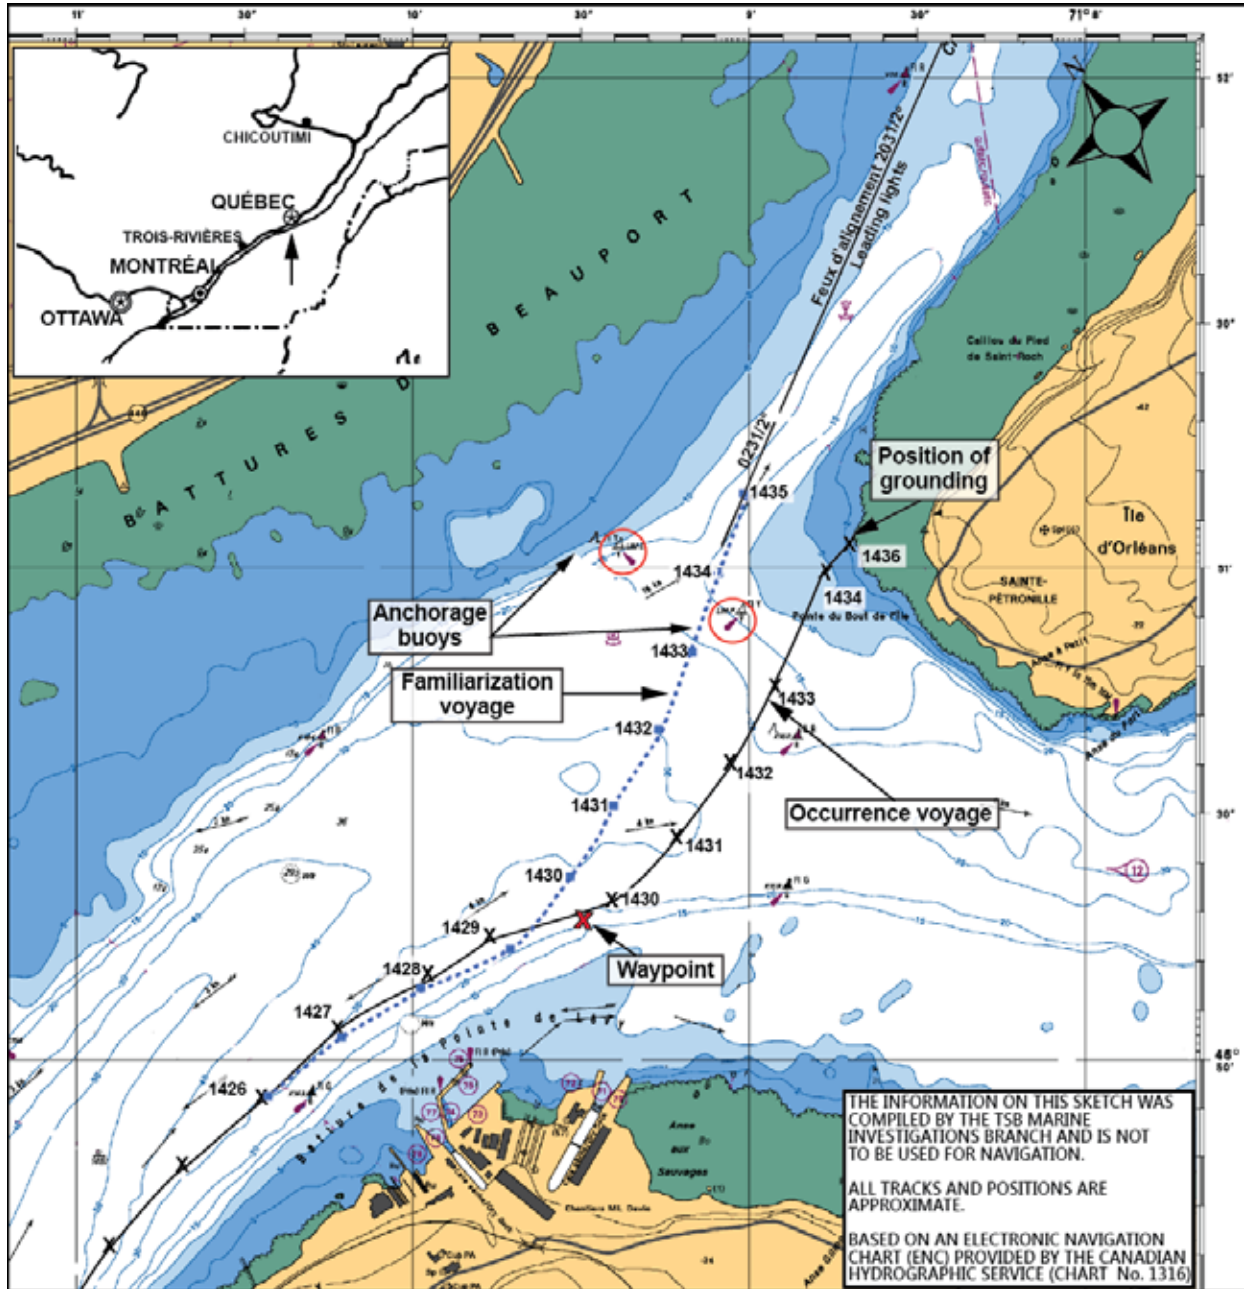
Appendix B – Area of the occurrence

Over the next 4 to 5 minutes, as the vessel crossed the channel in a northeasterly direction, the chief mate searched for the Ange-Gardien range indicating the Chenal de l'Île d'Orléans, but was unable to locate it. He was not utilizing the bridge navigational equipment or charts to position the vessel. At around 1432, the master looked up twice in close succession. There was no communication between the master and the chief mate. At this time, the vessel's course over ground was 035.6° true (T), and its position was approximately 2.1 cables east of the range line.
