MARINE INVESTIGATION REPORT
M13M0102

GROUNDING AND SUBSEQUENT SINKING

SMALL FISHING VESSEL *MARIE J*
TABUSINTAC BAY, NEW BRUNSWICK
18 MAY 2013

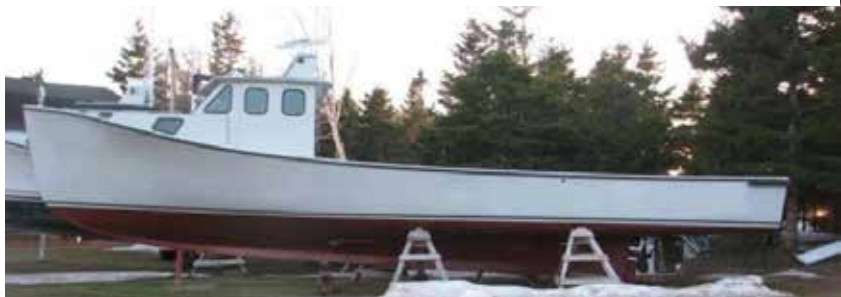
Photo 1. Sister vessel to the *Marie J*

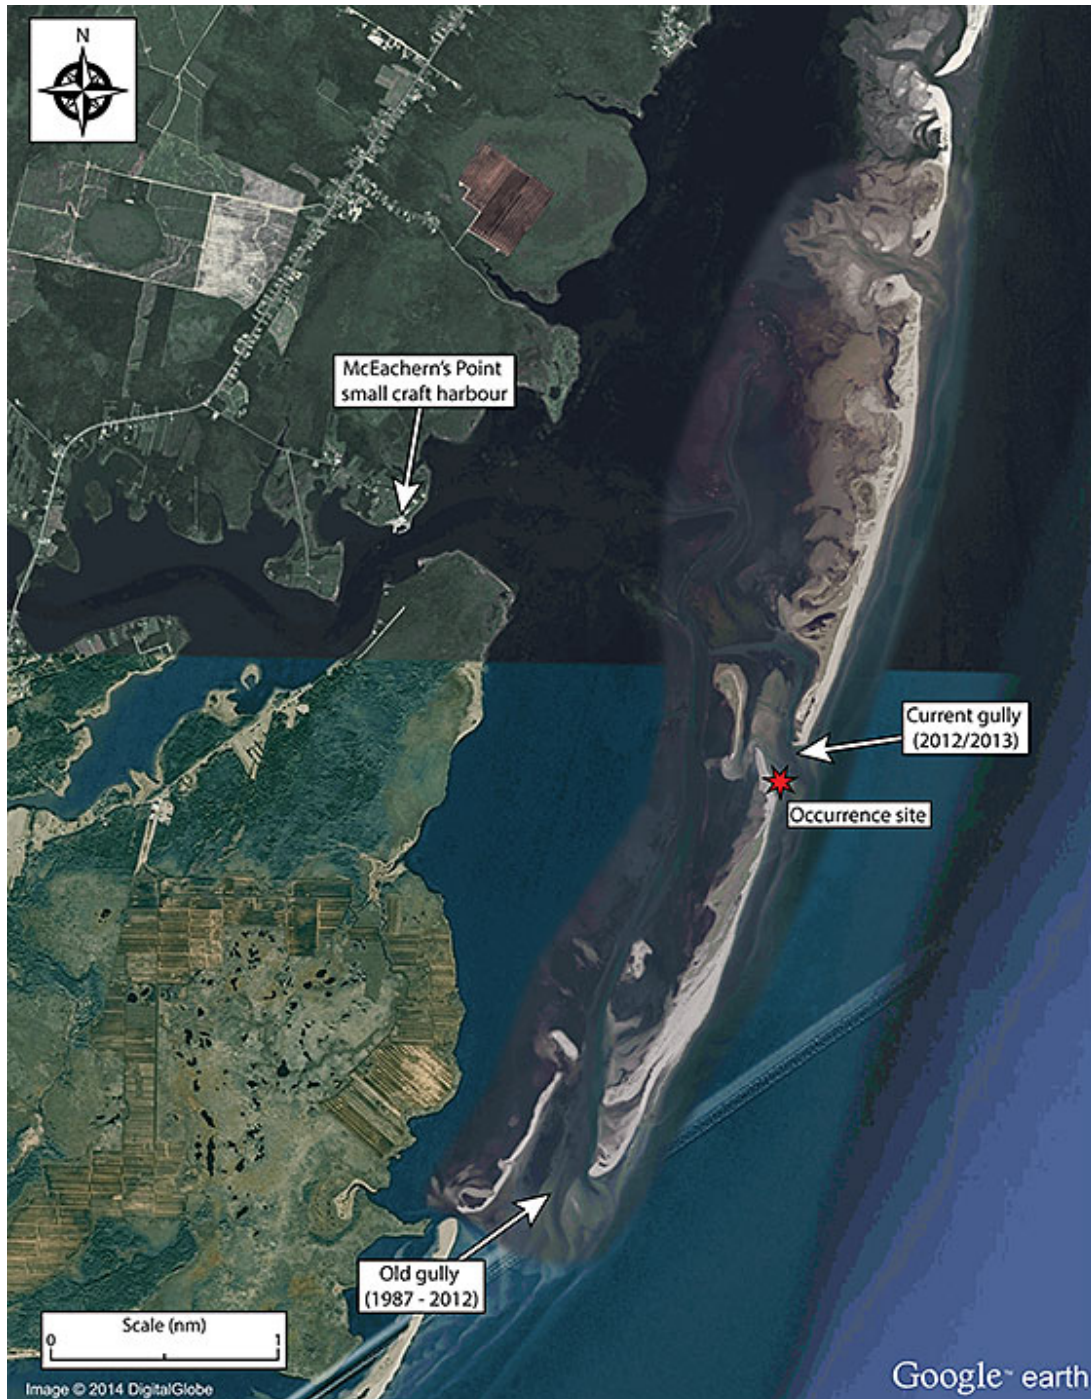
Appendix A – Tabusintac Bay

Tabusintac Bay, located at the mouth of Tabusintac River, is fronted by a 14-km stretch of sandbars that contain numerous tidal gullies (Appendix A). A route within a gully that allows vessels to pass through to the open sea is in a constant state of flux as a result of predominant wind and wave action from the north/northeast. These winds, waves and tidal action, as well as winter ice thickness, also affect the structure of the stretch of sandbars, causing existing gullies to gradually or suddenly silt in and new gullies to open up in different locations. This flux makes it difficult to represent these changes on Canadian Hydrographic Services (CHS) charts. The tidal range is moderate, with less than a 1.5-m difference between high and low tides, but the tide may run at 6 to 7 knots.²

Over the winter of 2012–2013, the buoyed channel in the old gully and the privately marked route in the north gully completely silted in. During the same winter, a new gully opened up 300 m to the southwest of the silted-in north gully with the privately marked route. In the spring of 2013, CCG NavAids approved the placement of buoys to mark a route in the new gully (Appendix B). To mark the best-depth⁴ route, a single row of red starboard-hand buoys was placed on the leading edge of the shallow water on the northeast side of the channel, while

The configuration of gullies in Tabusintac Bay in the spring of 2013 (source: Google earth; overlay of gully configuration from the CBCL Limited draft report, Coastal Study for Harbour Access at Tabusintac Bay, New Brunswick [November 2013]).
