**MARINE INVESTIGATION REPORT  
M14C0219**

**BOTTOM CONTACT**

**TANKER NANNY  
DEER ISLAND, CHESTERFIELD INLET, NUNAVUT  
14 OCTOBER 2014**

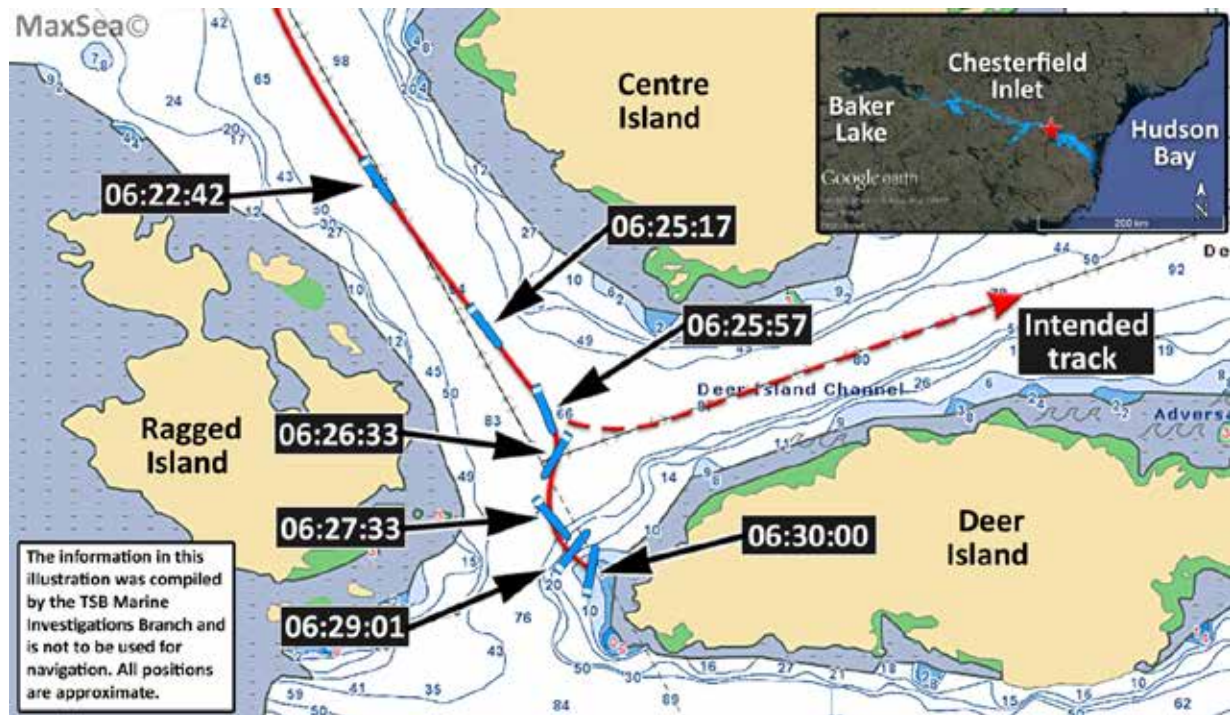
Figure 1. *Nanny's* actual track and intended track between change of con and time of bottom contact

At 0622:42, the OOW, who was at the con for the first time in this area, requested that the master take over before the large alteration to port at Deer Island (Figure 1), approximately 0.7 nm before the next course change waypoint.<sup>6</sup> The master took over the con shortly afterwards, and the OOW went to the chart table and began preparing the next chart.<sup>7</sup> The helmsman was manually steering a course of about 140° gyrocompass (G) and the vessel was proceeding at a speed of 16.7 knots. The master was monitoring the vessel's progress on the starboard radar, where he had set up a parallel index to determine when to commence the port turn off Deer Island. A parallel index line was also set up on a course of 071° T to maintain a distance of 0.22 nm off the northernmost point of Deer Island.

At 0625:17, the master ordered the helmsman to apply 10° port rudder to initiate the turn at the planned wheel-over position (Figure 1). The helmsman acknowledged the order by repeating it, but put the helm to 10° starboard. Within seconds, the master ordered the helmsman to apply 15°. The helmsman looked at the rudder angle indicator and repeated the order, but put the helm to 15° starboard.

At 0630, the *Nanny* made bottom contact 0.2 nm west of Deer Island in position 63°37.2' N, 091°31.2' W (Figure 1). The vessel's heading at this time was 012°G. The engines and the bow thrusters were used to manoeuvre the vessel back into the channel, and the *Nanny* continued its voyage while the crew sounded the tanks and checked for damage. They found a crack, approximately 0.6 m long, in way of No. 3 port water ballast tank that was allowing water ingress.

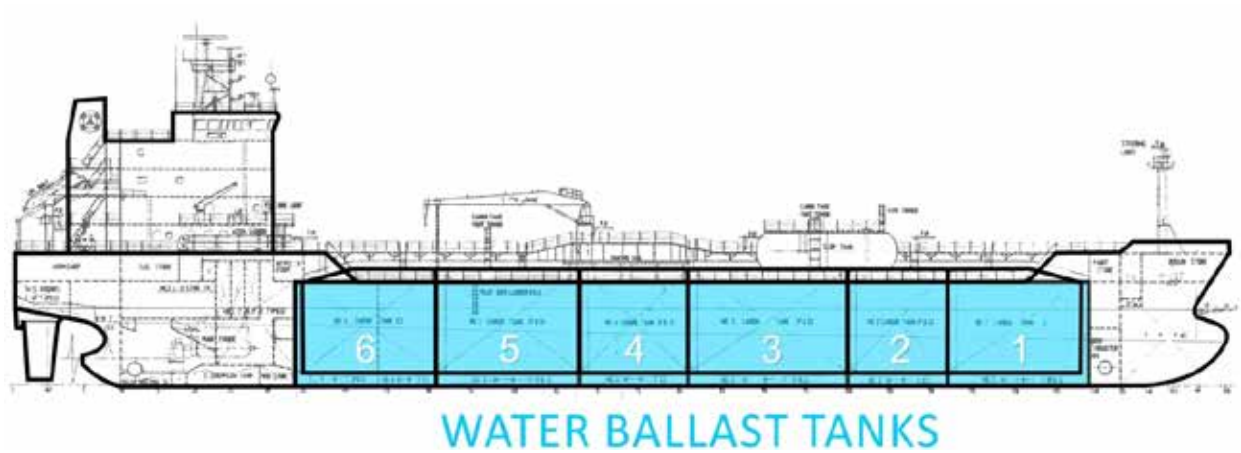
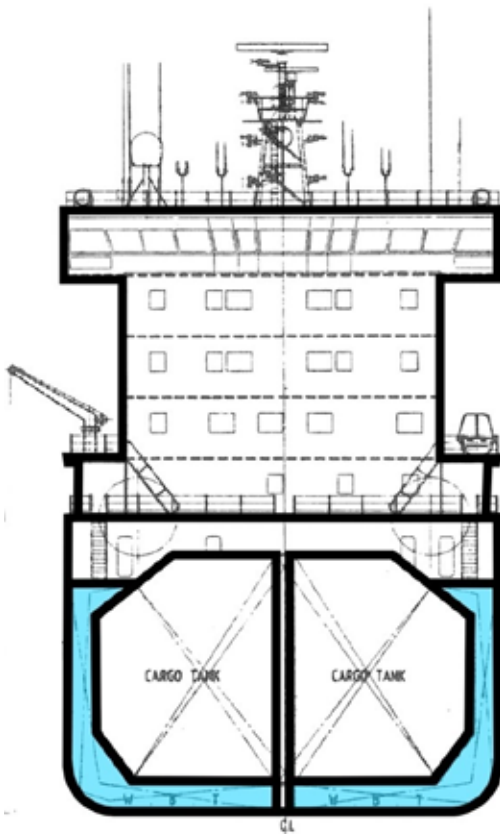
### Appendix A – Nanny profile and cross-section (not to scale)

An inspection following the occurrence found that the vessel had sustained damage to the tank plating and internal structures in way of the double-bottom water ballast tanks (Table 2). The vessel was out of service from 28 October to 29 November 2014 while the repairs were carried out in drydock.

Damaged areas:

- Tank #1: starboard bottom
- Tank #2: starboard bottom
- Tank #3: port and starboard bottom
- Tank #4: starboard bottom
- Tank #5: starboard bottom
- Tank #6: starboard bottom
