# MARINE INVESTIGATION REPORT

## M16A0141

### **Close-quarters crossing**

Passenger vessels *Grandeur of the Seas* and  
*Summer Bay*

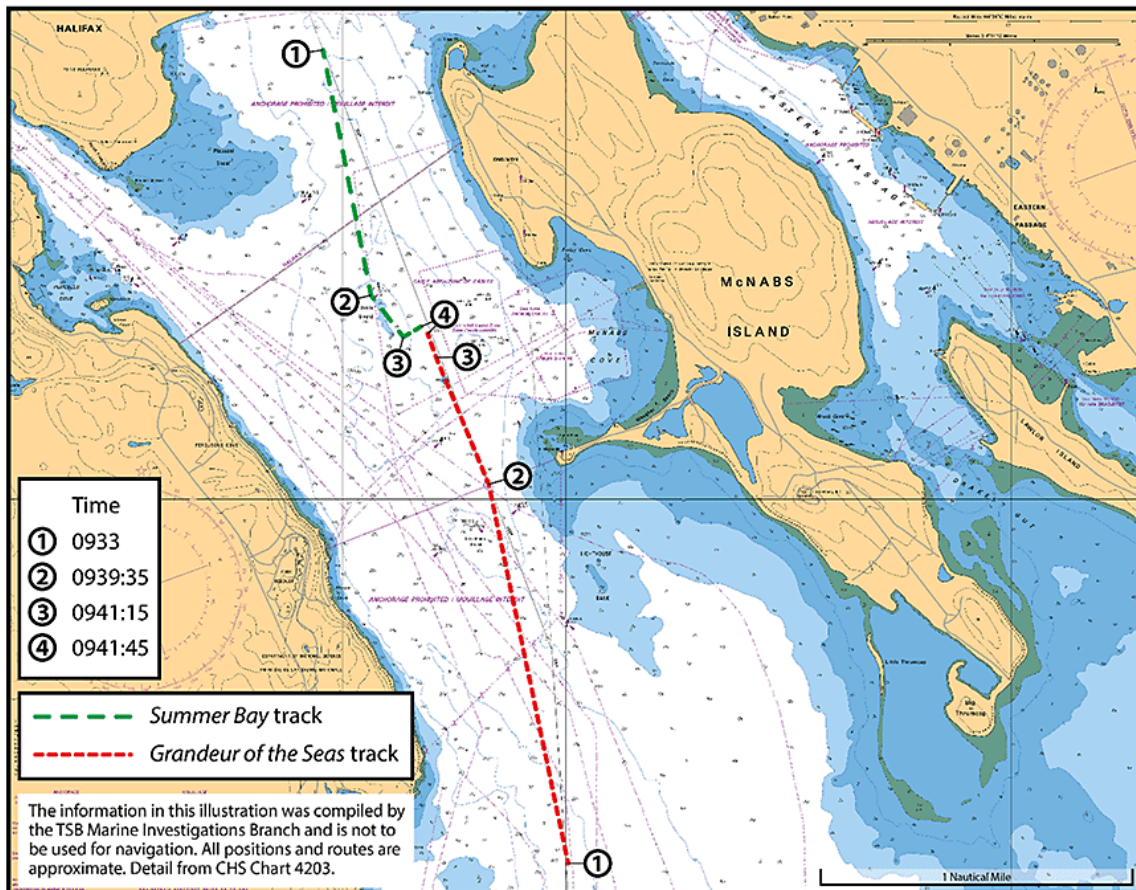
Figure 3. Tracks of the *Summer Bay* and the *Grandeur of the Seas*

The pilot of the *Grandeur of the Seas* picked up an outbound radar target, 2.7 nm to the northwest (Figure 3).<sup>2</sup> At 0933, he contacted Halifax Marine Communications and Traffic Services (MCTS) to inquire about traffic in the harbour. Halifax MCTS replied that the *Summer Bay* was the outbound vessel.

After making this arrangement, at about 0936, the *Summer Bay*, maintaining its speed of 7.5 knots, altered course to starboard to 170°, which would allow for a safe port-to-port passing. The bridge team of the *Grandeur of the Seas*, which was proceeding along the preferred course in the traffic separation scheme, saw the course alteration on their radar and maintained their course and speed of 10 knots. After that point, the bridge team of the *Grandeur of the Seas* continued to monitor the *Summer Bay's* position on their radar until the target was lost on the screen due to the proximity of the vessel.

At about 0939, the *Grandeur of the Seas* appeared on the *Summer Bay's* radar at a distance of 0.75 nm. At 0939:35, the *Summer Bay* altered course to 142° toward the *Grandeur of the Seas*. When the *Grandeur of the Seas* closed to 0.25 nm, the master of the *Summer Bay* picked up another echo on the radar bearing about 45° off the starboard bow at a distance of 0.25 miles.

At 0941:15, the master of the *Summer Bay* altered course to 110° at a distance of 0.12 nm from the *Grandeur of the Seas*.

At 0941:45, the master of the *Summer Bay* altered course to 071° and crossed the bulbous bow of the *Grandeur of the Seas* at a distance of about 25 m. The fog signal from the *Grandeur of the Seas* was heard on the *Summer Bay* about 10 seconds prior to the course alteration.<sup>4</sup> The *Grandeur of the Seas* bridge team was unaware that the *Summer Bay* was crossing their bow until the pilot saw the *Summer Bay*'s mast as it appeared from underneath the bow on the starboard side, after it had already crossed.

The master of the *Summer Bay* then made a last-minute alteration hard to port, crossing the bow of the *Grandeur of the Seas* at a distance of about 25 m from its bulbous bow.
