MARINE INVESTIGATION REPORT

M16C0005

Grounding

Container vessel *MSC Monica*

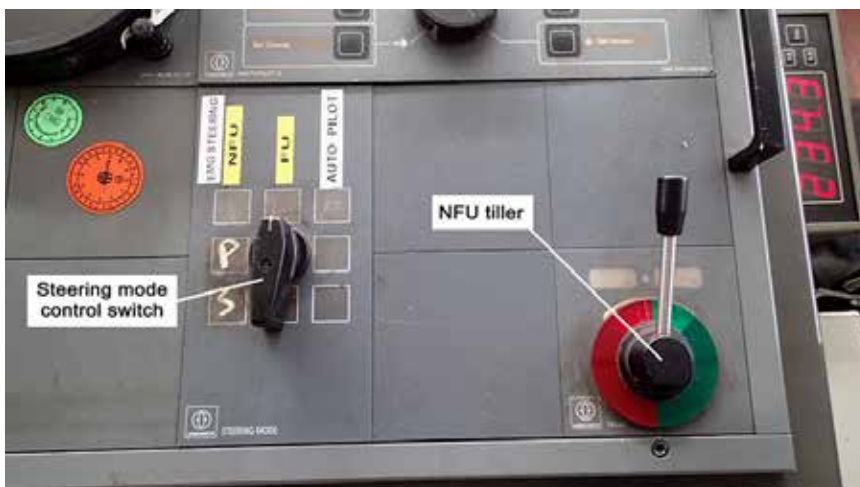
Figure 6. Non-follow-up tiller of the *MSC Monica*

On the *MSC Monica*, the NFU tiller is located in front of the helm, on the starboard side of the steering gear control panel. At the time of the occurrence, it consisted of a lever with the longer end pointing toward the bow of the vessel. At the base of the lever was a translucent plastic disc with one half coloured green and the other red. At the top, across the two halves where they met, was a strip of light that backlit that portion of the base, 25 percent of its total circumference (Figure 6).

According to the manufacturer of the NFU tiller switch on the *MSC Monica*, “if the rudder [...] is intended to moved [sic] to port, the control lever of the [t]iller must be turned until its port stop is reached.”² In the standard installation of this particular NFU tiller, the control

lever is mounted downward with the longer end of the lever pointing towards the stern of the vessel. When it is installed in that way and the rudder needs to be moved to port, the control lever must be moved left in a clockwise rotation, bringing the red part of the indicating disc in front of the lubber line (Figure 7).

By internationally recognized maritime standards, the colour red signifies the port side, while the colour green indicates the starboard side. On the *MSC Monica*, the NFU tiller was connected to the control system in an inverted manner; as a result, the red/green colour code operated in contradiction to the international standards. When the control lever of the NFU tiller switch was moved to the left, in a counterclockwise rotation, the green part of the indicating disc was brought over the illuminated section, and the steering gear moved the rudder to port. When the control lever of the NFU tiller was moved to the right, in a clockwise rotation, the red part of the indicating disc was brought over the illuminated section, and the steering gear moved the rudder to starboard (Figure 8).

Following the receipt of MSA letter 02/16 issued from the TSB, the owners of the *MSC Monica* carried out a thorough assessment of the vessel's steering gear and control systems. Although no malfunction was identified, some components were found "fragile." Consequently, the owners had several parts either overhauled or replaced during the periodic drydocking of the vessel, which took place in Turkey during the fall of 2016. Among others, the 2 hydraulic pumps were replaced, the pins, slide blocks and hydraulic cylinders (rams) were machined, and their seals were replaced with new ones. On the navigation bridge, the helm, autopilot, gyrocompass, and its repeater were replaced. The NFU tiller arm was correctly reinstalled with the longer end pointing towards the stern of the vessel according to the manufacturer's recommendations, and proper instructions were posted. Finally, the owners verified that all of the *MSC Monica's* sister vessels had the NFU tiller properly installed.

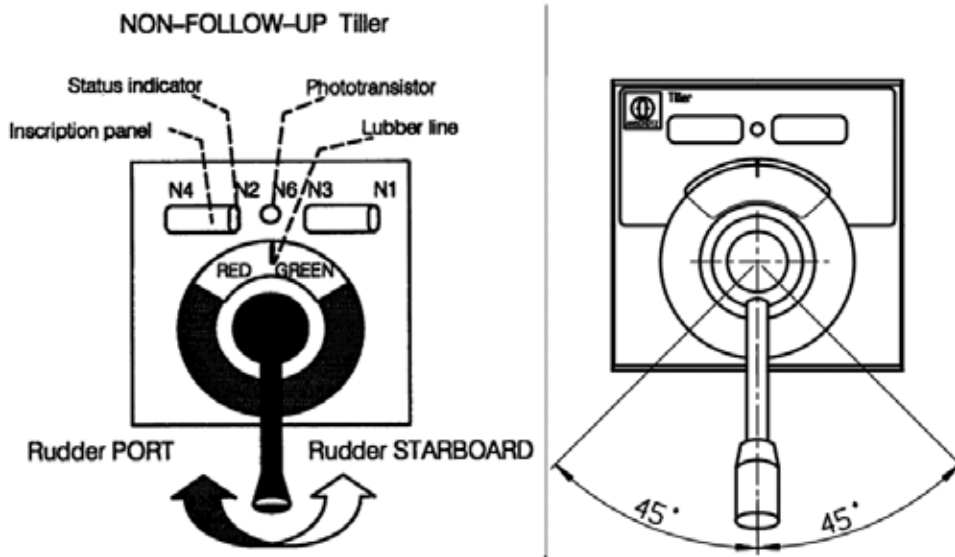
Figure 7. Schematic of the non-follow-up tiller installation showing the indicator disk and lubber line, the joystick pointing down, and the results of a clockwise and of a counterclockwise rotation, and the maximum angle of rotation of the joystick to the left and to the right (Source: Raytheon-Anschütz Marine GmbH)

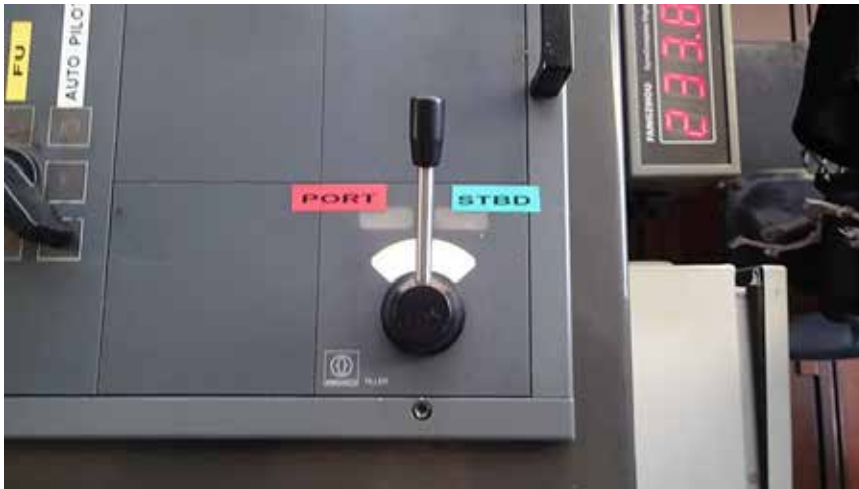
Figure 9. Non-follow-up tiller of the *MSC Monica* without the plastic disk, but with the new colour-coded labels

Before the vessel's departure from Québec, the crew modified the NFU tiller display: they removed the translucent plastic disc attached to its base and posted colour-coded labels (red with the word “PORT” and green with “STBD,” the abbreviation for starboard) on either side of the NFU tiller (Figure 9).
