MARINE INVESTIGATION REPORT

M16C0014

Mechanical failure and sinking

Fishing vessel *Bessie E.*

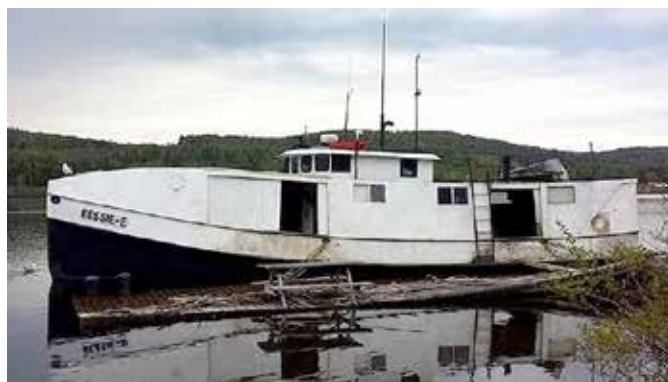
Figure 1. *Bessie E.*

The *Bessie E.* (Figure 1) was a fishing tug engaged in commercial fishing operations on the Great Lakes, with a design typical of this type of vessel: constructed of all-welded steel, with a single-chine hull and a partially enclosed superstructure extending from bow to stern. The superstructure had 5 doors: 2 forward (one on each side), 2 aft (one on each side), and 1 large door at the stern. The main deck was made of steel, and the hull was not subdivided. The vessel was also equipped with 2 anchors, which were operated manually.
