MARINE INVESTIGATION REPORT

M16P0362

Grounding and abandonment

Passenger vessel *Stellar Sea*

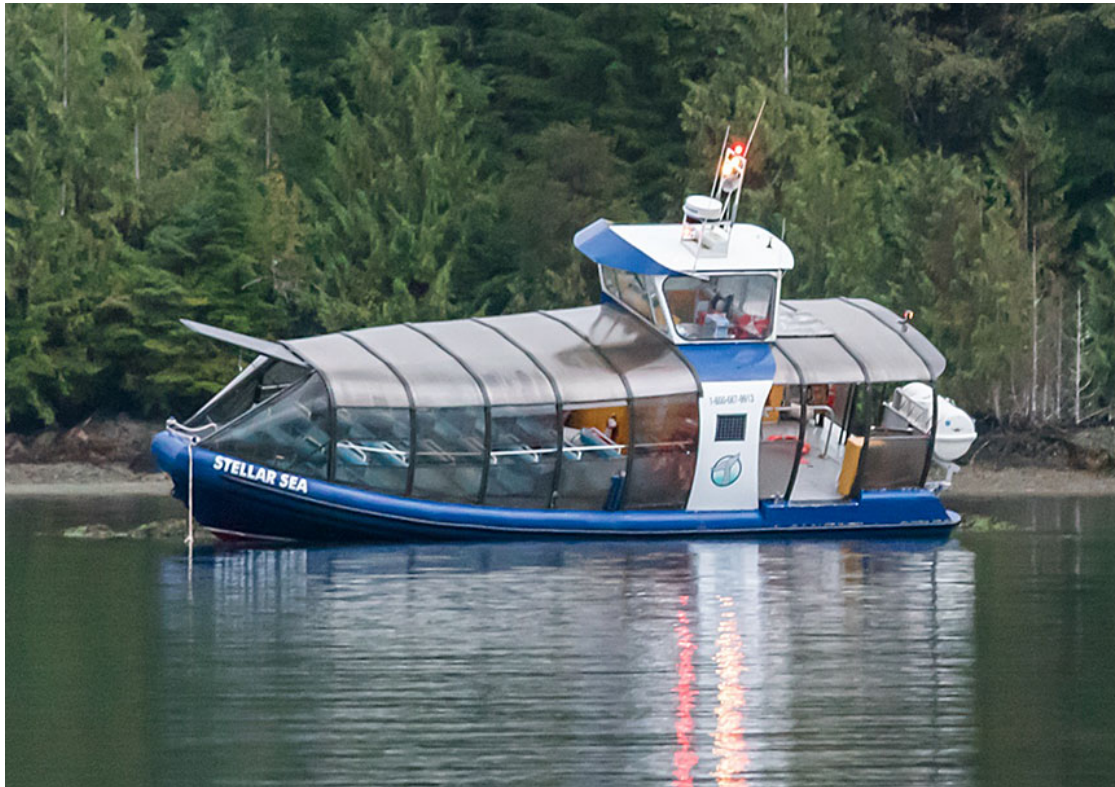
Figure 1. The *Stellar Sea*, at 1859 Pacific Daylight Time, 75 minutes after the grounding
(Source: Dmitry Cherov)

The *Stellar Sea's* aluminum hull was damaged below the waterline. In addition to numerous scrapes, keel fractures, deformations, and indentations on the hull, there were 2 large puncture holes. One of the punctures extended across the 2 main watertight compartments below the main deck, the engine room, and the middle space. The vessel's echo sounder transducer, the diesel engines, gearboxes, electrical wiring, and bilge pumps were also damaged due to submersion.

On the morning of 03 October, the company technicians made temporary repairs to the hull of the *Stellar Sea* and refloated the vessel. The vessel was then towed to Ucluelet for further inspection and repairs.

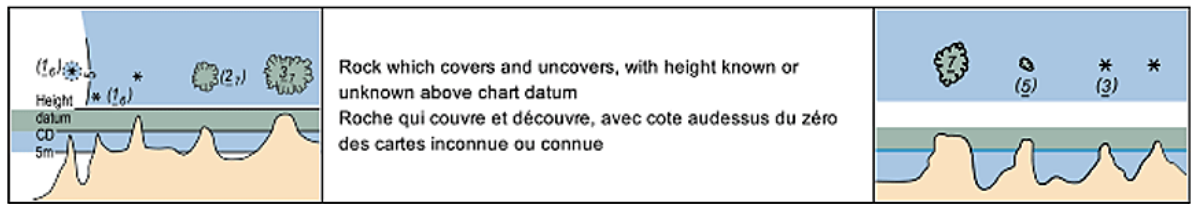
A rock, such as the one the *Stellar Sea* grounded upon, is represented on the chart by an asterisk (*). The asterisk does not describe the underwater dimensions of the rock (Figures 2 and 3).

Figure 2. Illustration of rock symbols on navigational charts (Source: Fisheries and Oceans Canada)

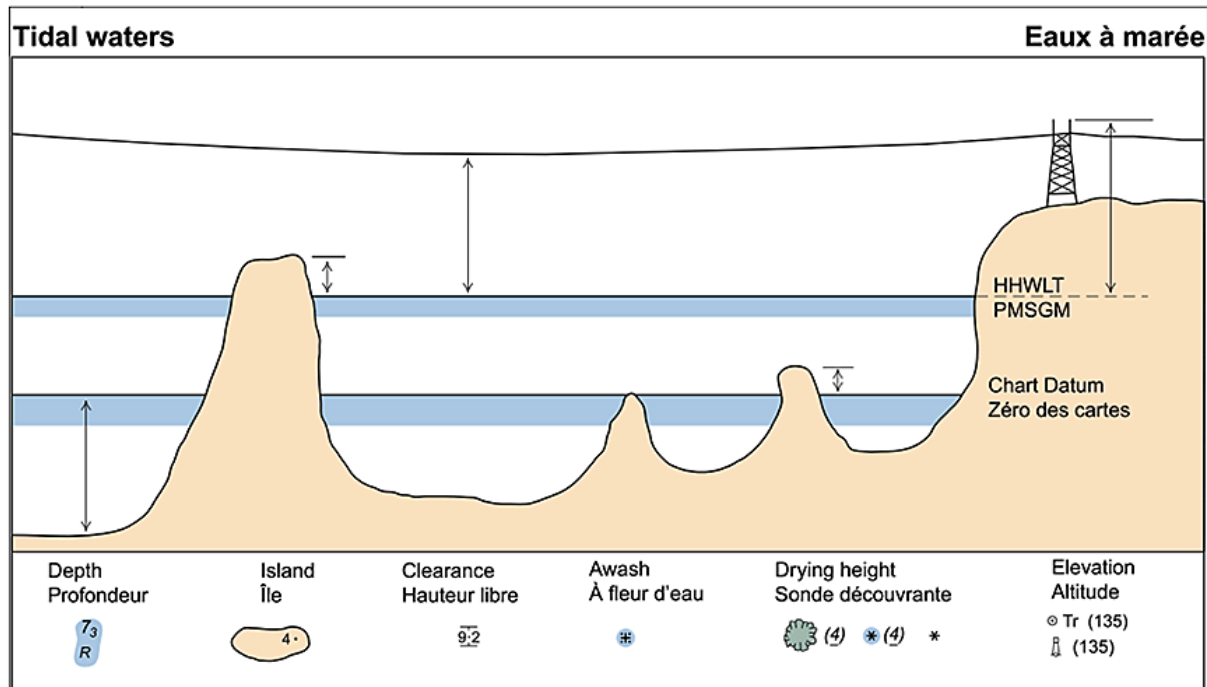
The rock had a drying height of 2 m and is marked on the navigation chart.

Figure 3. Illustration of drying heights for tidal waters (Source: Fisheries and Oceans Canada)

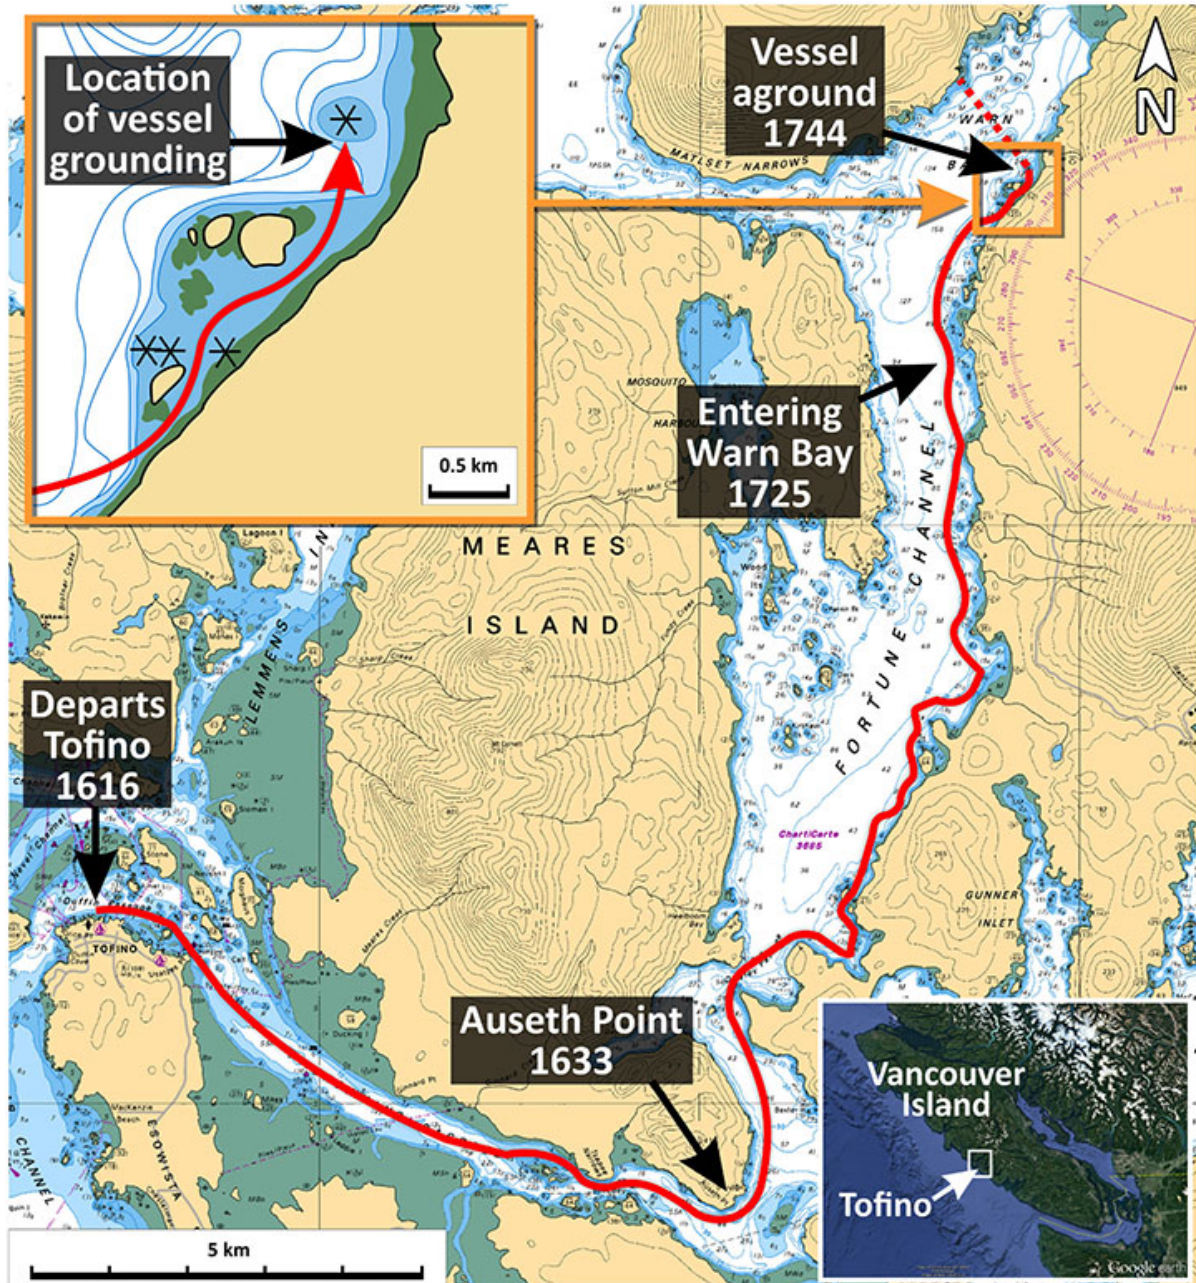
Appendix A – The Stellar Sea’s navigation route

The vessel exited the narrow channel at approximately 1742, moving on a northerly course in the general direction of a charted⁷ but unnamed rock (Appendix A).⁸ On previous voyages, the master passed the rock on the vessel's starboard side. The vessel's speed was approximately 5 knots.

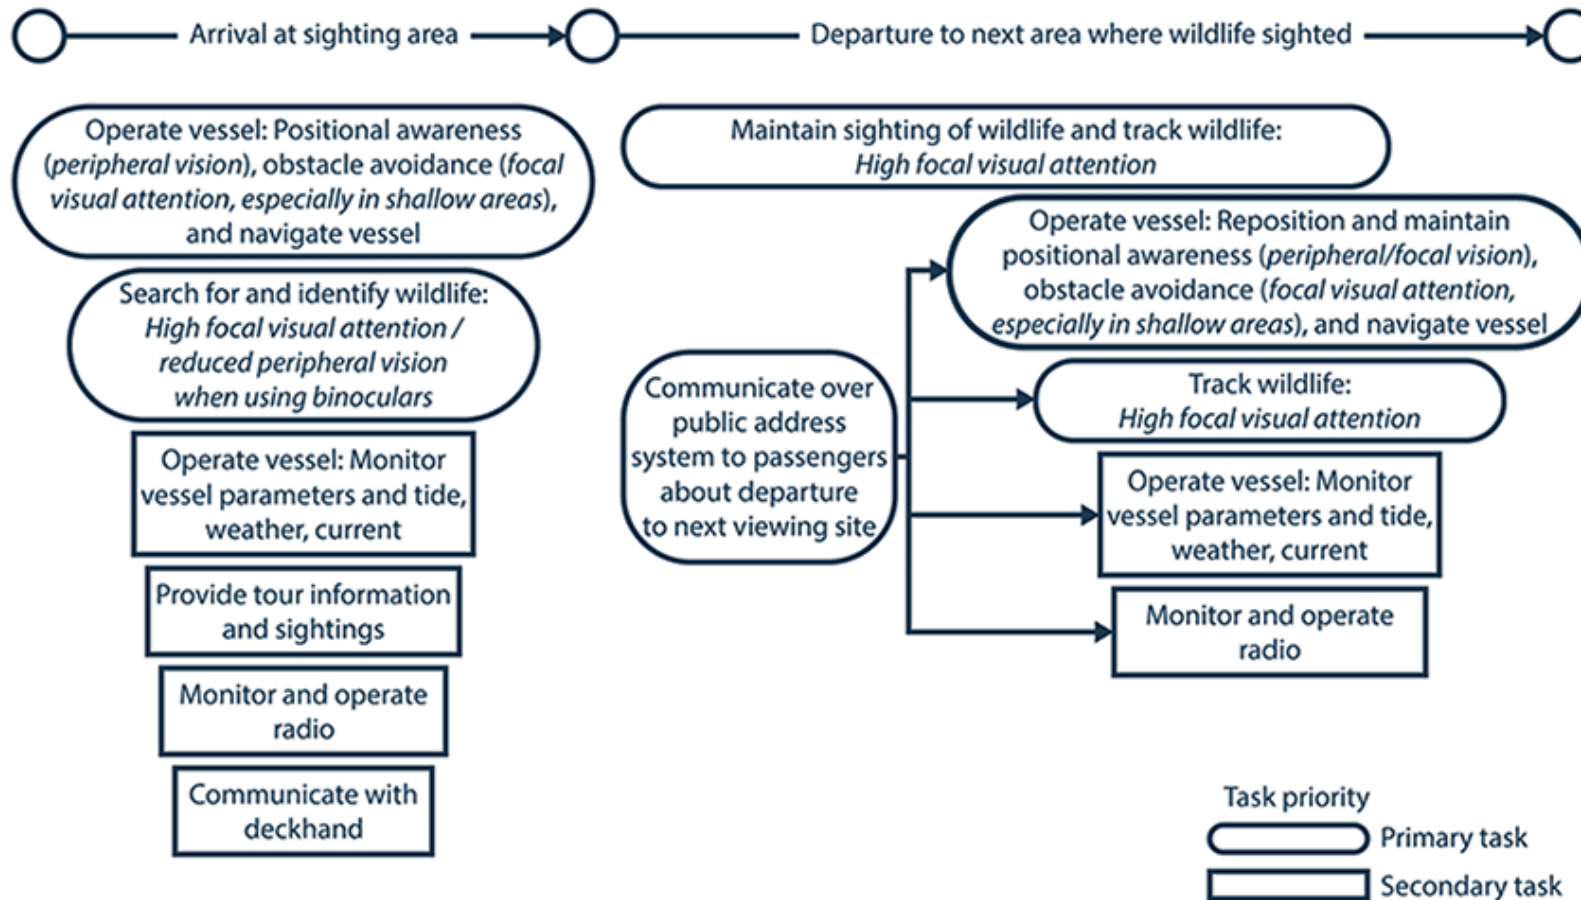
Appendix B – Tasks conducted by the master

- operating the vessel, including navigation and monitoring the vessel's instruments
- tracking wildlife visually and relaying information to the deckhand and the passengers
- repositioning the vessel and maintaining the vessel's position where necessary
- avoiding obstacles such as rocks or other hazards
- maintaining positional awareness
- communicating via VHF and with the deckhand where required
- maintaining continual awareness of the overall situation on board the vessel and with regard to the vessel's surroundings (Appendix B)
