MARINE INVESTIGATION REPORT

M17C0232

Person overboard and subsequent loss of life

General cargo vessel *Amazoneborg*

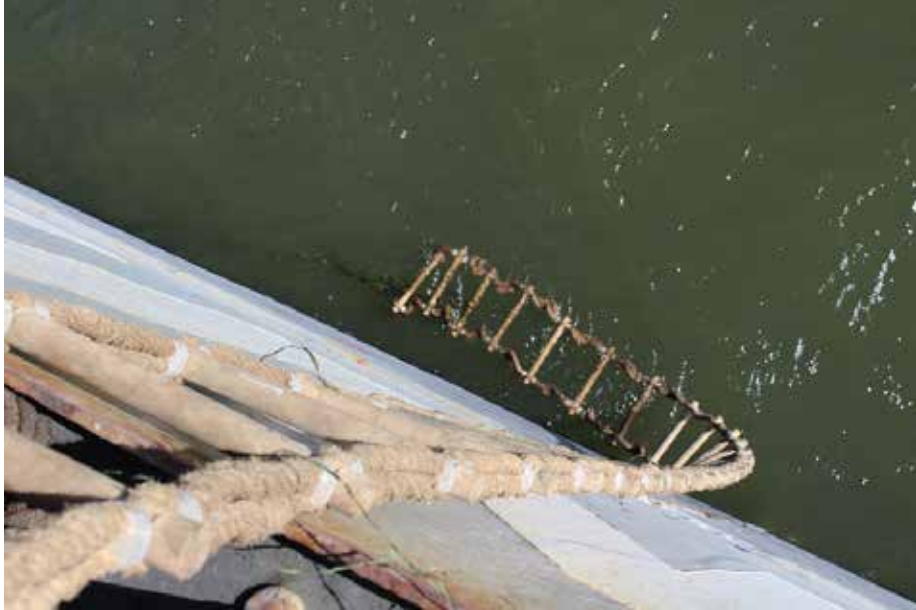
During their search, they found the Jacob's ladder used in the initial draft survey lowered and hanging over the port side at amidships. The last few rungs of the ladder were in the water and moving with the current (Figure 2 and Figure 3). A crew member found the draft measuring tape on the port side of the main deck (Appendix A).

Figure 2. Top view of the Jacob's ladder hanging over the port side of the Amazoneborg, near the amidships draft marks

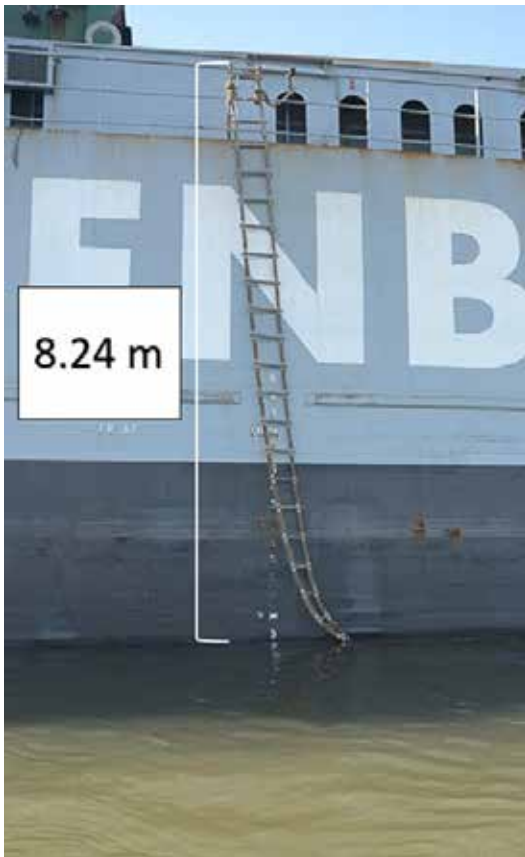
Figure 3. Side view of the Jacob's ladder, indicating height at the time of the occurrence (8.24 m) (Source: Louise Charbonneau/Sûreté du Québec, with TSB annotations)

1. In this occurrence, the Jacob's ladder was found lowered, suggesting that the third officer intended to use it to read the amidships seaward draft marks.
2. The Jacob's ladder was rigged to the guardrail in such a way that there was no safe means of accessing the ladder from the deck.
3. The Jacob's ladder was unsuitable for the task of reading the amidships seaward draft marks.
4. The third officer may have fallen either while climbing over the vessel's guardrail to access the rigged Jacob's ladder or while using the Jacob's ladder.
5. No one was aware of the third officer's actions, no fall protection system was used, and no one was present to initiate an emergency response when the third officer fell overboard.
6. The lack of a personal flotation device diminished the third officer's chances of survival in the water.

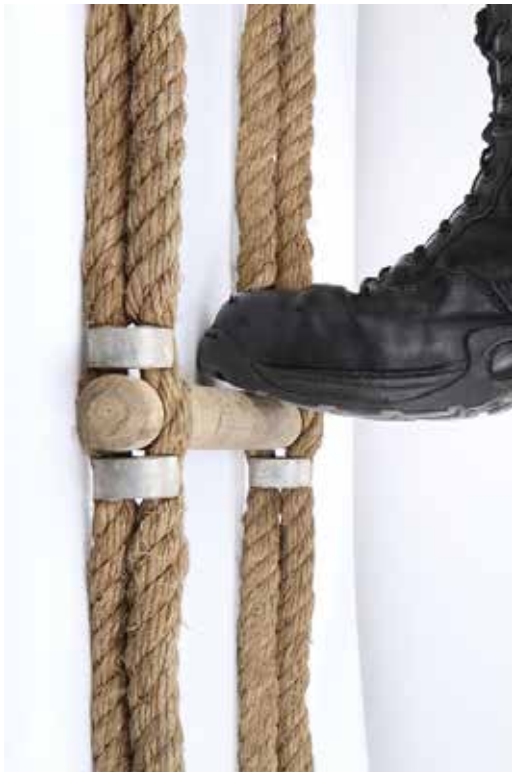
At the time of the occurrence, 2 Jacob's ladders were on board the *Amazoneborg*. They were made up of round wooden rungs inserted between manila ropes and attached with aluminum clamps. The ladder used in the occurrence was 9.4 m long, with rungs 34 mm in diameter and 400 mm long. When resting on a flat surface, other than the areas immediately surrounding the clamps, the ropes lie flat. The distance from the flat surface to the outer edge of the rung is 42 mm, which provides a toehold of approximately 25 to 35 mm (Figure 5).

Figure 5. View of the Jacob's ladder resting against a flat surface, with boot to demonstrate toehold

The TSB's examination of the ladder used in this occurrence also indicated that the ladder appeared to be in good condition.

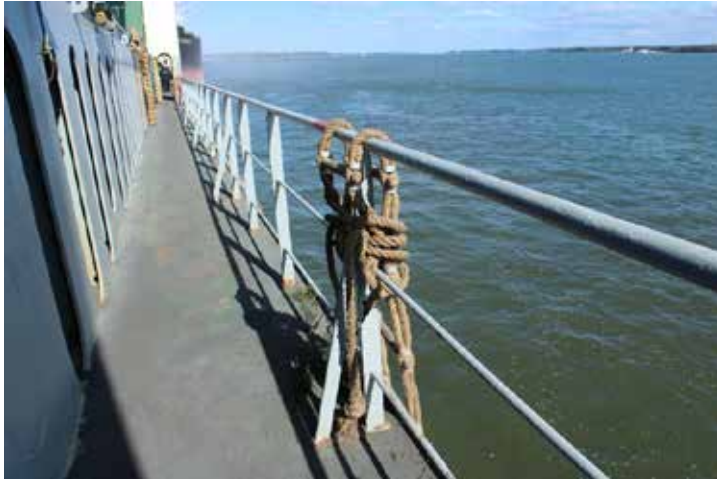
The Jacob's ladder used in this occurrence was rigged to the guardrail, above the amidships draft marks (Figure 6). This portion of the guardrail consisted of permanent rails and stanchions. On board the *Amazoneborg*, Jacob's ladders were typically rigged in this manner. During installation, the length of the ladder was typically adjusted according to the vessel's freeboard so that it hung above the water. To transfer between the deck and the ladder, the user had to climb up the guardrail, straddle it briefly, and then descend the guardrail. The permanent guardrail is intended to prevent personnel from falling overboard and is not intended to secure a ladder.

Figure 6. Rigging of Jacob's ladder to the guardrail on the *Amazoneborg* at the time of the occurrence

The Jacob's ladder was rigged to the guardrail in such a way that there was no safe means of accessing the ladder from the deck, such as through a gateway. However, the investigation found that the ladder itself appeared to be in good condition. Thus, the third officer may have fallen either while climbing over the vessel's guardrail to access the rigged Jacob's ladder or while using the Jacob's ladder.

- replace Jacob's ladders used for survival craft with embarkation ladders approved by the International Convention for the Safety of Life at Sea;
- prohibit the use and purchase of Jacob's ladders, and replace them with aluminum embarkation ladders, then remove or destroy all Jacob's ladders and check for the presence of Jacob's ladders during company visits to the vessels; and
- explain to crew the various methods available for taking draft measurements, as well as conduct research and introduce alternative means and methods of taking draft measurements.

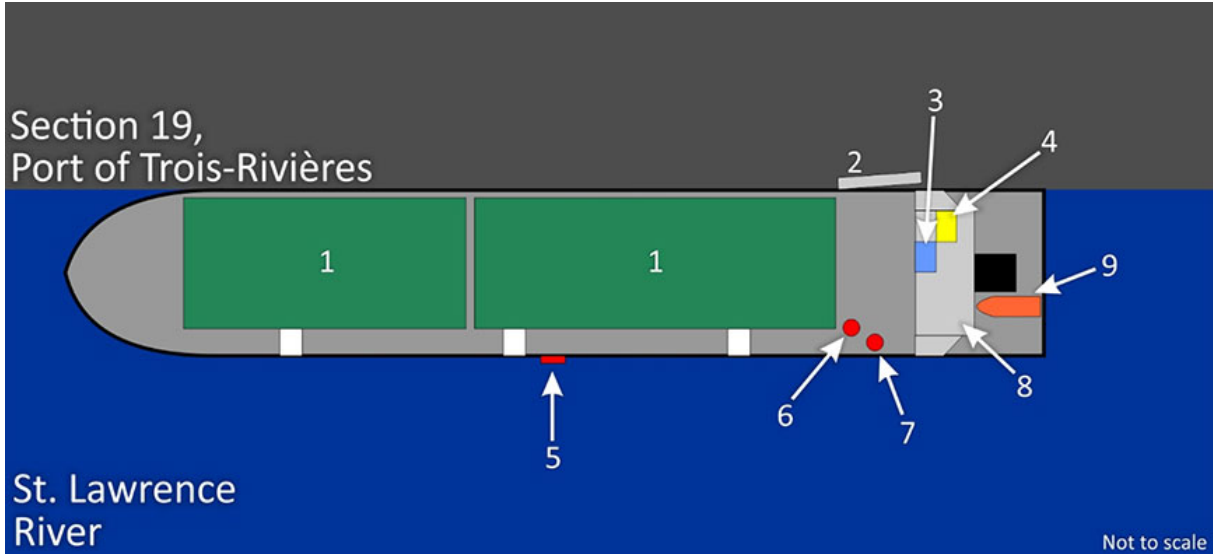
Appendix A – General arrangement of the Amazoneborg

- 1 Cargo hold
- 2 Starboard accommodation ladder (position of the able seafarer)
- 3 Crew locker room
- 4 Vessel office
- 5 Location of amidships ladder
- 6 Location where draft measuring tape was found
- 7 Last known position of the third officer
- 8 Accommodation space
- 9 Rescue boat
