# Marine Transportation Safety Investigation Report M18A0075

## GROUNDING

Fishing vessel *Roping the Wind*  
Hardys Channel, Prince Edward Island  
30 April 2018

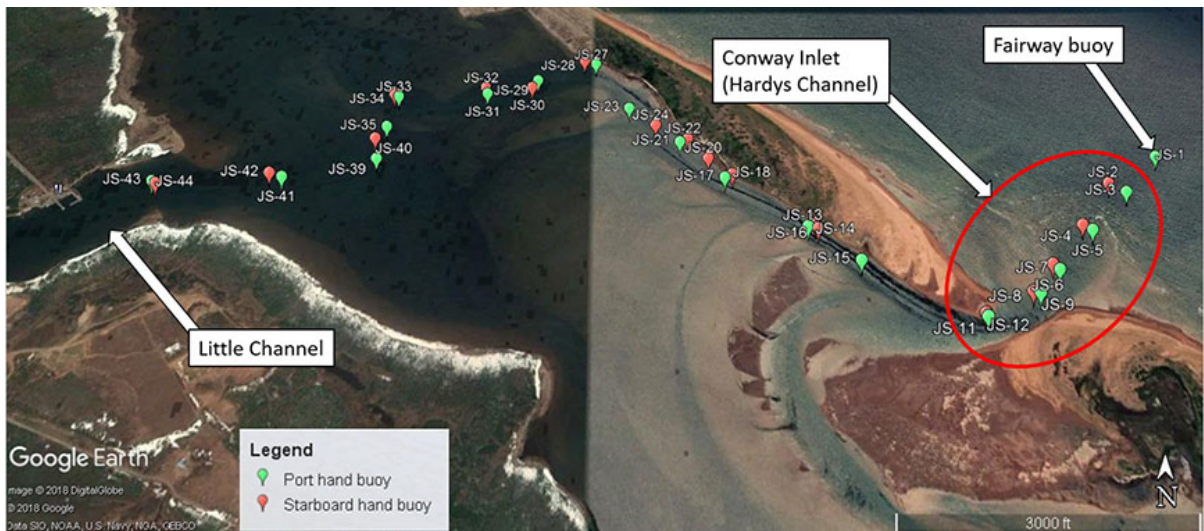
When the vessel departed at 1100 for its 2nd trip, visibility was good, the tide was ebbing, the winds were northeasterly at 10 to 15 knots, there were swells of 1 m to 2 m in height, and some white water was visible near the JS-2 and JS-3 channel buoys. Masters of other fishing vessels who had navigated Hardys Channel earlier that day had reported over very high frequency (VHF) radio channel 80 to pass close to the starboard hand buoys, because water there was deeper than at other locations within the channel (Figure 1).

Figure 1. Map depicting Little Channel and Conway Inlet (Conway Inlet is locally known as Hardys Channel) (Source: Google Earth, with TSB annotations)

Once the *Roping the Wind* entered Hardys Channel, it briefly made bottom contact with a sandbar and the engine slowed. The engine soon recovered, and the vessel continued its voyage until it grounded on another sandbar near the last port and starboard hand buoys in the channel, approximately 1.25 nautical miles northeast of Rocky Point, PEI.

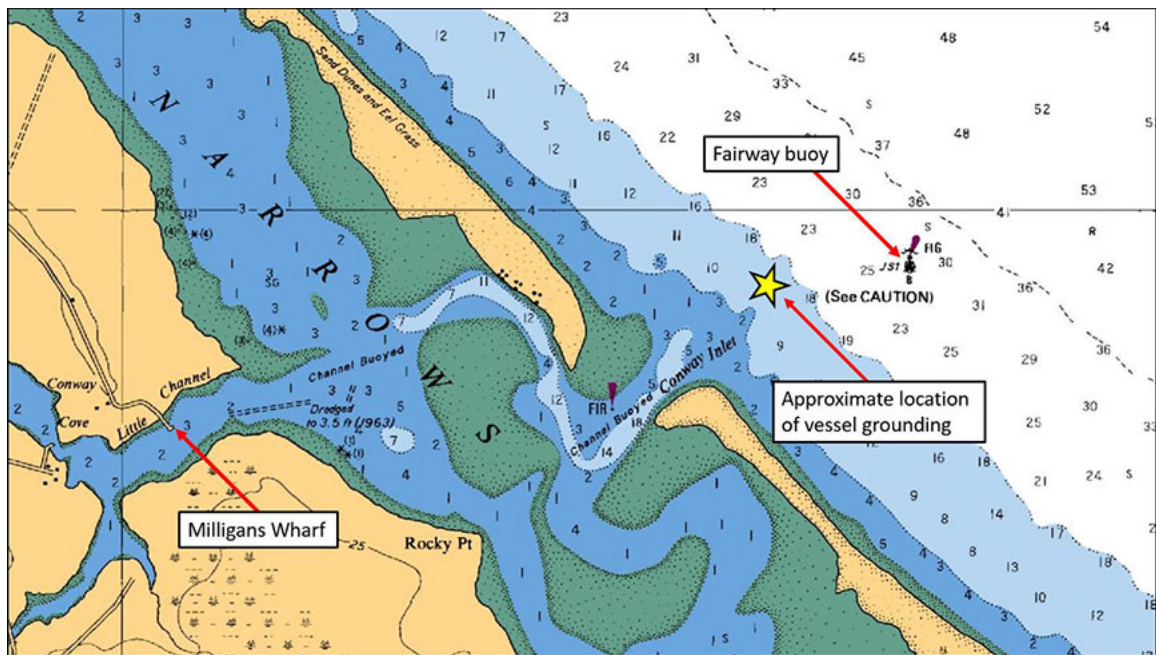
At the time of the occurrence, CCG Aids to Navigation required that a design and review officer conduct a local site visit every 5 years to assess the aids to navigation throughout the Narrows of Malpeque Bay and Hardys Channel (Figure 2). The last review was conducted in 2008, when it was determined that no revision to the aids to navigation was needed.

The Canadian Hydrographic Services Chart No. 4491 for Hardys Channel does not depict the port and starboard hand buoys marking the channel; rather, the chart states that the channel is buoyed, indicating that mariners must rely on the buoys in place for the best route (Figure 2).

**Figure 2. Chart depicting Little Channel and Conway Inlet (locally known as Hardys Channel) with depths in feet (Source: Canadian Hydrographic Service, with TSB annotations)**

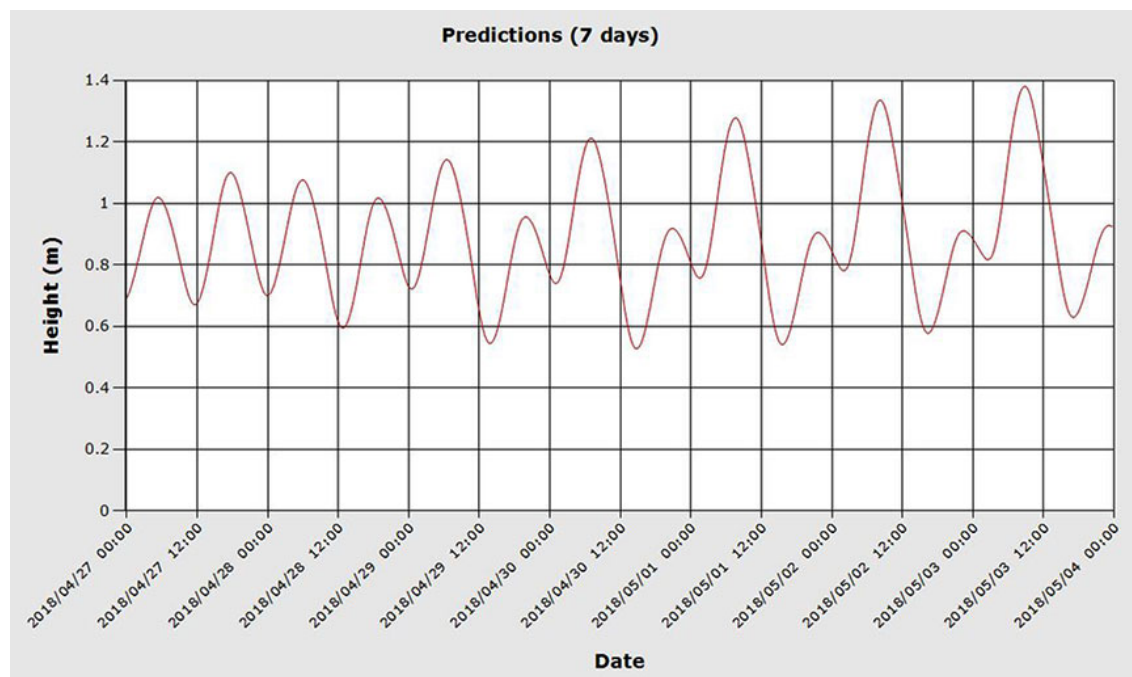
On 30 April 2018, there was a full moon. Full moon and new moon phases in the spring produce spring tides, causing significant differences in height between daily high and low tides. The graph below depicts tides at Ellerslie, PEI, which is the reference port for Hardys Channel (Figure 3).

Figure 3. Tidal predictions at Ellerslie, PEI, from 27 April to 04 May 2018 (Source: <http://www.waterlevels.gc.ca>)

When the *Roping the Wind* made its 1st trip of the day, there was sufficient water depth to safely navigate Hardys Channel. On its 2nd run, the tide was falling and was lower than the previous low tide. During the outgoing tide, the winds were from the northeast and opposing the tidal current in Hardys Channel, generating large, steep waves.
