# Marine Transportation Safety Investigation Report M18P0144

## UNCONTROLLED FALL OF RESCUE BOAT

*Spirit of Vancouver Island* rescue boat No. 3  
Swartz Bay, Vancouver Island, British Columbia  
19 June 2018

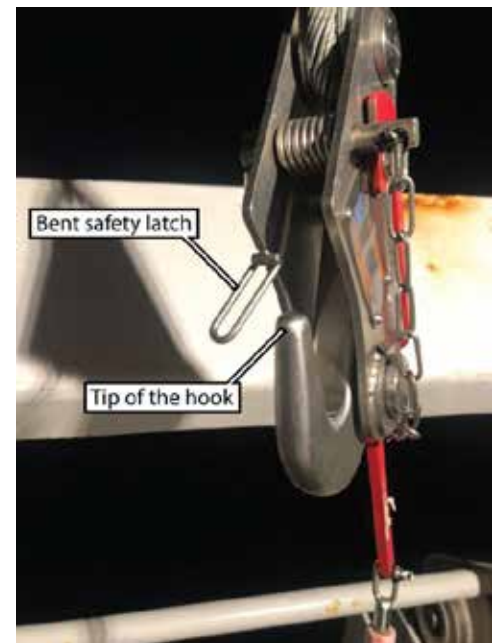
Following the occurrence, the first engineer, the deckhand, and the technician inspected the hook and observed that the spring-loaded safety latch on the hook was bent to the side, creating a gap between the latch and the tip of the hook (Figure 3). It could not be determined when or how the safety latch became bent.

Figure 3. Bent safety latch after the occurrence

The service company instructed all of its technicians to conduct service or repairs only after confirming that the rescue boat has been removed from its davit fall.

Following this occurrence, the company carried out a risk assessment that resulted in rescinding the restriction on personnel in the rescue boats during non-emergencies.

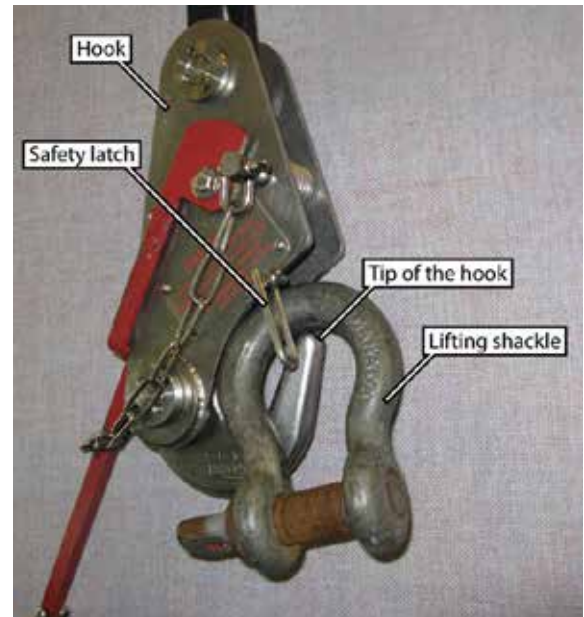
The investigation determined that the hook design is such that the lifting shackle can rest on the tip of the hook (Figure 4). When the falls were slack while the rescue boat was floating unmanned in the water, there may have been an opportunity for the lifting shackle to become positioned on the tip of the hook such that it could slip off the hook through the gap resulting from the bent safety latch.

In this occurrence, the rescue boat was lowered into the water and remained there for approximately 50 minutes with the fall slack and the hook and lifting shackle resting loose inside the rescue boat. During this time, the rescue boat was uncrewed and free to move about in the water, which may have created an opportunity for the lifting shackle to reposition itself on the tip of the hook. When the deckhand began raising the rescue boat, it was dark, and from his location on deck 6, he was unable to see the position of the lifting shackle on the hook.

Figure 4. Shackle positioned on the tip of the hook
