## **MARINE TRANSPORTATION SAFETY INVESTIGATION REPORT M19A0025**

### **SINKING AND LOSS OF LIFE**

Workboat *Captain Jim*

29 January 2019

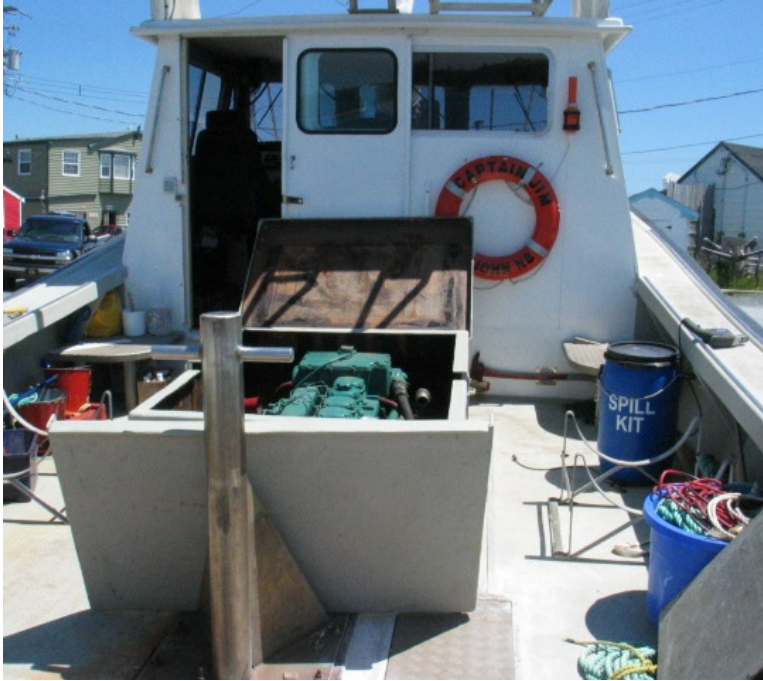
There were 4 hatches and a raised coaming around the engine compartment (Figure 2). Since the *Captain Jim* was an undecked vessel, the hatches and coaming were designed to be weathertight, but not watertight, and water that entered the vessel accumulated in the bilge.

Figure 2. View of the wheelhouse from aft showing raised coaming around engine compartment and one of the hatch covers (Source: Third party, with permission)

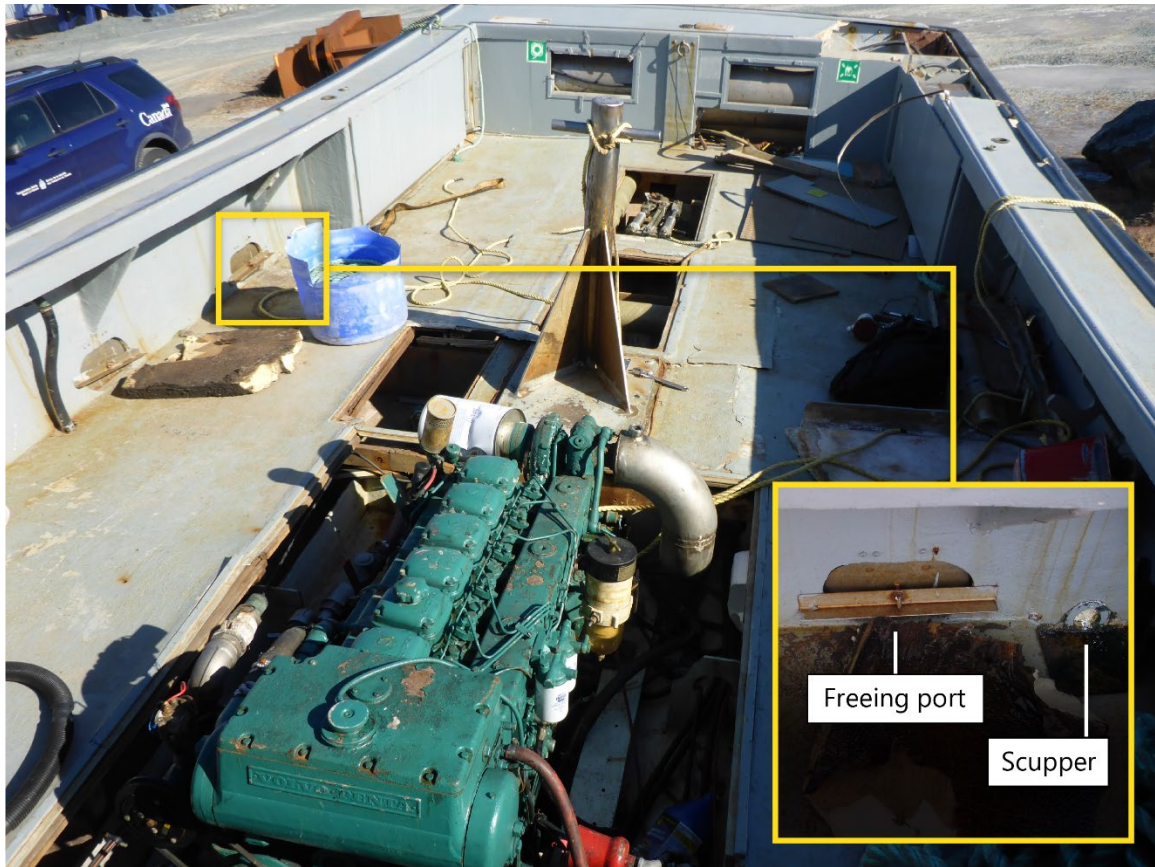
The port and starboard sides of the vessel each had 3 freeing ports, installed in July 2008, with hinged aluminum flaps. Subsequently, a securing arrangement was installed on each freeing port to allow the aluminum flaps to be fastened shut (Figure 3). The workboat also had 2 scuppers just aft of the stern-most freeing ports. The scuppers could be fitted with screw plugs but were normally left open.

Figure 3. View from the wheelhouse facing aft, with inset photo of starboard aft freeing port and scupper. Following the occurrence, TSB removed the hatch covers and raised coaming for examination purposes. (Source: TSB)

After the *Captain Jim* was raised, the vessel's hull was examined and was found to be structurally intact. The aluminum flaps on all of the freeing ports were still secured by the securing arrangements, with the exception of the forward starboard freeing port. The scuppers were found to be open. No other areas were identified that could allow for unexpected ingress of water.

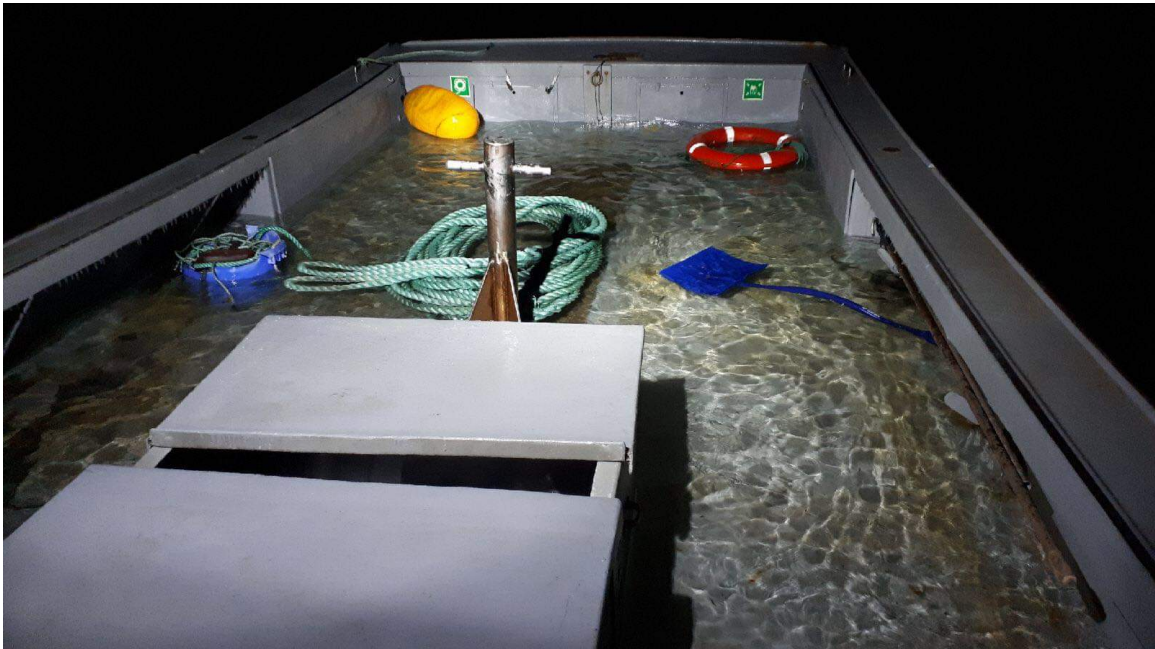
The master continued navigating until 0207, when the vessel's engine was overcome by water and stopped. The vessel was just outside of calm waters. The water level had risen to approximately 40 cm at the stern (Figure 4).

Figure 4. The back deck of the Captain Jim, awash with sea water (Source: Third party, with permission)
