## **MARINE TRANSPORTATION SAFETY INVESTIGATION REPORT M19P0020**

### **STRIKING OF BERTH AND SHORE GANTRY CRANE**

#### **CONTAINER VESSEL *EVER SUMMIT***

Vanterm, Port of Vancouver  
Vancouver, British Columbia  
28 January 2019

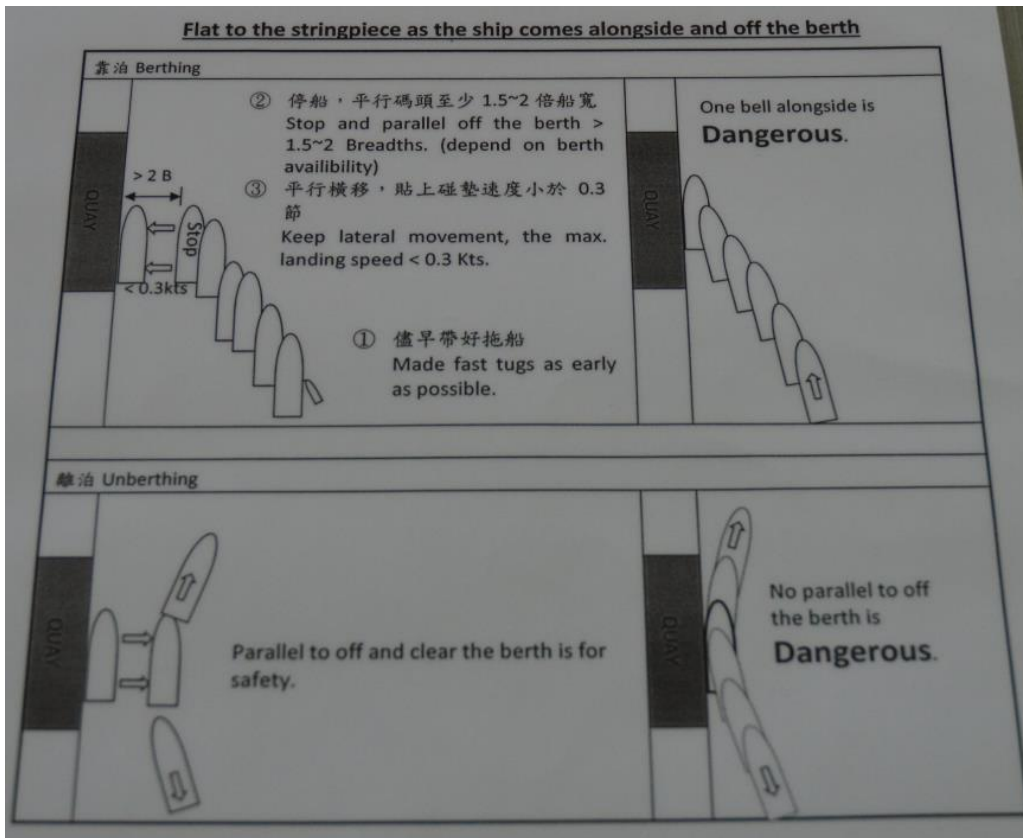
Figure 2. Photograph of berthing guidance on the pilot card (Source: TSB)

The back of the pilot card included brief guidance for approaching and leaving a berth (Figure 2). The guidance indicated that, for berthing, the vessel was to be stopped parallel to the berth at a distance of approximately 1.5 to 2 vessel breadths (64 to 86 m). Tugs were to be made fast as early as possible, and the vessel was to be manoeuvred laterally into the berth at a maximum landing speed of less than 0.3 knots (15.4 cm/s). The guidance also highlighted manoeuvres for berthing and unberthing that were considered dangerous for this particular vessel.

In the case of the *Ever Summit*, the company guidance recommended the vessel be stopped parallel at least 1.5 vessel breadths (64 m) off the berth and then pushed in laterally using tugs. However, the vessel transited the berth approximately 10 m off, an approach which limited the time to respond to any deviations during the berthing manoeuvre. In the master's experience, it was not uncommon for pilots to approach the berth at Vanterm at distances less than described on the vessel's pilot card, and he did not express concern during the berthing of the *Ever Summit*.

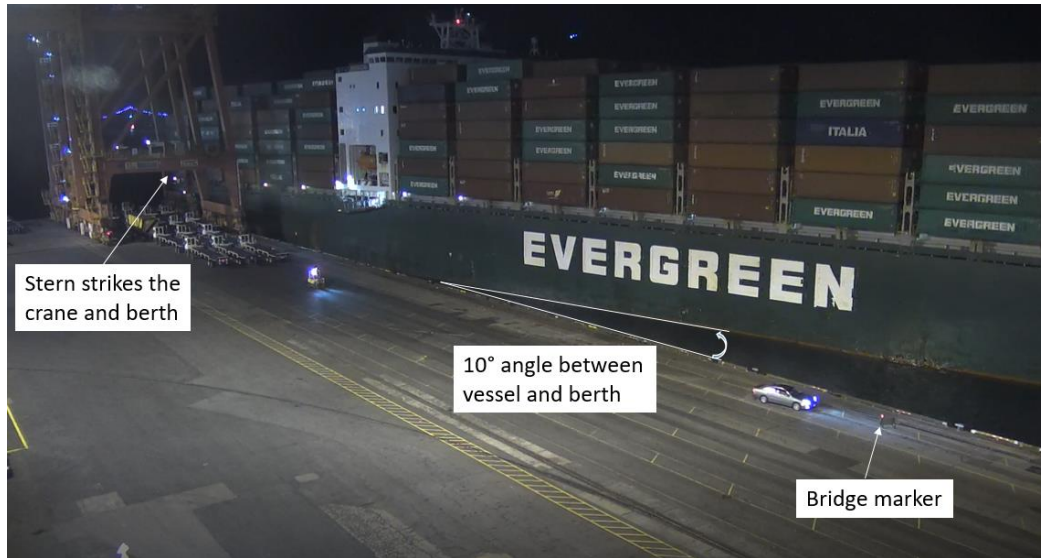
Figure 5. Capture from the closed-circuit television footage of the *Ever Summit* at the time of the striking (Source: GCT Canada, with TSB annotations)

Corrective action using the vessel's engine, rudder, and thruster had insufficient effect, and the vessel's stern struck the dock at an angle of 10° with the berth line and a speed of approximately 0.4 knots. The vessel's large overhang and the proximity of the crane to the berth line resulted in the vessel's hull striking the berth and the crane, which caused the gantry bogies to collapse and the boom to fall onto the vessel.

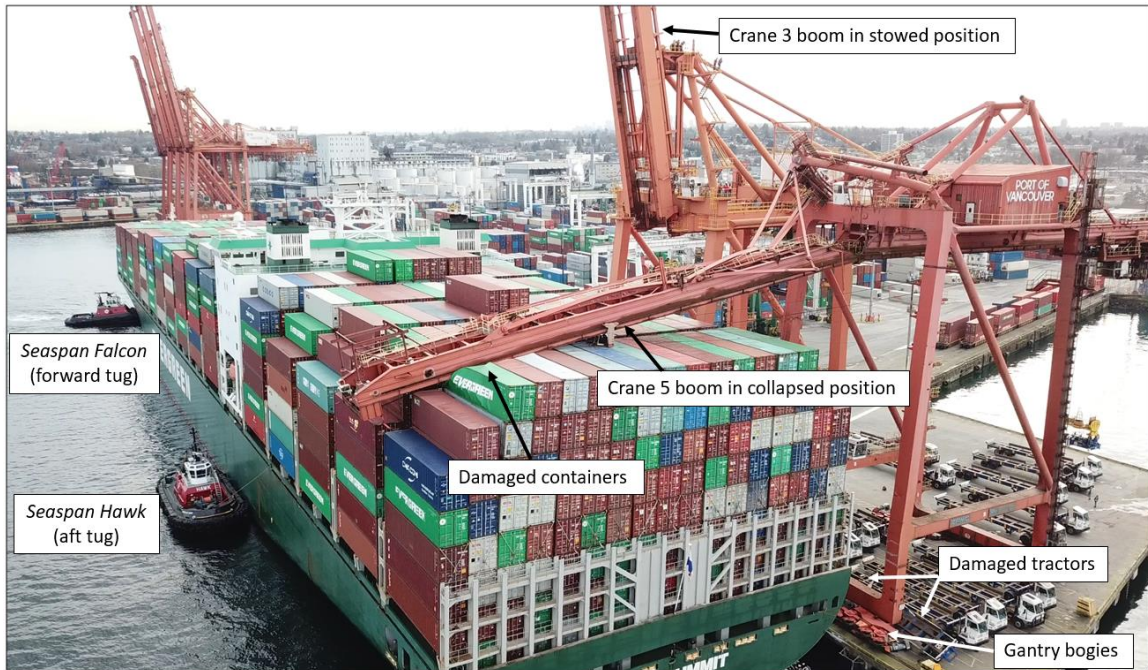
Figure 6. The *Ever Summit* maintaining position after the occurrence (Source: GCT Canada, with TSB annotations)

Approximately 6 containers stowed in the uppermost bays were damaged when the crane boom fell onto the vessel (Figure 6).

Crane 5 was declared a total loss, and Crane 3 sustained minor damage. In addition, numerous tractor-trailers stowed below Crane 5 were damaged (Figure 6).

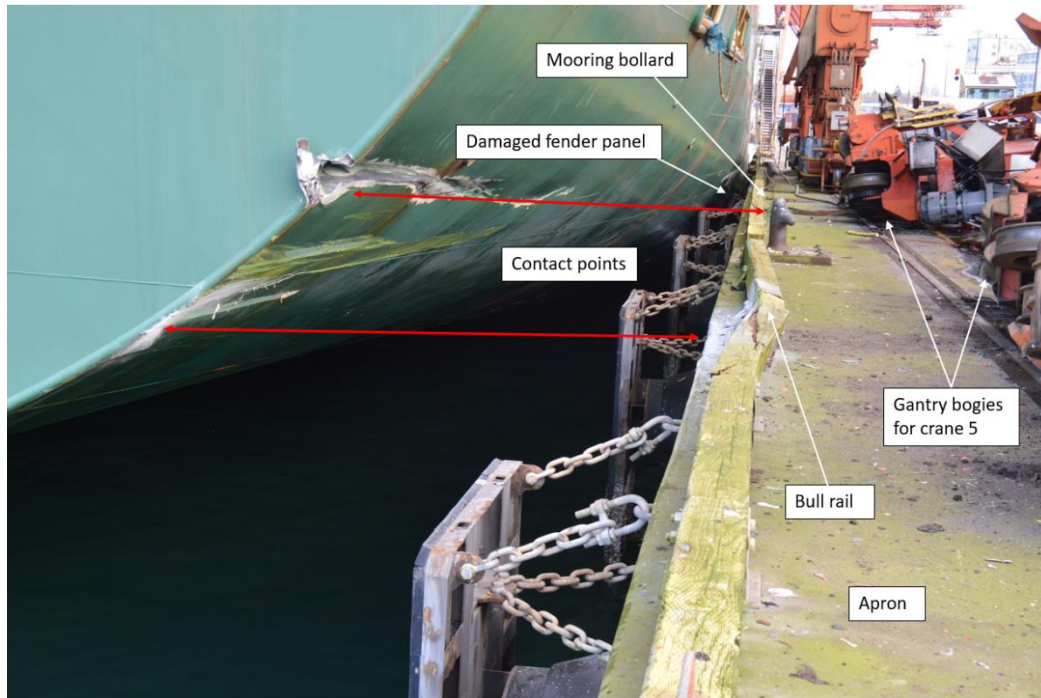
Figure 7. Damage to the vessel's starboard aft shell plating. The red arrows show the points where the vessel came into contact with the berth. (Source: TSB)

The concrete edge of the berth sustained impact damage, and the wooden bull rail was cracked and pushed back by approximately 8 cm at the point of contact (Figure 7). The mooring bollard showed signs of abrasion (Figure 7), and 2 of the fender panels were bent and had topside damage.

Before the vessel departed for its next voyage, temporary repairs to the hull were completed on 06 February in Vancouver, BC, to the satisfaction of the attending classification society surveyor.

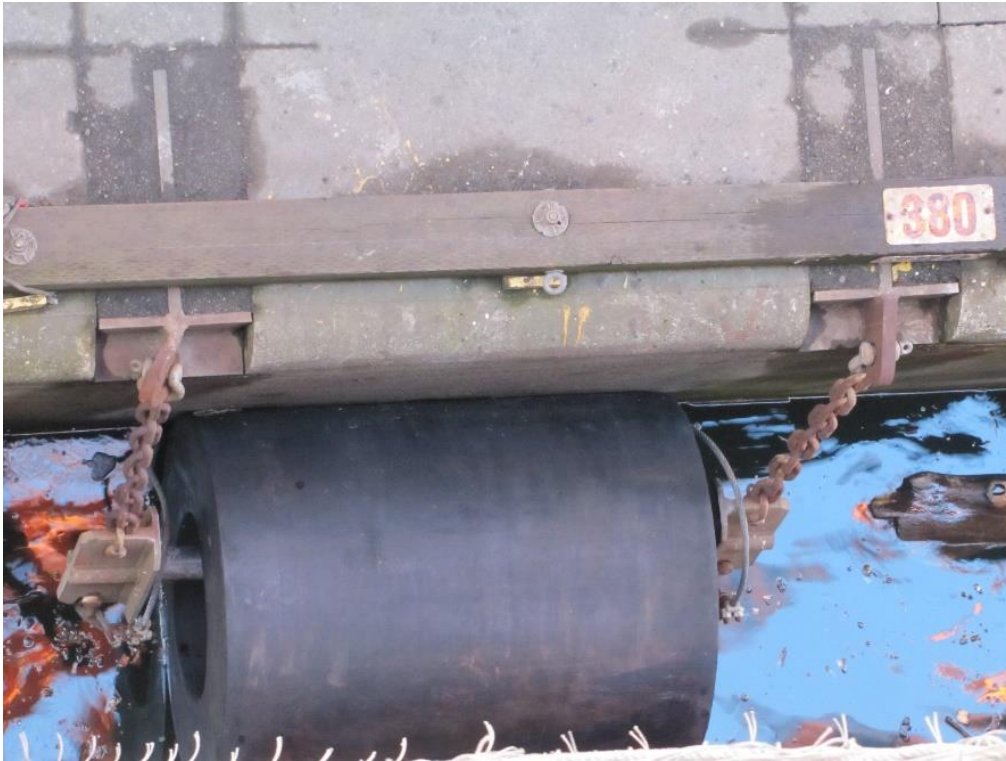
Figure 8. Cylindrical fender on Vanterm berth 5 (Source: TSB)

When a vessel's hull presses on the cylindrical fenders, they will compress up to a maximum of 60 cm, which is equal to the inner diameter of the fender, leaving a clearance of approximately 60 cm between the vessel's hull and the berth face. Once the fender is fully compressed, it behaves as a solid rubber element. Any further compression past this point causes pressure on the vessel's hull.

The cylindrical fenders do not have a means of reducing sliding friction. Large friction forces can develop as the rubber fender is compressed between the vessel hull and the concrete berth face, resulting in damage to the anchoring chains or plates. The fenders are known to the pilots as being "sticky," meaning that the vessel's hull does not slide easily along the fenders, but rather "sticks" on them, which can make berthing more difficult.

The review concluded that the damage was a result of the existing fendering system not having sufficient capacity to absorb the kinetic energy of the large vessels berthing at the terminal. Specifically, when the fenders are compressed to their maximum, large vessels can make contact with the berth face, causing impact damage to both the berth and the vessels.

The review also identified that the existing cylinder fender system was inappropriate for the size of container vessels that dock at the berth. The energy absorption capacity of the fenders was significantly less than the required energy absorption for the maximum design vessel<sup>30</sup> (1662 kN-m). The fender stand-off distance<sup>31</sup> was inadequate, and the fender spacing was too far apart considering the size of the fenders and the heavy loads placed on them.

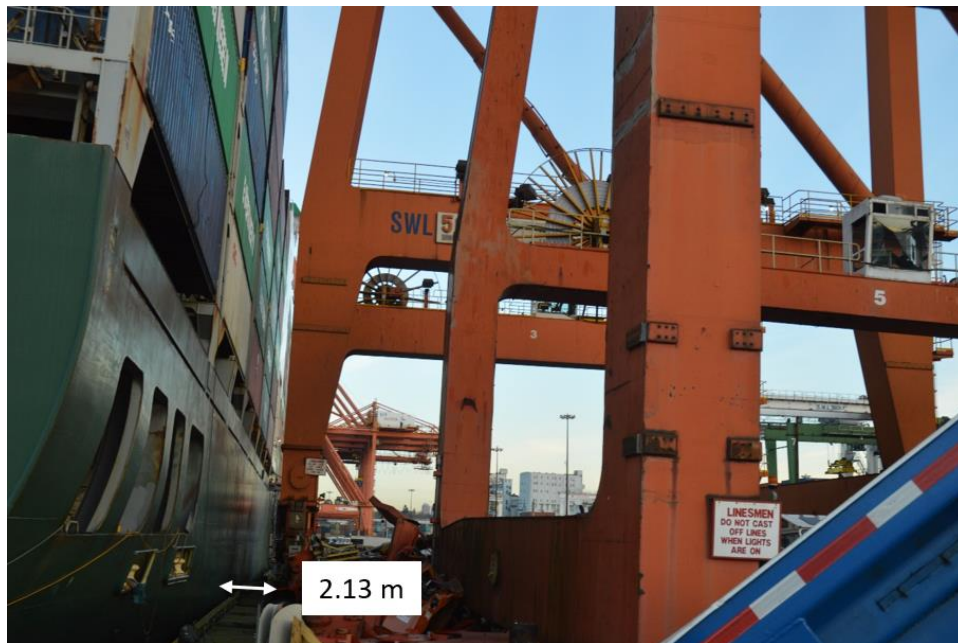
Figure 12. Distances between the berth line and crane rail at Vanterm (Source: TSB)

The distance from the crane rail to the berth line at Vanterm is only 2.13 m, which means that even a slight angle on a vessel while berthing could cause the flare of its bow or stern to come into contact with a crane if one is in the vicinity. At Deltaport, by comparison, the distance from the crane rail to the berth line is 6.96 m.

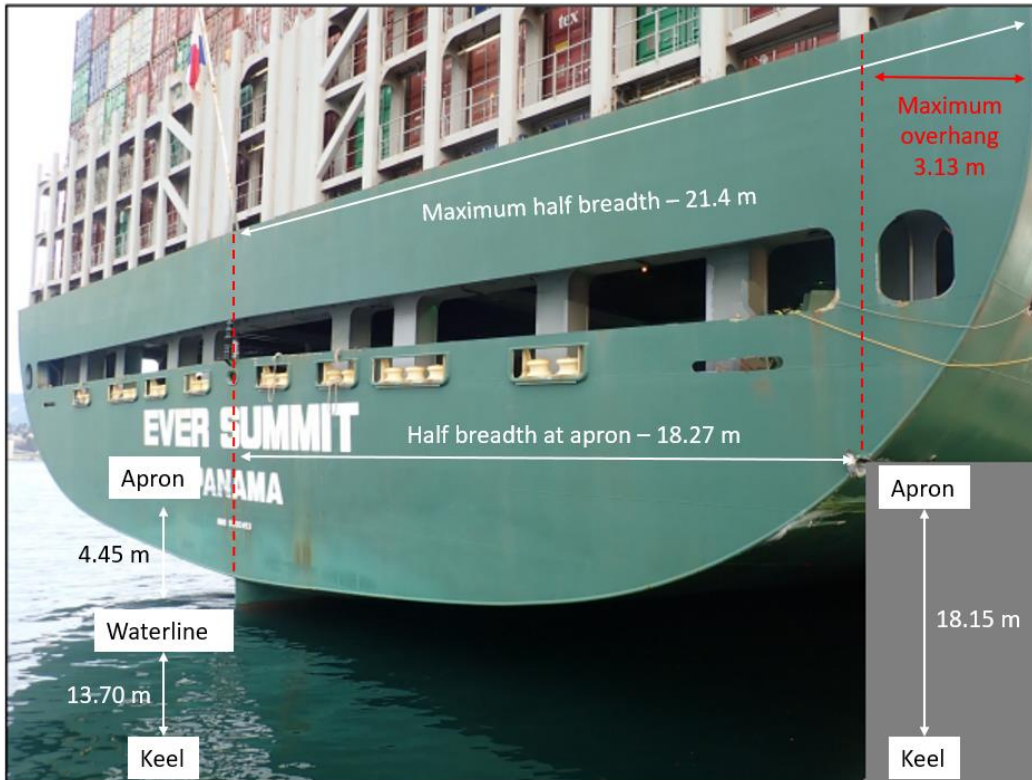
Figure 15. The *Ever Summit's* maximum overhang at the stern at the time of the occurrence (Source: TSB)

The TSB determined that, at the time of the occurrence, the *Ever Summit's* maximum possible overhang at the stern was approximately 3.13 m (Figure 15 and Appendix D).

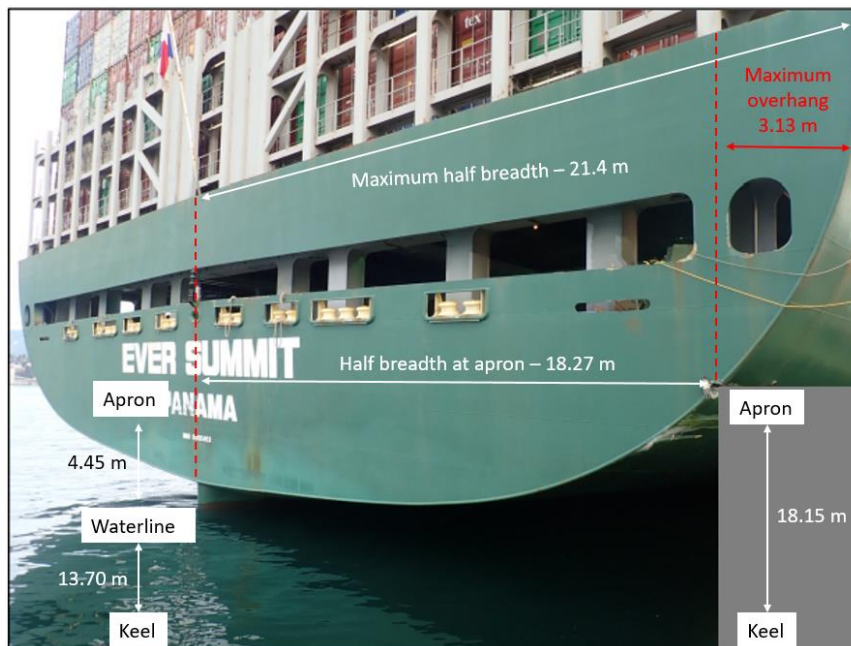
Figure D1. The *Ever Summit*'s maximum overhang at the stern at the time of the occurrence (Source: TSB)

To determine the maximum overhang at the transom, the difference between the half-breadth of the vessel at the apron level and the maximum half-breadth of the vessel was calculated. The maximum possible overhang at the transom was determined to be **3.13 m** (Figure D1).
