MARINE TRANSPORTATION SAFETY INVESTIGATION REPORT M20P0353

ACCIDENTAL RELEASE OF FREE-FALL LIFEBOAT

Bulk carrier *Blue Bosporus*
English Bay, British Columbia
01 December 2020

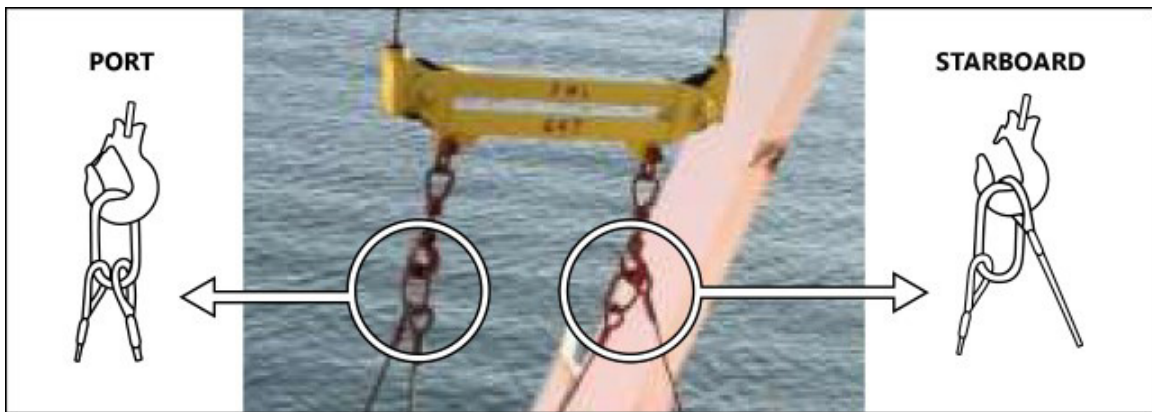
The third officer used hand signals to communicate with the bosun to lower the davit so that the lifeboat's slings could be connected to the hooks on the spreader bar. Once the hooks were within reach, the launching crew took the oval rings and attached them to the hooks on the spreader bar. On the port side, the crew placed the oval ring into the hook. On the starboard side, they placed the oval ring and the eye of the aft starboard sling into the hook, shortening the sling length (Figure 4).⁶

Figure 4. Photo and diagram showing how the slings were attached to the hooks during the occurrence drill (Source: Apollonia Lines S.A., with TSB annotations)

However, in this occurrence, the launching crew members unknowingly deviated from the instructions outlined in the manufacturer's manual when they placed both the oval ring and the eye of the aft starboard sling into the starboard hook. This caused the active length of the aft starboard sling to be shorter than the other slings. As a result, when the lifeboat was released, the shock load concentrated entirely on the aft starboard sling.¹⁹ This sling was held together by a weakened crimp sleeve which, in combination with the concentrated force, caused the sling to fail.

The manner in which the slings were attached to the hooks caused the load to concentrate on the aft starboard sling. This, in combination with the weakened crimp sleeves, caused the sequential failure of the slings and the aft port sling bracket.

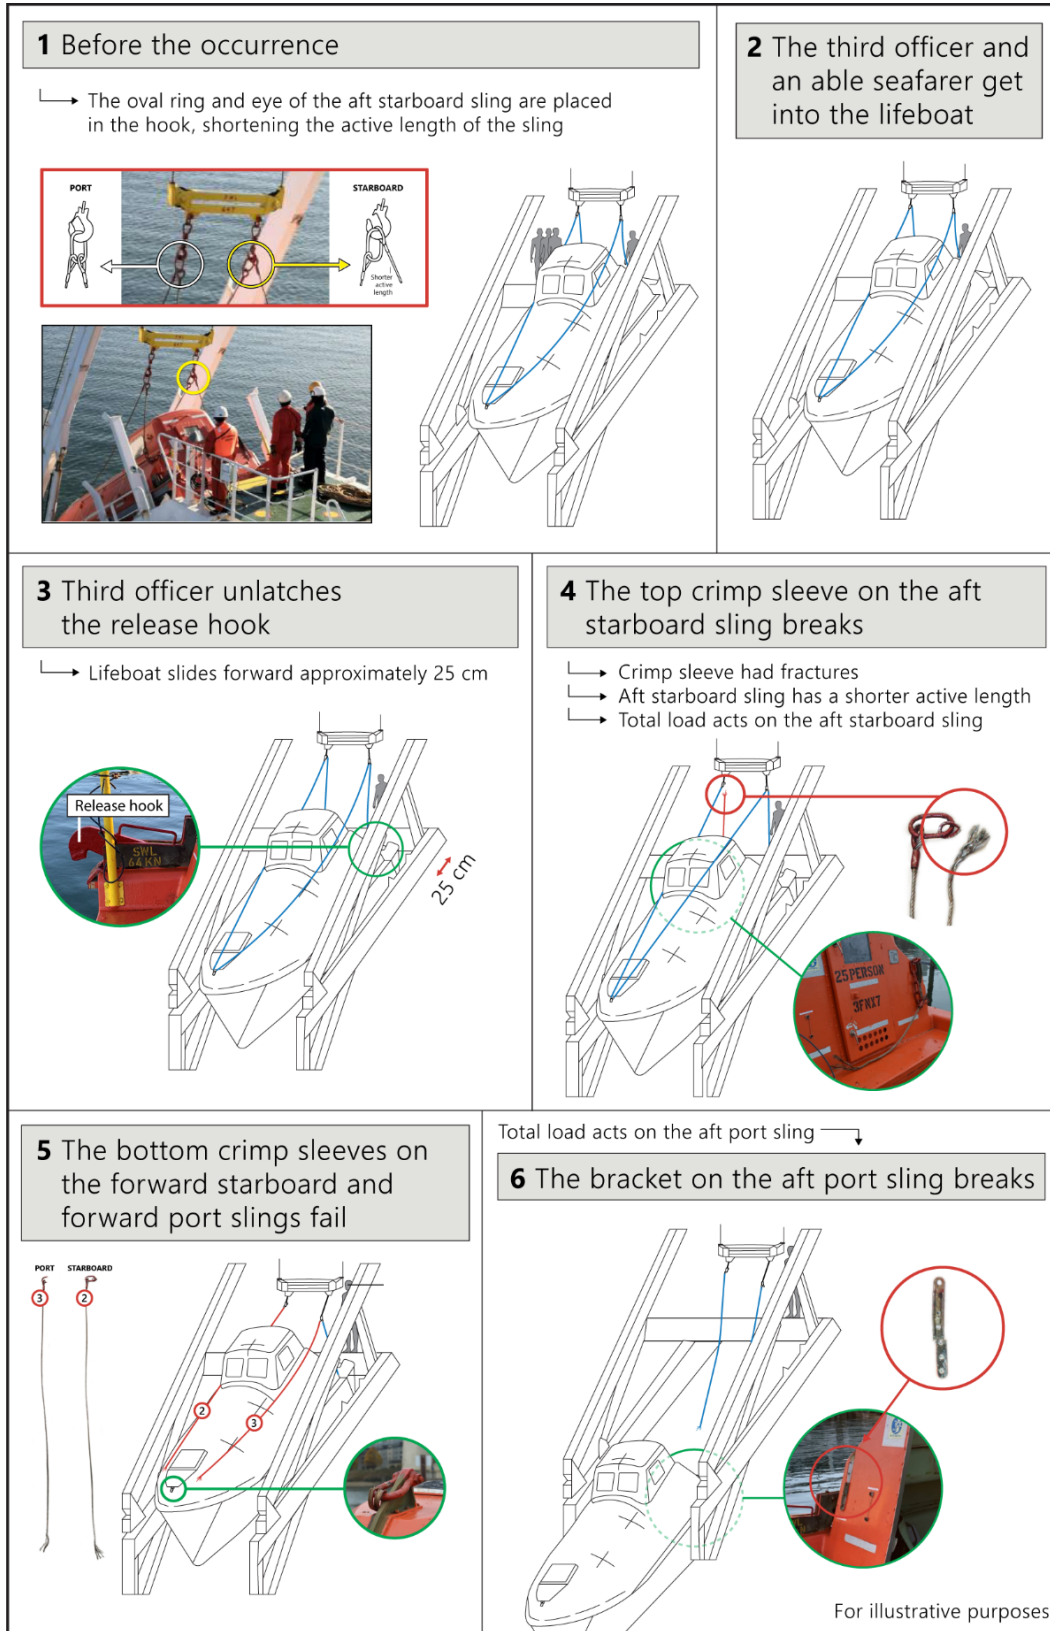
Once the hydraulic pressure was sufficient, the release hook unlatched, and the lifeboat slid forward approximately 25 cm. At this point, the aft starboard sling failed, followed by the 2 forward slings. The bracket holding the aft port sling onto the lifeboat broke off as well. The lifeboat fell about 14 m into the water.

Figure 6. Sequence of events (Source: TSB)

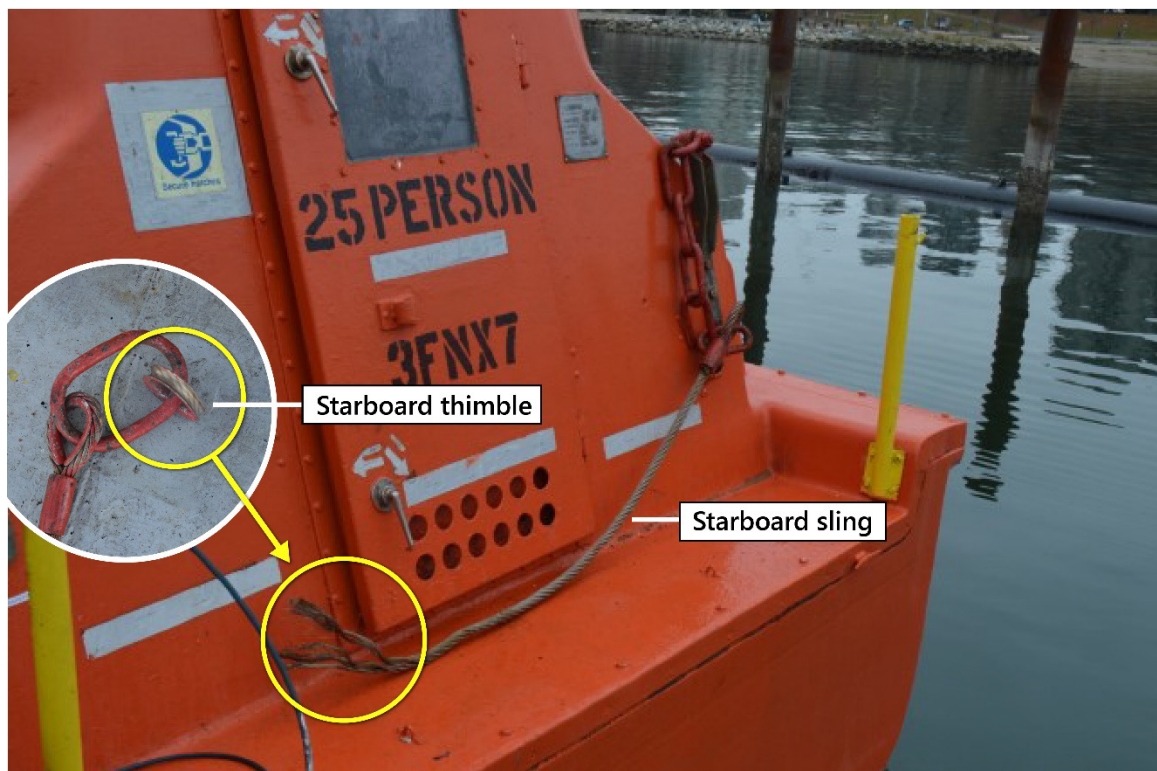
The crimp sleeve on the upper end of the aft starboard sling broke off, and the wire rope detached from the thimble (Figure 7). A portion of the broken crimp sleeve was retrieved. It was cracked in half.

Figure 7. Aft starboard sling detached from thimble (Source: TSB)

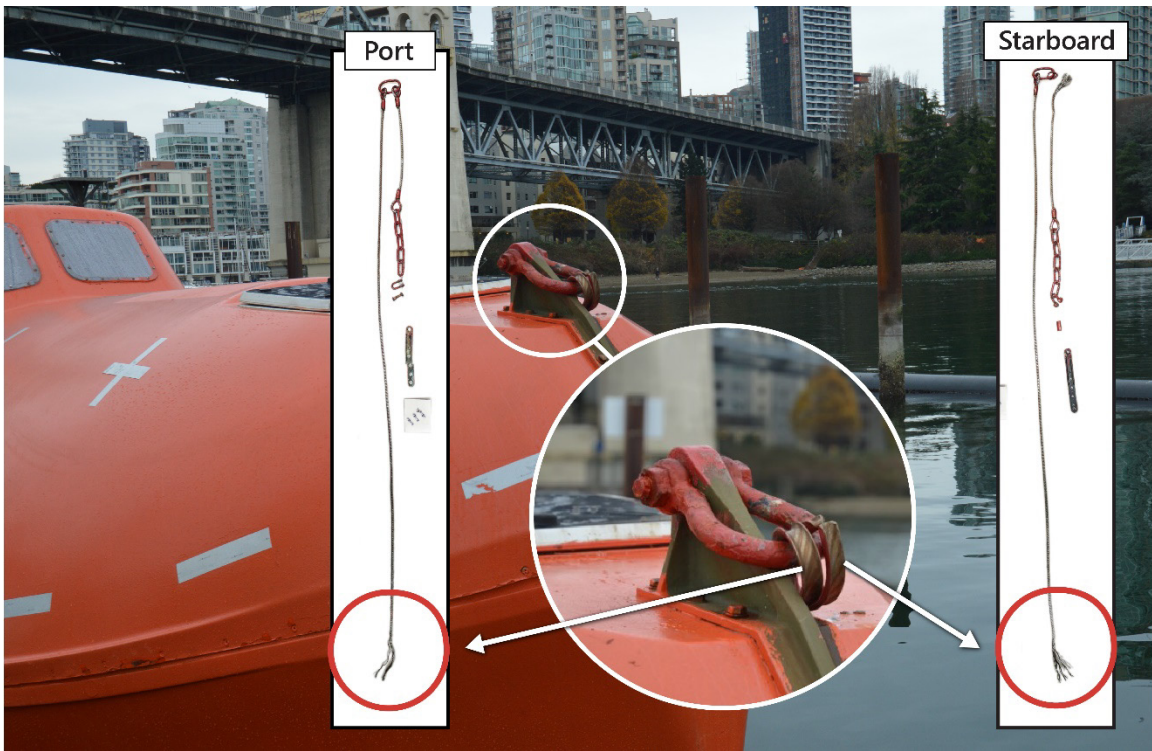
Both of the crimp sleeves that attached the 2 forward slings to the lifeboat broke off and the wire ropes detached from their thimbles (Figure 8). These crimp sleeves were lost in the water.

Figure 8. Forward port and starboard slings detached from their thimbles on the forward shackle of the lifeboat, with inset images showing the frayed ends of the slings (Source: TSB)

Once the aft starboard sling failed, the shock load shifted to the other slings, causing the crimp sleeves on the 2 forward slings to also fail. The load then shifted to the remaining aft port sling and its sleeve which, although cracked, remained intact. However, the bolts and the aft port bracket could not withstand the load and were pulled off the lifeboat by the force on the aft port sling.

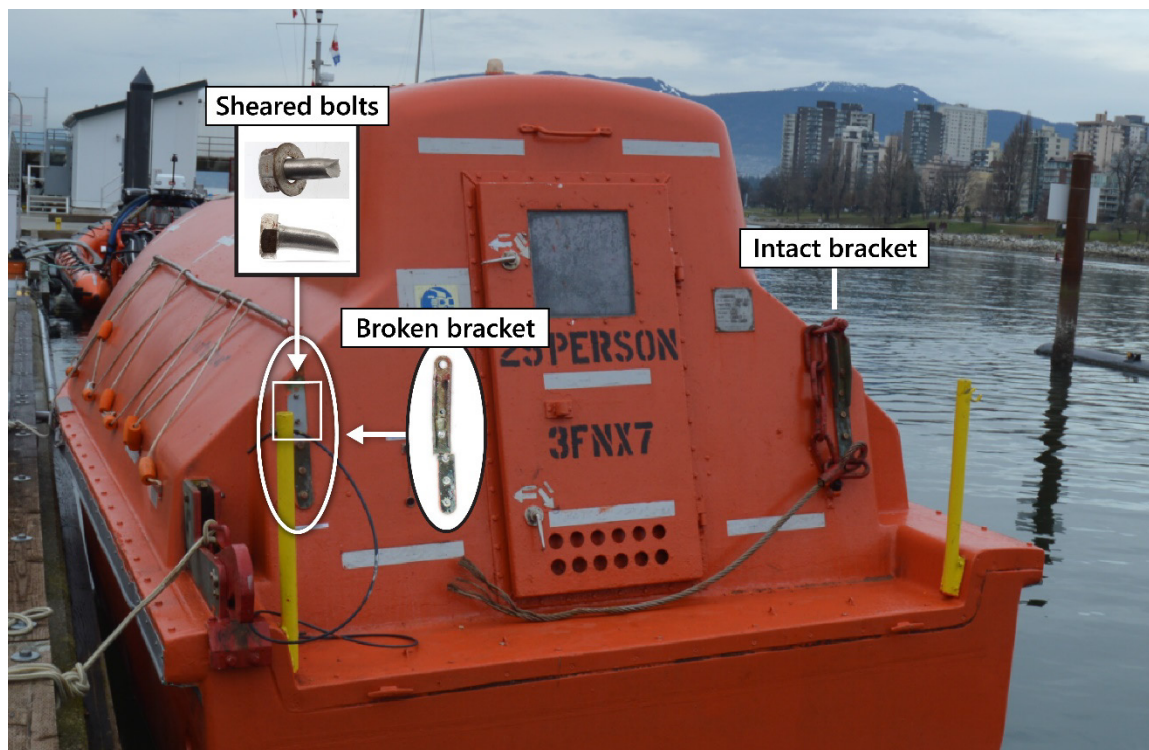
The aft port sling remained intact, but the bracket that attached the sling to the lifeboat broke off (Figure 9). The bolts that were securing the bracket to the lifeboat were retrieved and were found to have sheared off (Figure 9).

Figure 9. Broken bracket and sheared bolts on port side (Source: TSB)

The brackets used to attach the aft slings to the lifeboat were made of aluminum bronze. Aluminum bronzes have a strength similar to low alloy steels, and they are typically resistant to corrosion. Post-occurrence examination of the bracket indicated that it had bent significantly and had fractured at the middle bolt hole.

The bolts were made of austenitic stainless steel similar to the AISI 300 series. Post-occurrence examination of the bolts by scanning electron microscope showed signs that the bolts sheared off as a result of overstress applied when the bracket bent and broke.

- replaced the failed sling assembly, including the failed lifting brackets, with a newly manufactured, load tested, and certified sling assembly and brackets;
- included the lifeboat sling assembly in the *Blue Bosphorus's* wires and ropes inspection log;
- sent safety management system circular 05/2020 to all vessels operating under Apollonia lines S.A. the day after the accident. This circular requested that an extra safety meeting be carried out with all crew participating in order to update them on the occurrence and avoid a recurrence.

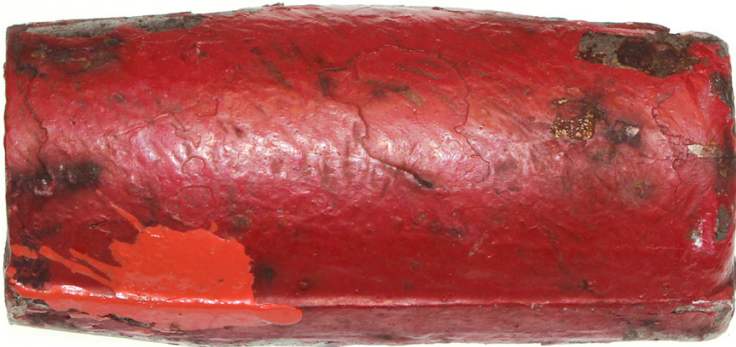
The crimp sleeves on the slings were also made of an austenitic stainless steel similar to AISI 304 grade steel. They were about 9 cm in length and were painted. After the occurrence, some of the crimp sleeves remained on the slings. The TSB recovered these crimp sleeves, as well as a broken portion of the aft starboard crimp sleeve (Figure 10).

Figure 10. Broken portion of aft starboard crimp sleeve from upper end of sling (Source: TSB)

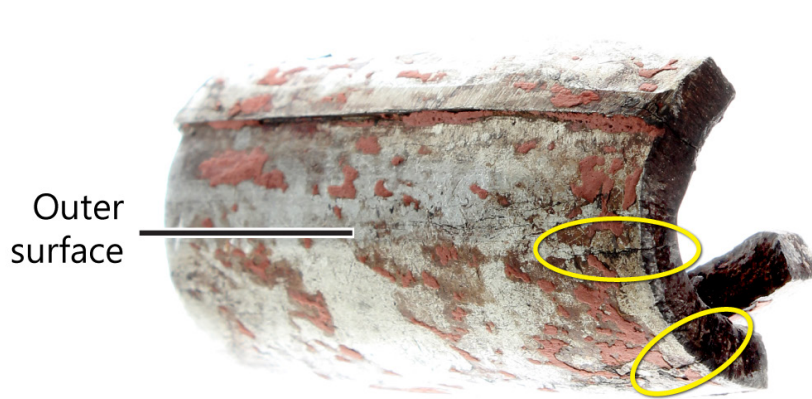
The TSB laboratory removed most of the paint⁸ from these crimp sleeves using commercial paint-stripping paste. A close visual examination of the crimp sleeves identified that the sleeves on the aft port sling had small cracks, the largest of which was approximately 1 cm in length. The cracks extended inward from the outer edges of the crimp sleeves. Similar cracks were visible on the broken portion of the aft starboard crimp sleeve. Figure 11 shows some of the cracks on one end of the aft starboard crimp sleeve.

Figure 11. Outer surface of the broken aft starboard crimp sleeve with paint removed showing cracks (circled) (Source: TSB)

The results of the laboratory examination indicated that the failure of the crimp sleeves was due to intergranular stress-corrosion cracking. Stress-corrosion cracking is a type of cracking induced by a combination of stress and a corrosive environment. The cracks can result from stress that is either directly applied or residual. In the case of mechanical splices such as crimp sleeves, residual stress may result from the original pressure applied on the crimp sleeve to crimp it to the wire. Crimp sleeves may also come under directly applied stress if they are load-bearing. Stress-corrosion cracking is a progressive failure process that develops over time, but it may eventually cause the sudden and catastrophic failure of a component. Intergranular stress-corrosion cracking is a variant of this process that occurs when the cracks follow grain boundaries in the material. It is typical for austenitic stainless steel.

The eyes of the slings were secured with crimp sleeves that had weakened over time as a result of intergranular stress-corrosion cracking. The cracks likely resulted from a combination of exposure to the elements, residual stress placed on the crimp sleeves when they were originally crimped onto the sling wires, and load-bearing stress placed on them each time they were used to hold the weight of the lifeboat.

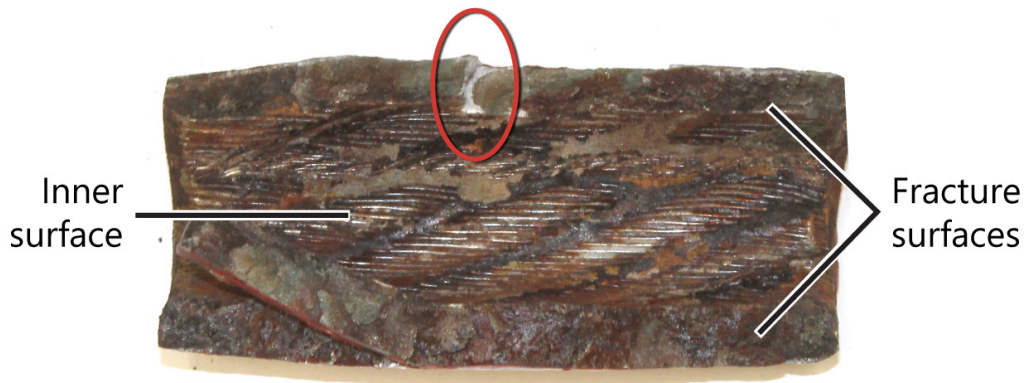
The TSB laboratory also examined the inner surface of the aft starboard crimp sleeve and the fracture surfaces created when it broke. Over 90% of the fracture surface on the upper side of the sleeve had an aged, corroded appearance. There was a small region of fresh fracture (circled on Figure 12) where a ledge about 3 mm high was visible. The ledge had formed when 2 cracks propagated on different levels. The fracture surface on the lower side of the crimp sleeve (Figure 12) also had an aged, corroded appearance.

Figure 12. Inner surface and fracture surfaces of the broken aft starboard crimp sleeve, as well as a small region of fresh fracture (circled) (Source: TSB)

The fracture surfaces were examined using a scanning electron microscope. The majority of the surfaces were covered by a thick corrosion scale with a dried mud appearance. Analysis of this scale showed that it consisted primarily of chromium oxide, with traces of sodium, chlorine, calcium, and sulphur. These elements are consistent with corrosion resulting from contact with sea water or humid sea air. Some corrosion was also observed on the inner surface of the crimp sleeve.

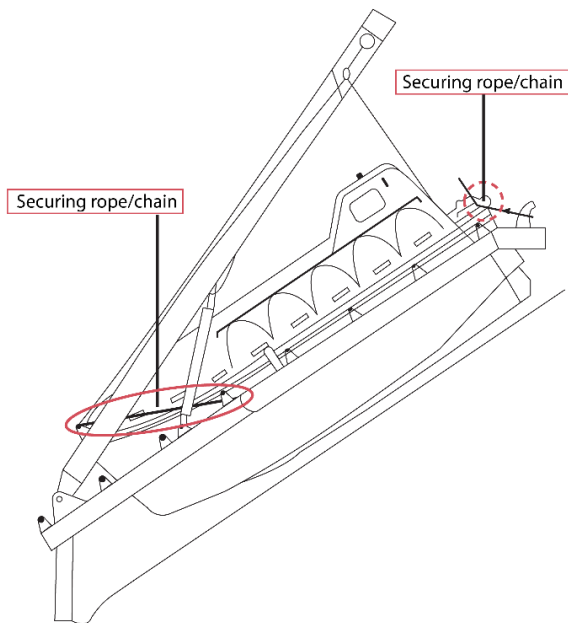
The lifeboat manufacturer's manual specifies that during a release test without launching (i.e. a simulated launching), the lifeboat should be additionally secured with applicable ropes or chains. The securing points for these ropes or chains are different from the points used for the slings. The manual recommends that the ropes or chains be secured from the forward hoisting shackle downwards and aft to the launching way on either side of the lifeboat and/or through cut-outs in the aft release arrangement to shipside retaining devices (Figure 13). This provides additional restraining devices with secondary securing points in the event that the slings fail.

Figure 13. Additional restraining devices (Source: Shigi Shipbuilding Co., Ltd., with TSB annotations)

There was no additional restraining device in use to protect the crew on the *Blue Bosporus* from falling when the slings failed.
