## **MARINE OCCURRENCE REPORT**

### **SINKING**

**OF THE FISHING VESSEL "NADINE"  
GULF OF ST. LAWRENCE  
16 DECEMBER 1990**

**REPORT NUMBER M90L3034**

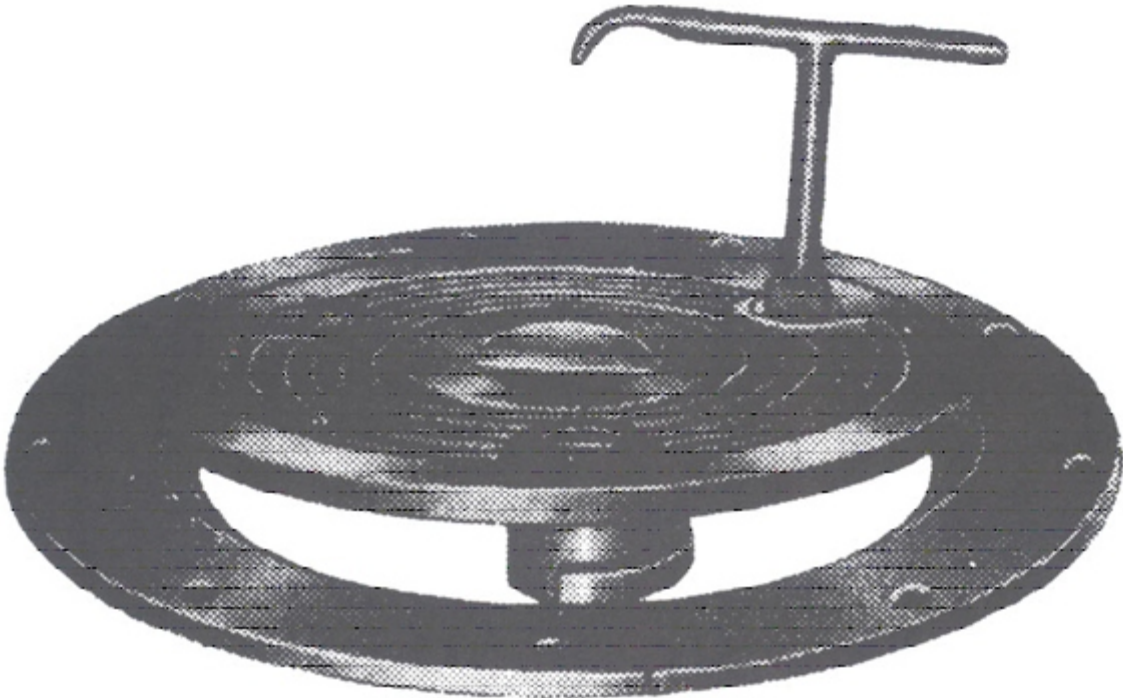
*Appendix L - Photograph of a Manhole Cover and its Dogging Clip*

When the trawl is hauled in, it is hoisted onto the afterdeck above the manholes and then opened. The catch spreads over the afterdeck and drops into the fish holds through those manholes from which the covers have been removed. The catch is then stowed in the various compartments of the holds. When a compartment is full, and before the manhole covers are replaced, silicone is applied to the rim of the manholes to ensure a proper seal. The covers are then replaced and secured with dogging clips. Without the silicone, water may leak in around the rims or dogs of the manholes. New covers are provided on request when defects are noted.

It is common practice for the manholes to be secured during the outbound voyage to preserve the ice supply and during the return voyage to preserve the catch (see Appendices L, M and N). The CCG inspected these openings in May 1990 and found no defects.

In the interest of safety, the Large Fishing Vessel Inspection Regulations state that the covers should be secured or attached by a permanent chain. The TSB found only one piece of chain on the underside of a single cover.

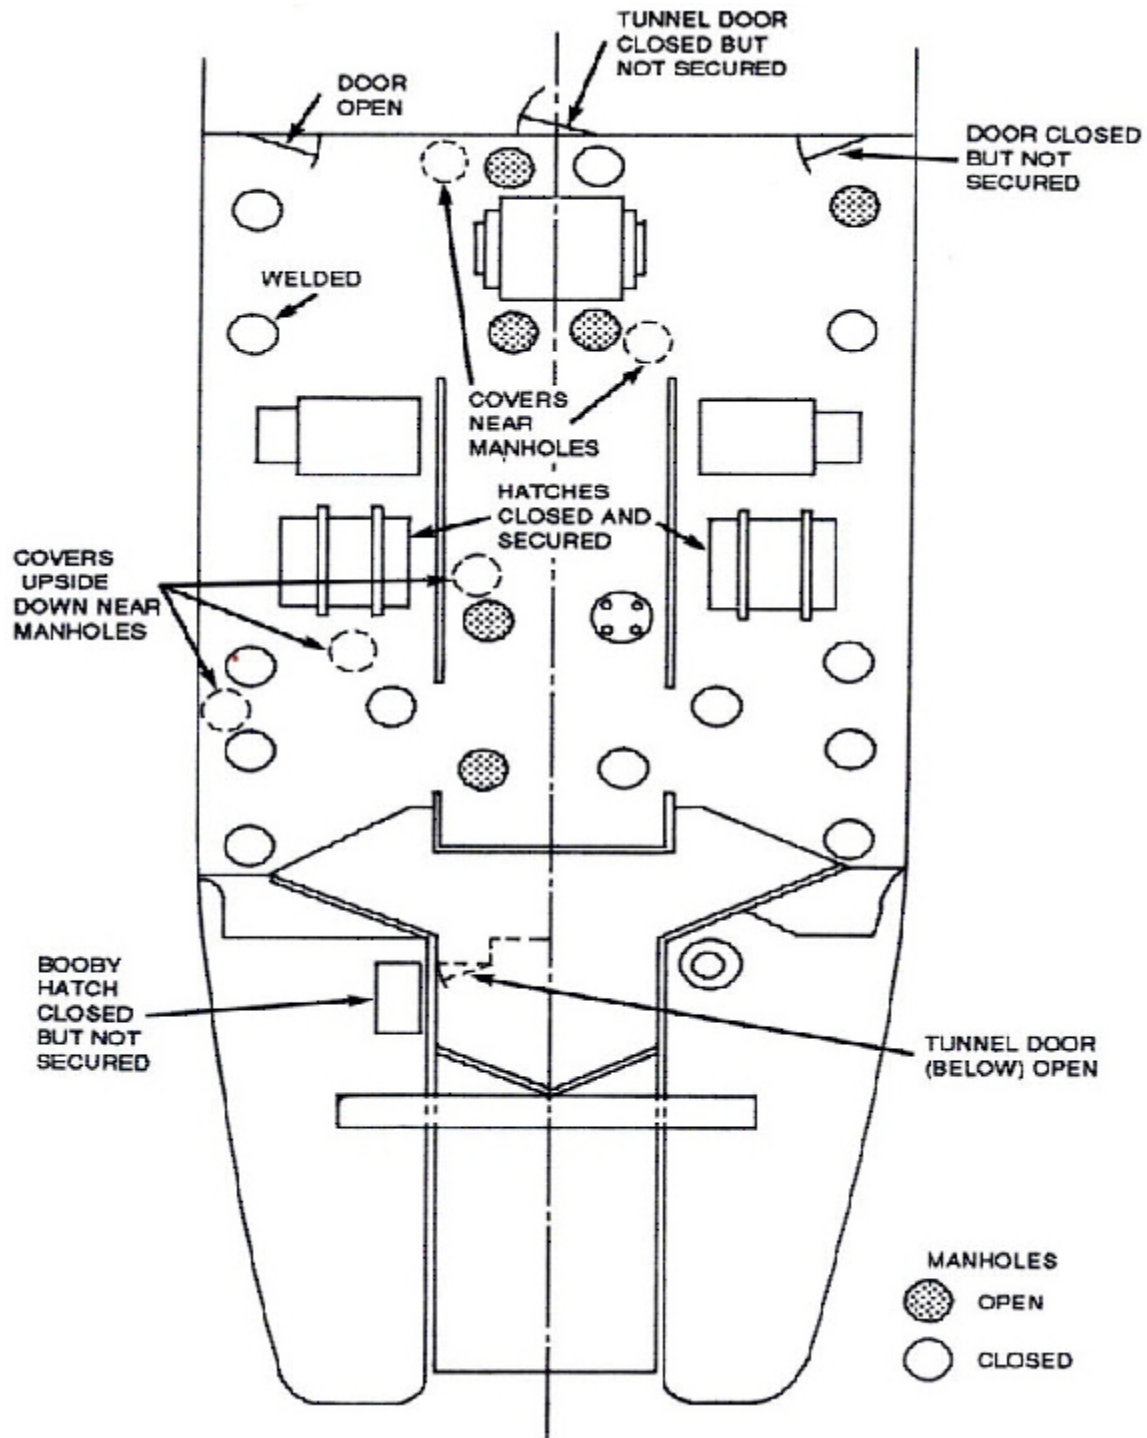
*Appendix M - Diagram of Manholes, Hatches and Doorways as Found After the Sinking*

- there was no sign of damage to the dislodged covers;
- no damage was evident to the rims of either the open or the closed manholes;
- the lazaret scuttle cover was closed but not secured, the after hinge was broken, and the steel wedges were not in position;
- the after door from the tunnel into the lazaret was partially open and a section of net was lying on the doorsill;
- the forward door from the tunnel to the engine-room was closed but not secured.

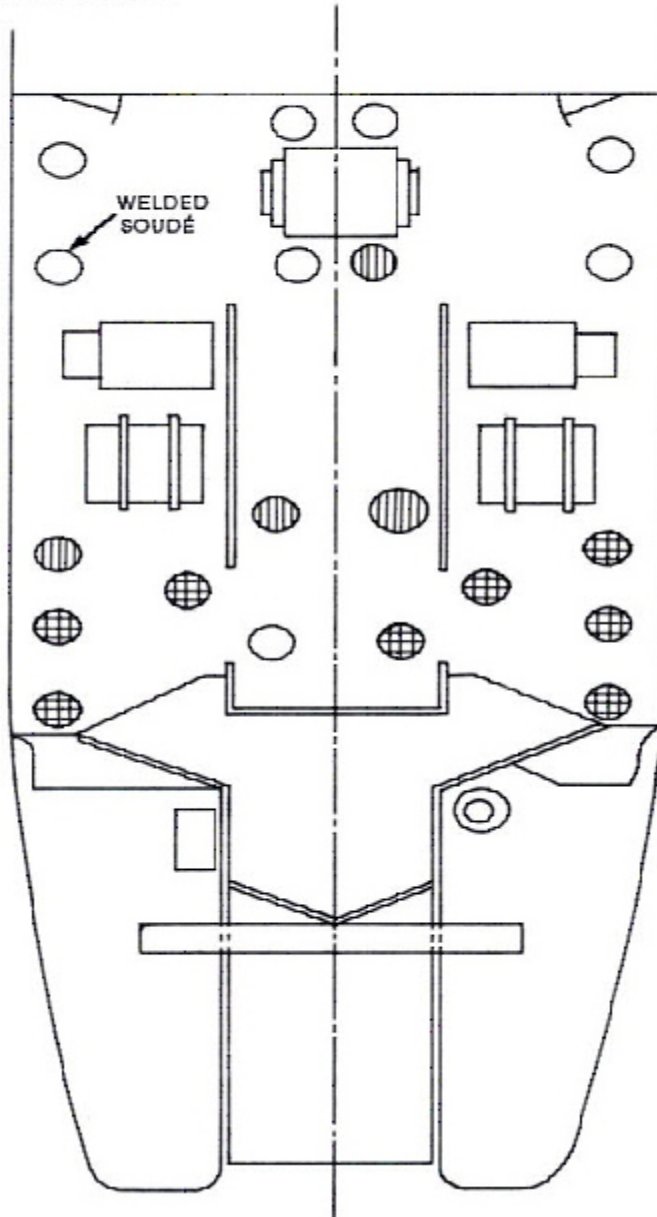
*Appendix N - Condition of Manholes and Covers After the Refloating*

- SILICONE APPLIED  
SILICONE APPLIQUÉ
- ▨ TRACES OF SILICONE FOUND  
TRACES DE SILICONE RETROUVÉES
- NO SILICONE FOUND  
AUCUNE TRACE DE SILICONE

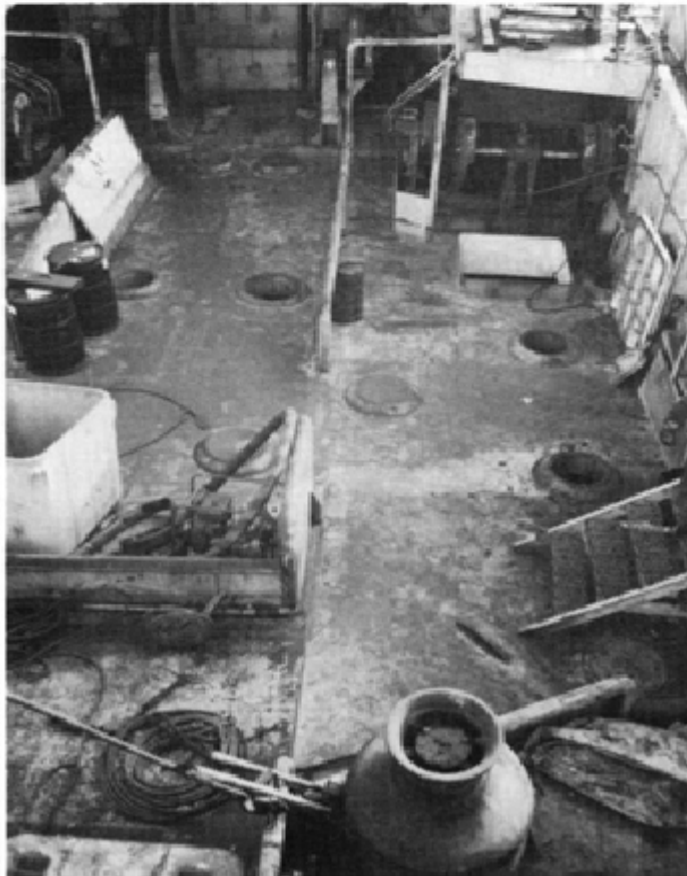
Main deck looking forward towards port bow. Note open manholes and door to port of winch drum.

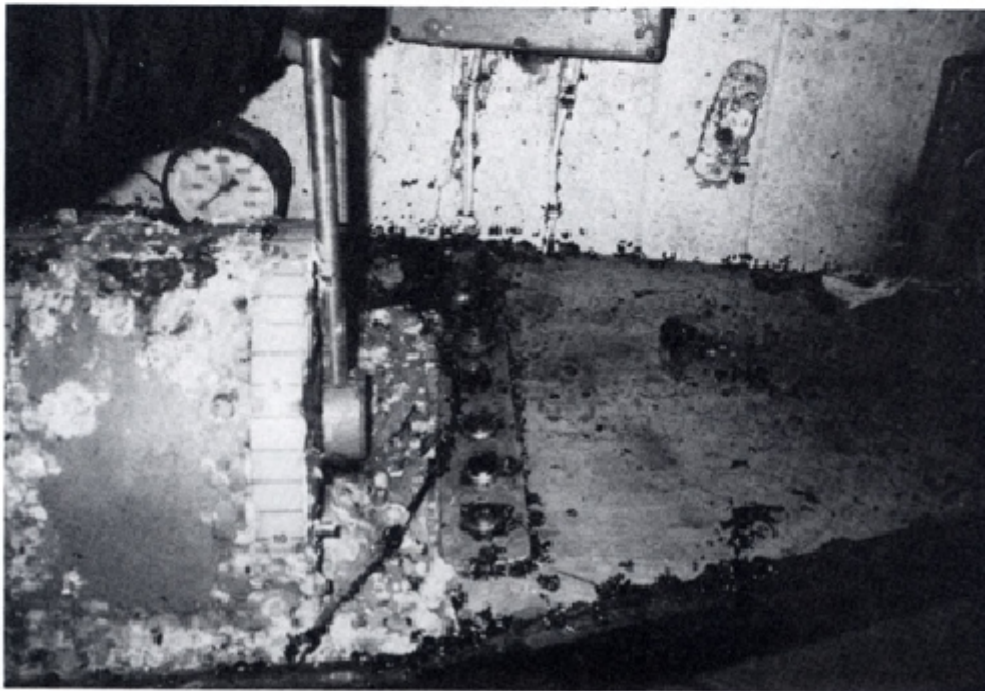
Push-buttons to the right of bridge control. Note absence of labels.

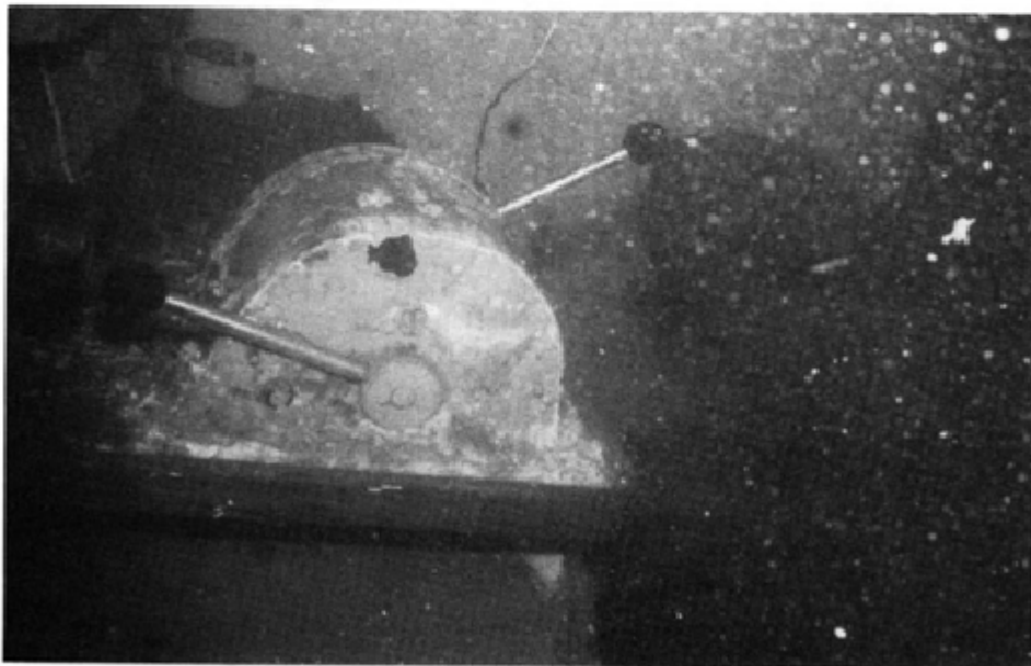
On 10 November 1991, divers from the Quebec Police Force (SQ) inspected the hull and found that there was no major damage except for a crack in the shell plating in way of the after port ballast tank. They found that the propeller pitch control was set to astern.

Starboard wheel-house engine and propeller pitch controls photographed underwater before refloating.

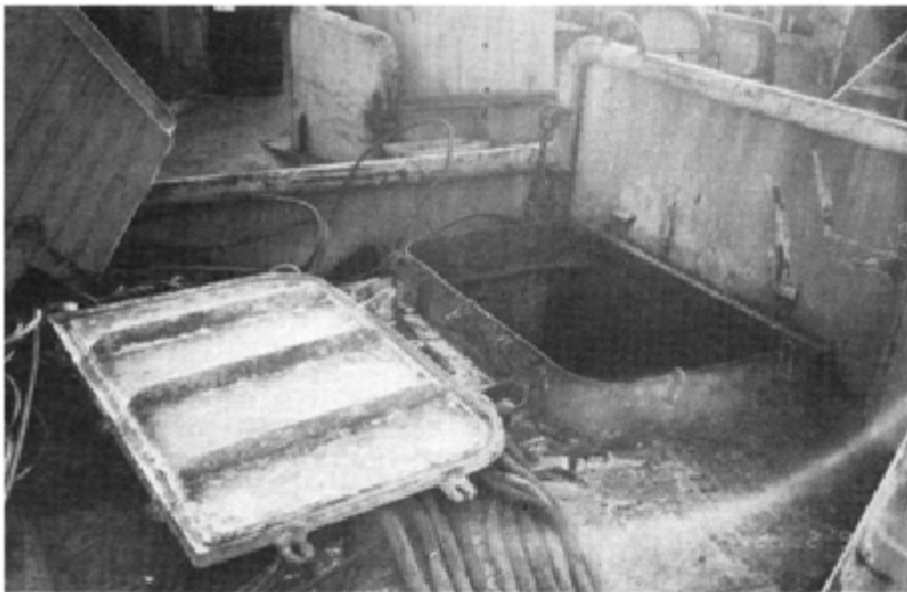
Lazaret scuttle cover.

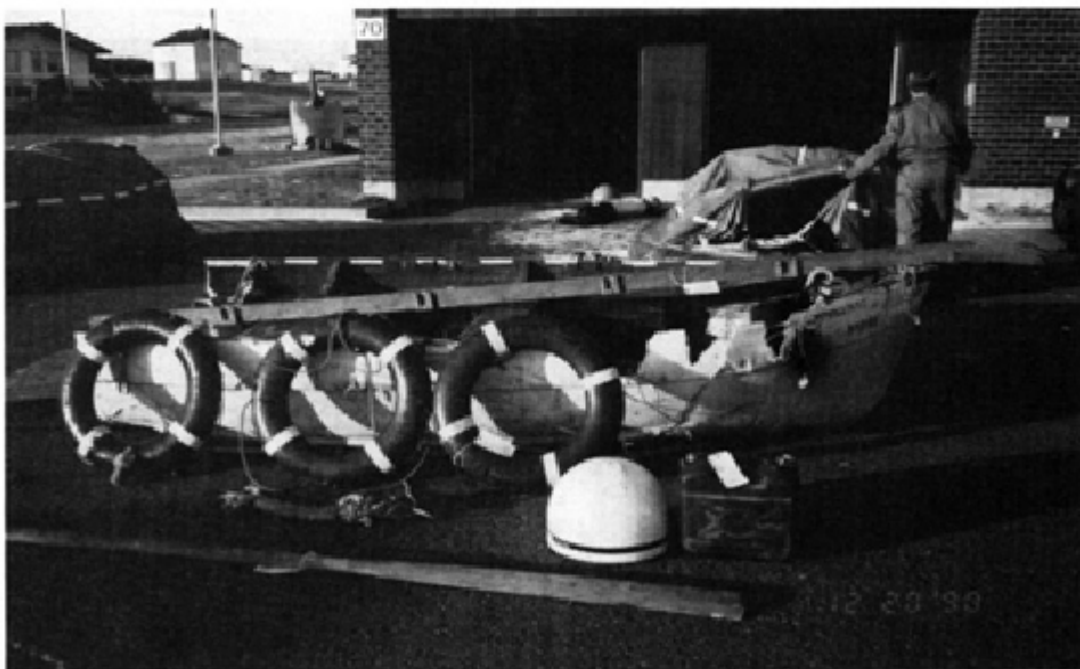
At 0610, the first search objective, the lifeboat, was located by the Aurora aircraft with the assistance of the "SUZANNE P". This was the forward portion of the boat, which had broken in two, and no survivors were found with it.

Recovered lifesaving equipment includes 2 liferafts, 3 lifebuoys and forward section of lifeboat.

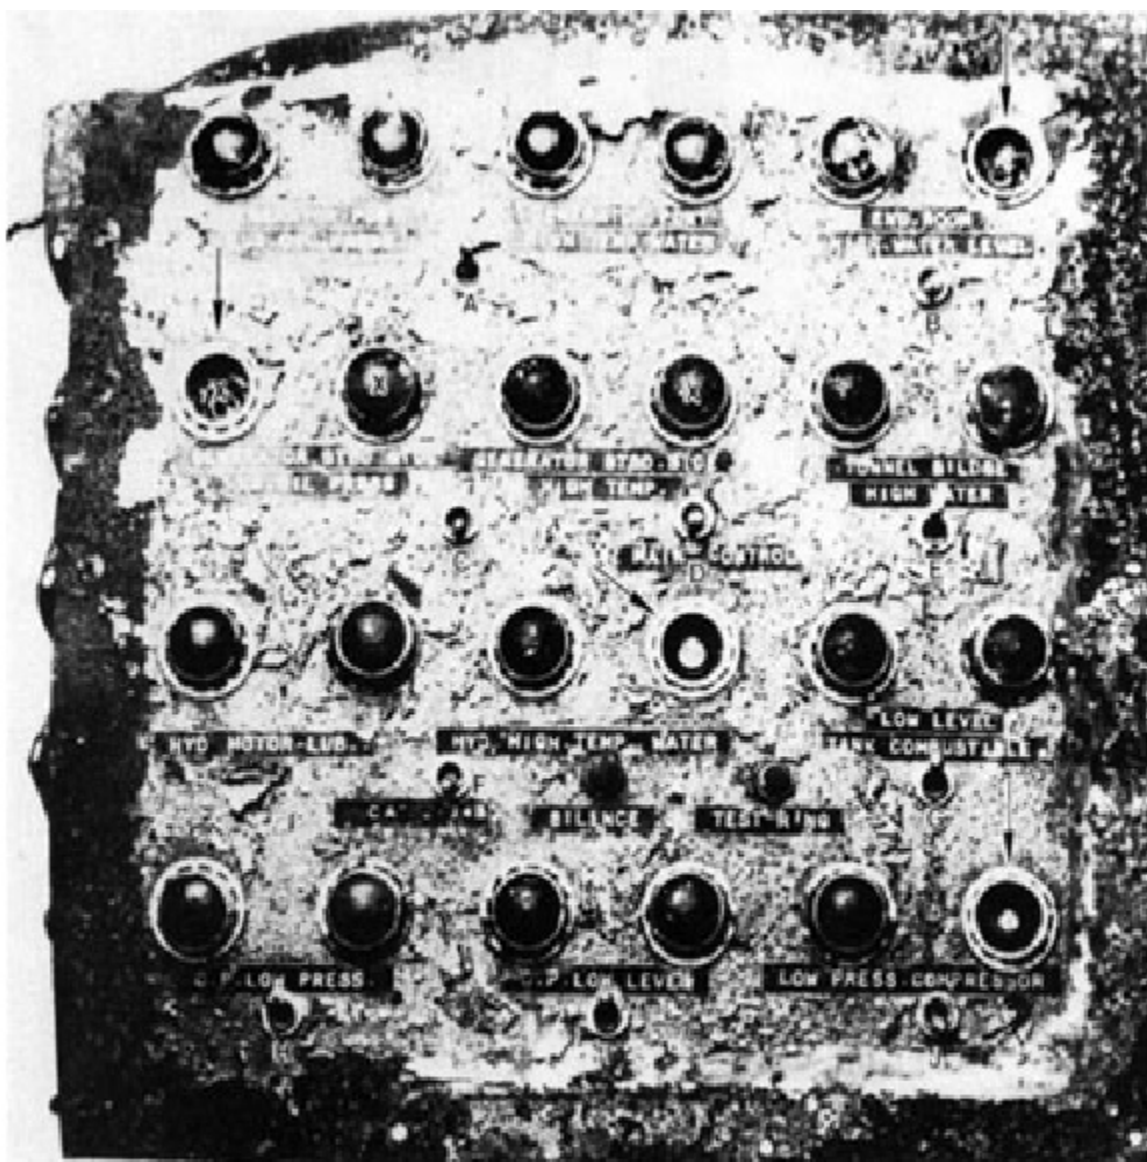
- the after port ballast tank was damaged;
- the lower section of the port quarter shell plating was holed;
- the afterdeck plating around the port ballast tank had buckled;
- the port door to the accommodation on the boat deck was bent inward and its porthole was shattered;
- the cradle of the port liferaft on the boat deck was missing;
- the forward cradle and the forward portion of the lifeboat on the boat deck were missing;
- the after hinge of the lazaret scuttle cover was severed; and
- some lens caps from the alarm panel in the wheel-house were shattered.

The panel was recovered from the wreck but, although several indicator bulb filaments were broken, it could not be determined if the bulbs were illuminated at the time of the sinking.

Front view of the alarm panel as recovered from sunken vessel and received by TSB laboratory. Switches are indicated by letters A-J. Arrows indicate missing lamp caps. The "X" indicates the sockets without lamps.
