Marine Occurrence Report

Collision

between the "SILVER ISLE"
and the "SERSOU"
near Buoy M140
St. Lawrence River, Quebec
12 April 1991

Report Number M91L3008

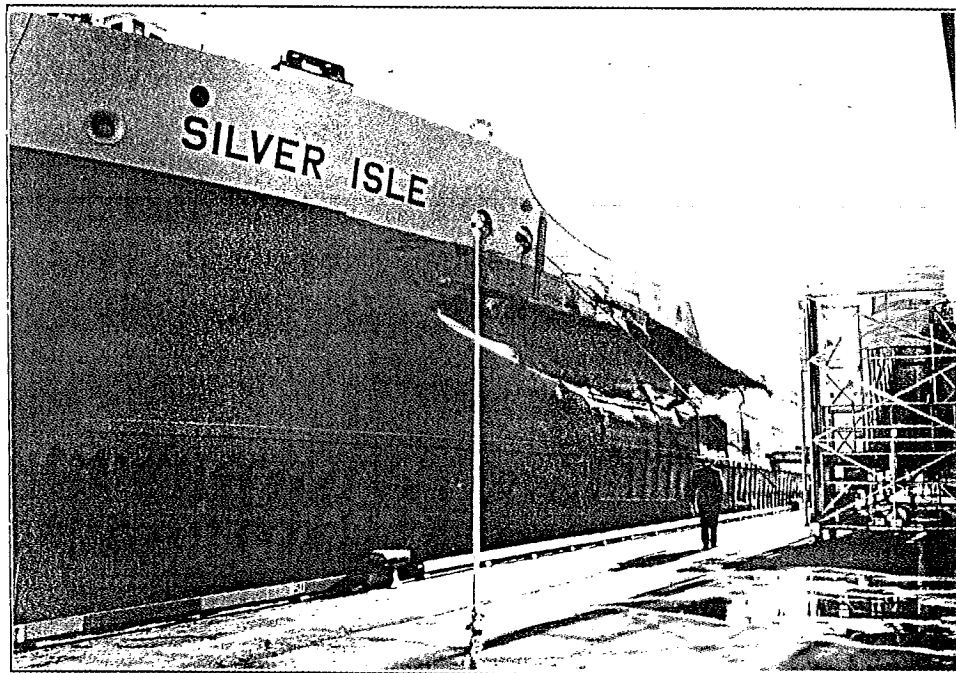
The "SILVER ISLE" sustained heavy damage on the port side forward, amidships and aft. The "SERSOU" also sustained heavy damage, but it was limited to the port bow.

"SILVER ISLE" - Damage Forward.

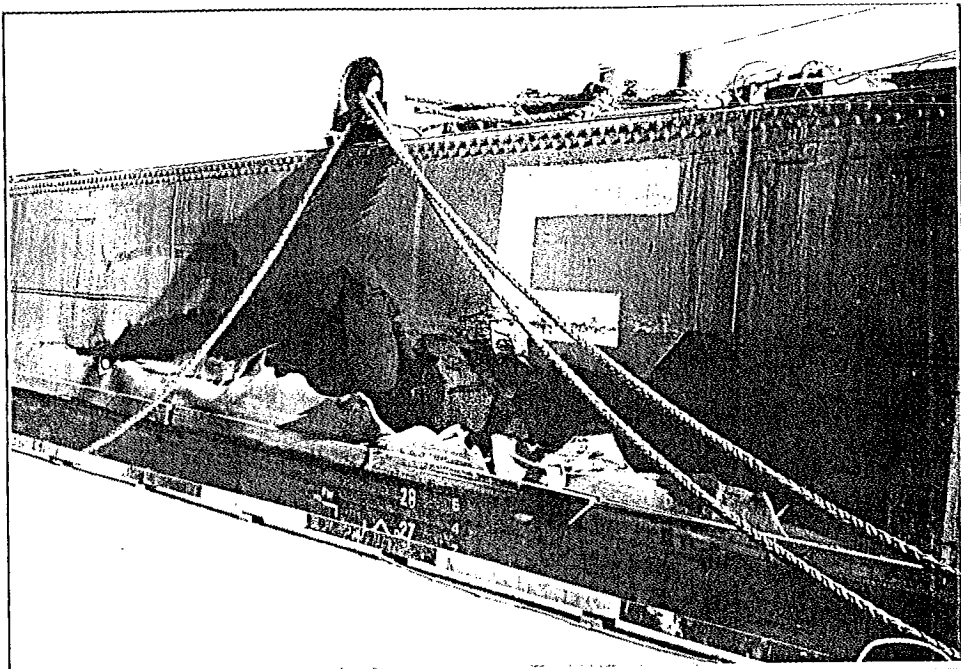
The two vessels put their main engines to full speed astern, but to little effect; a collision was inevitable at that point. First, the forepart of the "SERSOU" struck the port bow of the "SILVER ISLE". As the two vessels passed each other, there was a second impact amidships and then a third one aft. The forecastle of the "SERSOU" heavily damaged three cabins and the crew's lounge on the "SILVER ISLE".

"SILVER ISLE" - Damage Amidships.

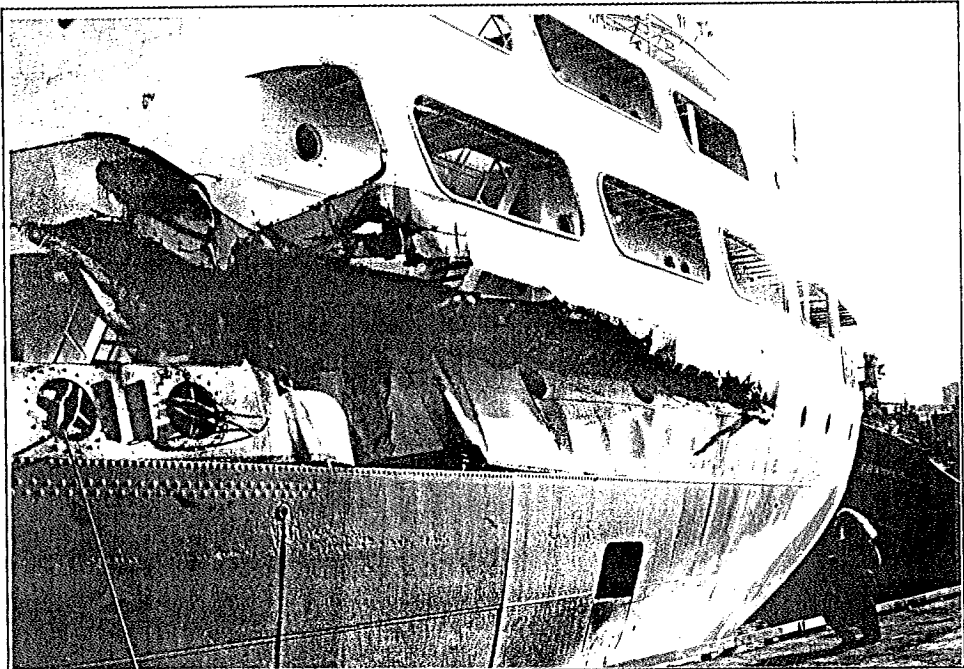
When the master of the "SILVER ISLE" sounded the general alarm, he provided valuable warning time to crew members who were in the cabins and the lounge on the port side aft. That part of the "SILVER ISLE" sustained heavy damage in the collision. The master's action likely saved lives.

"SILVER ISLE" - Damage Aft.

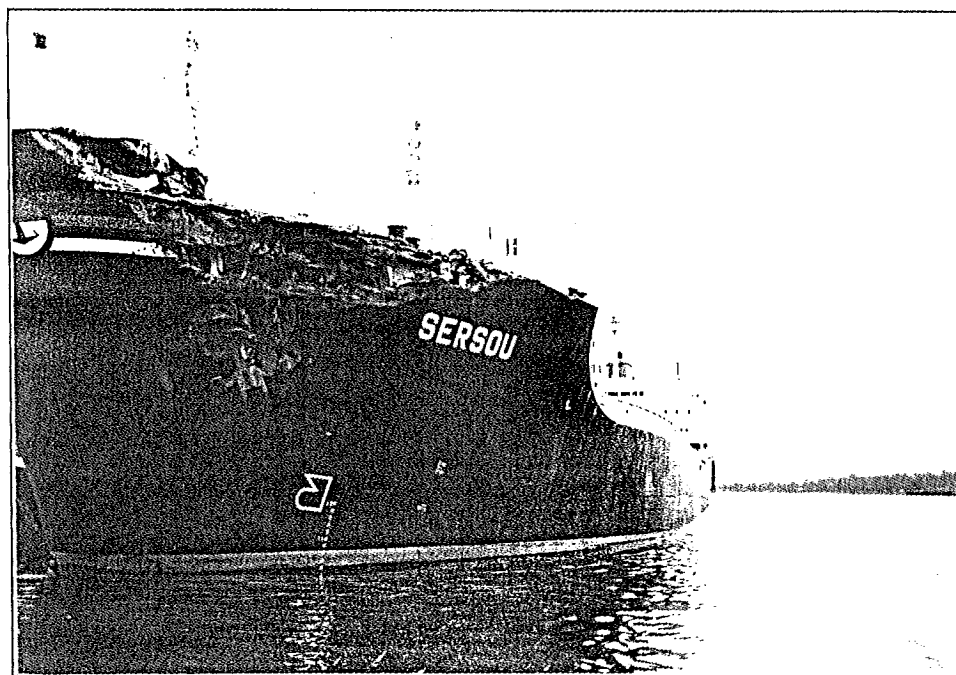
"SERSOU" - Damage to Forecastle.
