Marine Occurrence Report

Bottom Contact

"IRVING NORDIC"
St. Lawrence River
Near Grondines, Quebec
08 May 1991

Report Number M91L3012

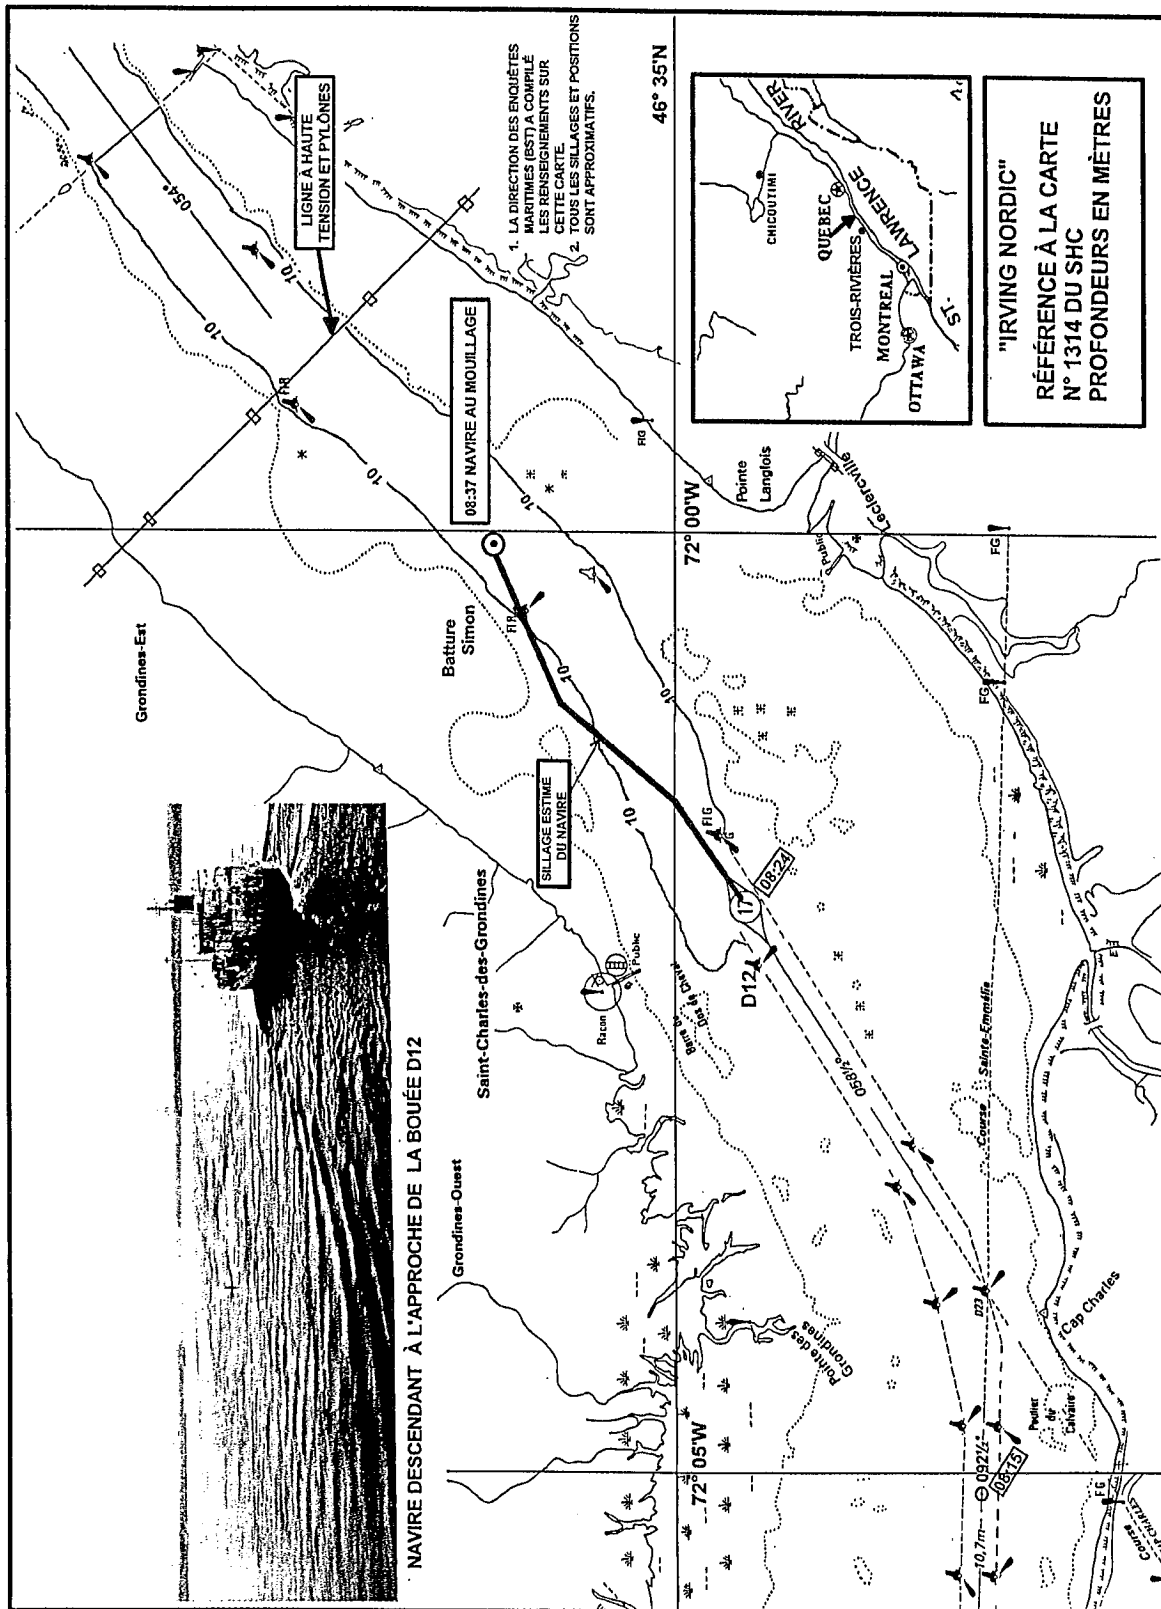
Appendix A - Chart--Area of Occurrence

1. The "IRVING NORDIC" left the navigation channel between the Grondines wharf call-in point (CIP) and buoy D4 and contacted the bottom.
2. The alteration out of the channel was made in response to an order from the pilot, who believed the vessel to be farther downstream than she was.
